A durable coating to prevent stress corrosion effects on the surface strength of annealed glass

A durable coating to prevent stress corrosion effects on the surface strength of annealed glass / Marigiò, G.; Dalle Vacche, S.; Bongiovanni, R.; Louter, C.; Corrado, M.. - In: GLASS STRUCTURES & ENGINEERING. - ISSN 2363-5150. - ELETTRONICO. - 6:4(2021), pp. 449-462. [10.1007/s40940-021-00161-x]

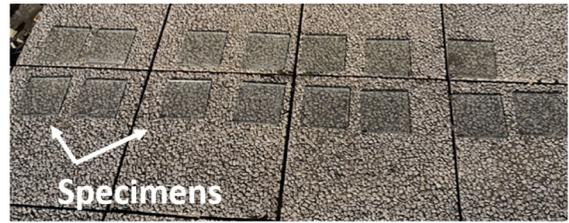
Fig. 4 Set of 15 coated glass specimens exposed to atmospheric agents

A set of 15 coated square glass samples having $l = 120$ mm and $h = 4$ mm were exposed to atmospheric agents for 510 days (17 months), from February 4th 2019, to June 30th 2020, to assess the durability of the coating against natural weathering. The samples were mounted on a frame placed horizontally on the roof of a building of Politecnico di Torino, Corso Duca degli Abruzzi, 24, Torino (Lat: 45.0628, Long: 7.6621, Alt: 254 m. a.s.l) (see Fig. 4). The actual peak to peak variations in temperature and maximum irradiance (SRmax) were between 38.8°C (summer) and -1.5°C (winter) and

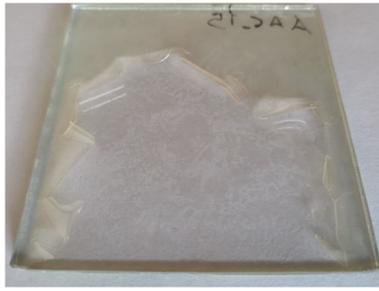
Fig. 7 Qualitative assessment, by visual inspection, of coating deterioration after seven weeks of exposure to artificial weathering

After the ageing processes, all the specimens were cleaned and inspected by naked-eye to localize defects in the coating. The surface damage was visually examined with the specimen placed on a table under regular ceiling-lighting conditions. No evident imperfections were detected on the coated surfaces of cyclic loaded and naturally weathered samples, whereas artificially weathered specimens exposed for six and seven weeks exhibited cracking and delamination of the coating (see Fig. 7).
