Laboratory Test Campaign Aimed at the Analysis of an Uncommon Wear Phenomenon in a Marble Quarry

Article

Featured Application: This paper presents a laboratory test campaign focused on the reduction of the wear phenomenon related to a material extracted from a marble quarry. The aim of the work is to propose a potential solution for the wear reduction pertaining to chainsaw cutting machine tools.

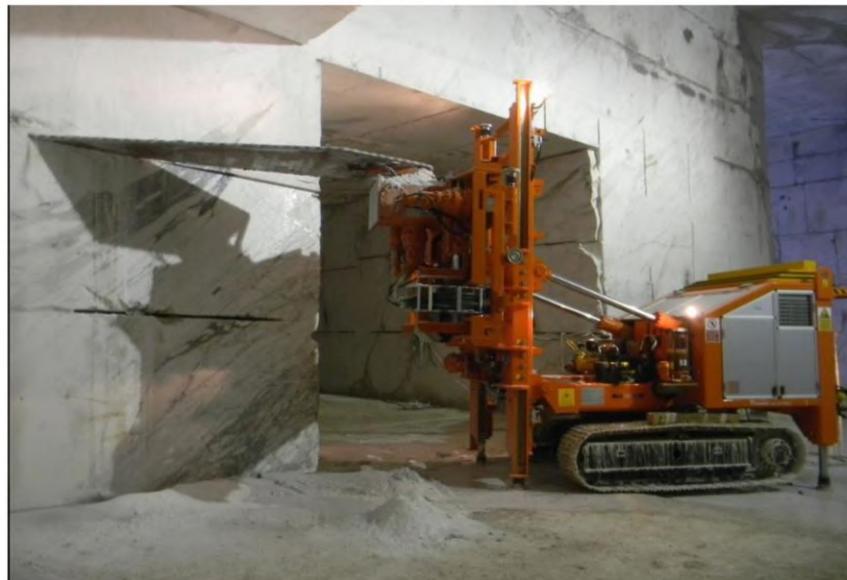
Figure 1. The chain cutting machine adopted in the quarry. The machine is engaged in a series of horizontal cuts to widen the underground opening (link <https://www.fantinspa.it/en/gu70rxc-tunnel-chain-saw-machine/>, accessed on 2 October 2021).

At 869 m a.s.l., where the development was planned for the expansion of the underground exploitation, the presence of grey-white marble with flint nodules was noticed. In this area, during the works started in 2018, a “sheath fold” emerged, with a siliceous marble core in entrochi, characterized by a trend of about 350° , immersion at NW of about 10° , and boudinage. Initially, this structure seemed to close quickly, while in a short space corresponding to the execution of about three development advances in the tunnel, for about 9 m in total, the core opened into a boudinage, and the structure progressed towards the inside of the cluster. The core of this structure proved impossible to cut, due to the fast wear of the tools. The machine used in marble cutting operations is the chain cutting saw (Figure 1), which has the great advantage of not requiring preliminary cutting operations. The arm operates easily, even in the presence of only one free surface. In all cases where it is necessary to perform blind cuts, the chainsaw, alone or in cooperation with the diamond wire saw, is frequently used. At the quarry, the excavation works are carried out with a chainsaw on which a 3.5 m long cutting blade is installed, equipped with guides, where a single-mesh metal chain runs (74 mm pitch, 42 mm cutting width), equipped with polycrystalline diamond plate tools. Seven sets of tool-holders are installed on the cutting chain; each series includes 12 tool holders with different cutting configurations. The tool has a diameter of 8.0 mm, a diamond layer thickness of 1.5 mm, and a tungsten carbide (WC) layer thickness of 6.6 mm, for a total height of 8.1 mm. The WC area is welded directly on the tool holder and does not contribute to the cut (made expressly from polycrystalline diamond) but represents an intermediate support between the diamond and the tool holder. Figure 2 shows a detail of the tools adopted.

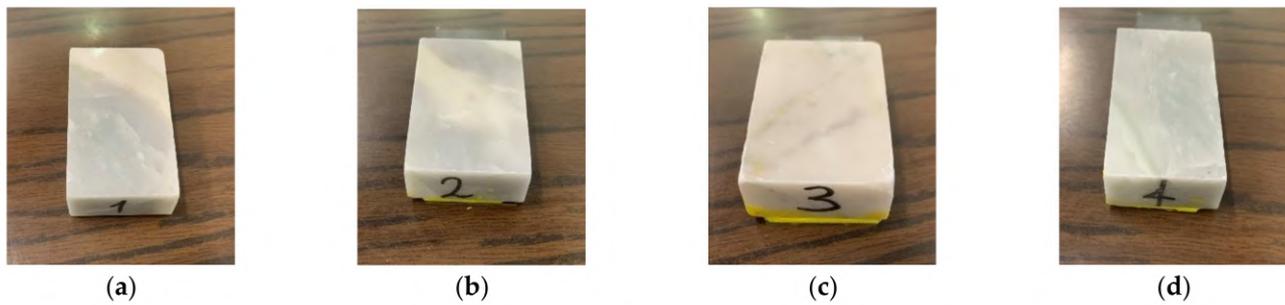
Figure 6. Samples analyzed. The grey veins are marginally present in sample 3 (c), while in samples 1 and 2 (a,b), the presence of impurities is greater. Sample 4 (d) is almost entirely composed of grey material.

The marble specimens, $50 \times 30 \times 15$ mm in size, had a perfectly polished upper surface. The dimensions were chosen in order to maximize the available surface, compatible with the constraints of the instrument. Four different samples were prepared, taking care to select material with different mineralogy. Considering the grey veins embedded in the calcite matrix (white color of the background of the samples), the patterns were selected by choosing marble pieces with different presences of impurities (grey veins), as shown in Figure 6. For each sample, 80 microhardness measurements were performed by applying a load of 200 g (1.96 N). On average, the distance between two successive footprints was 100 μm . Regarding the outcome analysis, the microhardness values for each sample were sorted and, subsequently, the values in terms of cumulative frequency were displayed, giving a characteristic curve. Figure 7 shows the microhardness characteristic curves obtained.
