Technology, Diagnosis and Structural Assessment on Timber Composite Beams in Venice Arsenal at the Biennale

Technology, diagnosis and structural assessment on timber composite beams in Venice Arsenal at the Biennale

Keywords: constructive technology, composite beams, timber floor, burned structures, diagnosis NDT, dendrochronology

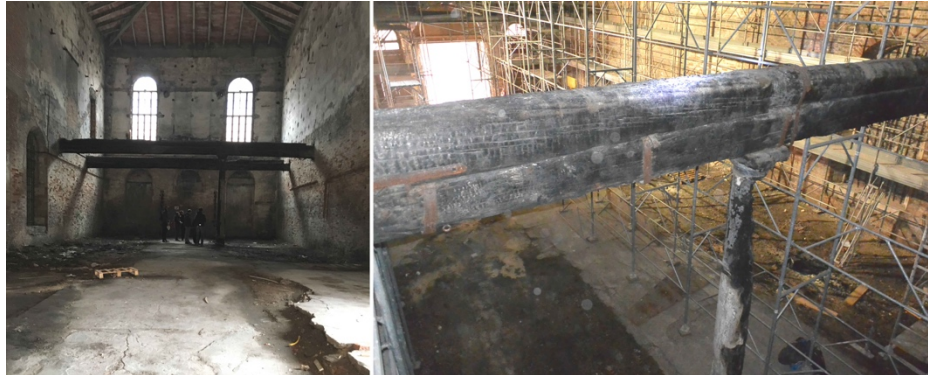
As evidence of the architectural importance of the building, the two large wooden beams, object of the present study, were still preserved on site (Fig. 5).

Fig. 5 Interior view of the Sala d'Armi “E” (left), detail of the burned wooden beam with wooden column (right). (Photo D. Ferrante, 2019)

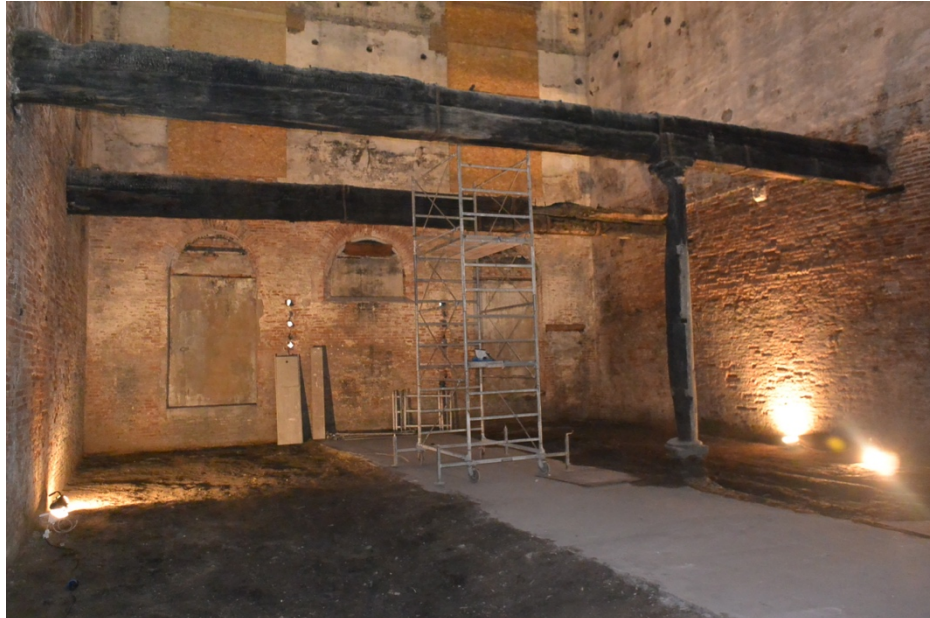
The two composite beams, which have remained in the "Sala d'Armi" building "E" building today, have extended traces of fire.

A single wooden column with Doric capital is currently present in the first beam, with a height of about 4.30 m (Fig. 7).

Fig. 7 Interior view of the Sala d'Armi "E", composite beams and wooden column (Photo D. Ferrante, 2019)
