# Technology, diagnosis and structural assessment on timber composite beams in Venice Arsenal at the Biennale

**Abstract** In the architectural and cultural heritage of the Arsenale of Venice, the authors have worked on several interventions for diagnosis and recovery of roofs, foundations and floors of the so-called "woods of Venice". The work refers to the complex of the "Sale d'Armi" located in the central area of the Arsenale, currently used as exhibition space for the Biennale of Venice. The original nucleus (1460) was used as weapons deposit of the Serenissima. The South "Sala d'Armi", three buildings on two levels realized in the 17<sup>th</sup> century, were rebuilt after the fire of 1728. This article describes the diagnostic assessment, including dendrochronological and mechanical assessment, carried out in one of these buildings, the largest one, a large room at full height, which currently preserves original timber elements left in place after the fire: composite beams belonging to a timber floor supported by timber columns. The paper focuses on a very interesting construction system such as the historical composite wooden beams. This technology, although in frequent u

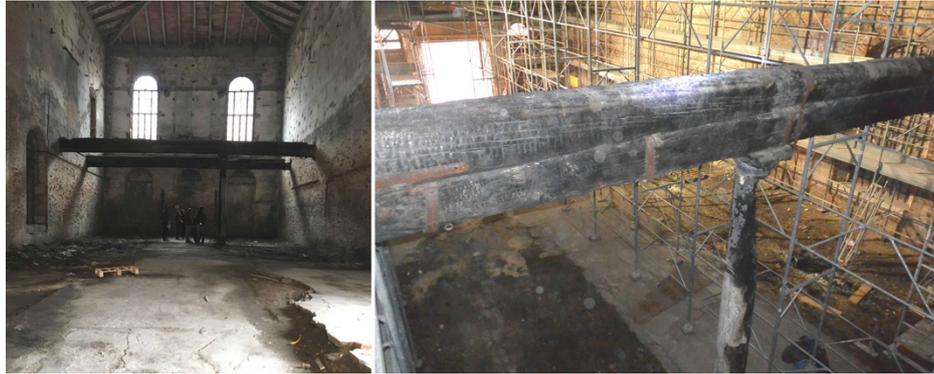
**Fig. 5** Interior view of the Sala d'Armi “E” (left), detail of the burned wooden beam with wooden column (right). (Photo D. Ferrante, 2019)

As evidence of the architectural importance of the building, the two large wooden beams, object of the present study, were still preserved on site (Fig. 5).

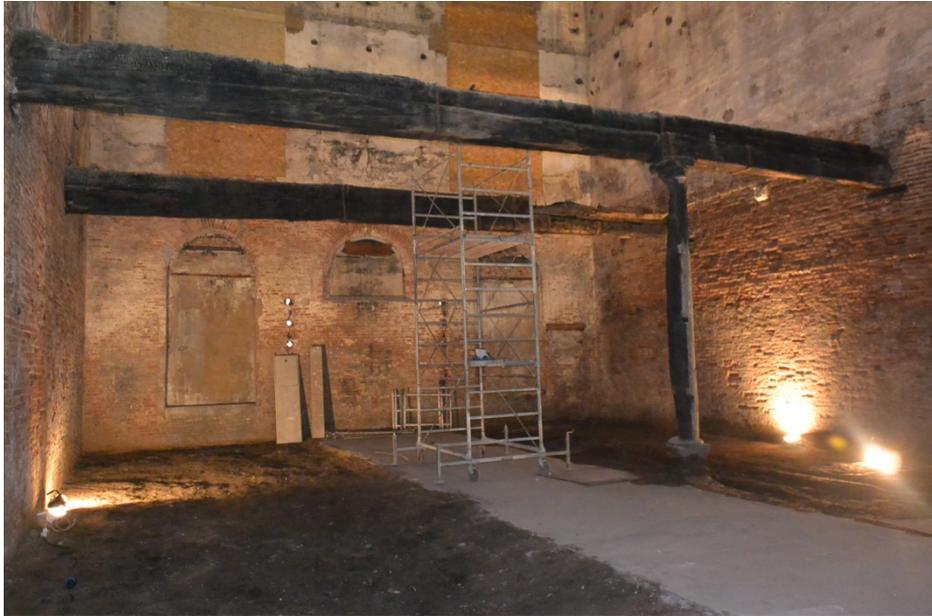
A single wooden column with Doric capital is currently present in the first beam, with a height of about 4.30 m (Fig. 7).

**Fig. 7** Interior view of the Sala d'Armi "E", composite beams and wooden column (Photo D. Ferrante, 2019)
