Raman spectroscopic characterization of corrosion products of archaeological iron

A Vietti <sup>1</sup>, E Angelini <sup>2</sup>, S Grassini <sup>2</sup>, N Donato <sup>3</sup>

**Abstract.** Raman spectroscopy is a versatile analytical technique which allows the detection of different molecules analysing the vibrational modes. As a matter of facts, the vibrational frequencies are typical of a specific chemical bond or of a structural symmetry. In this study, the Raman technique is used for the determination of iron corrosion products, mainly oxides and hydroxides. Metallic artefacts buried in soil are affected, in dependence of their electrochemical nobility, by corrosion phenomena of various entities, which partially modify their chemical composition and their structure. The process may occur both during burial time and after the extraction from the archaeological site, implying the potential loss of information about the metallurgical technology and structure of the object. The study of the corrosion phenomena allows to propose tailored strategies for the restoration and conservation of the artefacts, especially in view of the storage of the artefacts in a museum. This study va

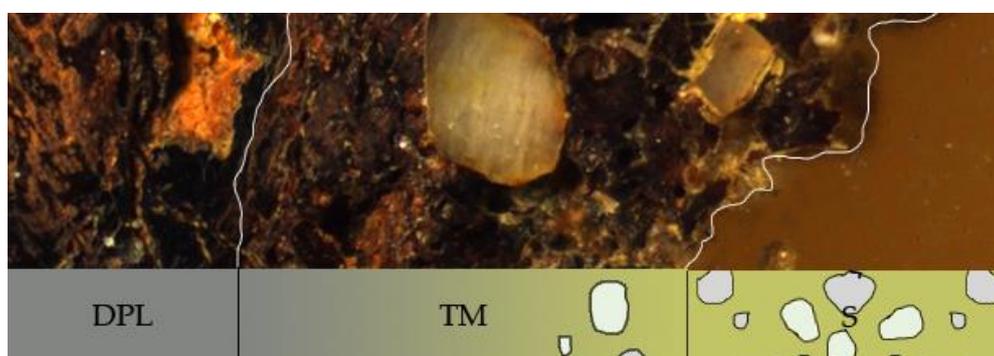
**Figure 5.** The schematic corrosion layers correlated with the section of sample CH\_03. The soil layer (S) is not present anymore, because the sample was cleaned before the inclusion in resin.

The Transition Zone, where the corrosion products are less crystallized, is composed essentially of goethite, maghemite and lepidocrocite. Regarding the lepidocrocite, which is a very reactive phase most probably formed after the excavation, is located especially in the cracks of the nail or at the interface with the soil. An example of the general corrosion stratigraphy is briefly schematized in Figure 5.
