A Machine Vision—Based Pipe Leakage Detection System for Automated Power Plant Maintenance / Bao, Nengsheng; Fan, Yuchen; Ye, Zihao; Simeone, Alessandro. - In: SENSORS. - ISSN 1424-8220. - 22:4(2022), p. 1588. [10.3390/s22041588]

# A Machine Vision—Based Pipe Leakage Detection System for Automated Power Plant Maintenance

**Abstract:** Industrial pipework maintenance inspection can be automated through machine vision-based effusion monitoring. However, colorless effusions such as water can be difficult to detect in a complex industrial environment due to weak illumination and poor visibility of the background. This paper deploys the reflective characteristics of effusion and its lower temperature compared to the environment in order to develop an automatic inspection system for power plant pipeworks' maintenance. Such a system is aimed at detecting the colorless fluid effusion based on dual source images and a contour features algorithm. In this respect, a visible light source unit highlights the reflective features of the effusion edge. Meanwhile, high-definition images of the potential effusion are acquired under both visible and infrared lights. A customized image processing pr

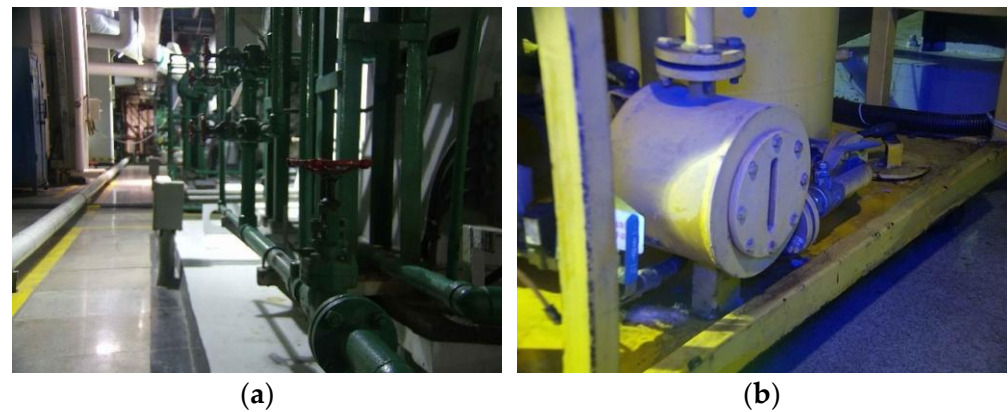
**Figure 2.** Significant difficulties in the actual factory environment: (a) Complex pipework layout; (b) diverse illumination conditions and non-uniform light distribution result in highly variable detection area background.

The visual detection technology survey suggests that the two major characteristics of colorless effusion, namely the reflective characteristic under full lighting and the low temperature characteristics in the environment, can be deployed by existing technology for detection purposes. However, the design and implementation of a comprehensive detection system results difficult in complex industrial environments. With reference to a generic thermal power plant, on the one hand, the site environment is complex and characterized by crisscrossing pipelines, with significant environmental interference problems occurring during maintenance inspection such as humidity and cold areas (as shown in Figure 2a). On the other hand, the areas affected by fluid effusion are usually poorly illuminated, making the colorless effusion detection hard to be directly performed (as shown in Figure 2b).

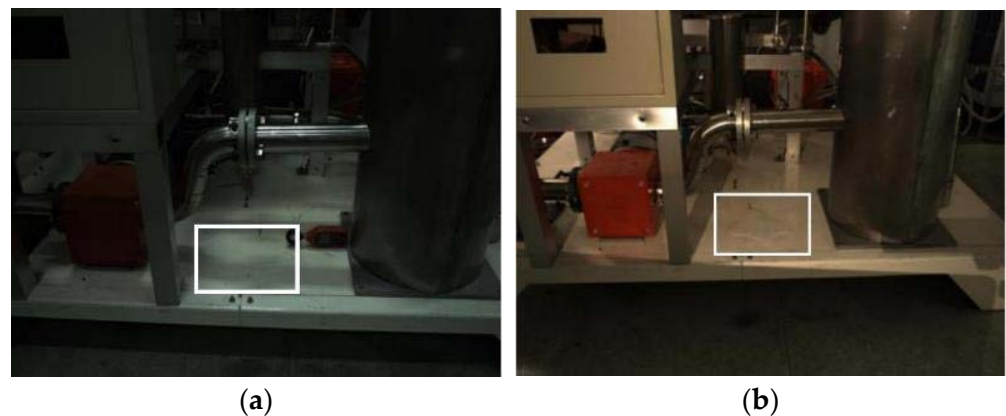
**Figure 3.** Difficult to detect colorless effusion (in the white box): (a) effusion feature in natural light; (b) effusion feature under LED flash light.

In general, the illumination conditions of the overall environment can be enhanced through a flash light, but visual characteristics of the leakage would still tend to appear as colorless, as shown in the white box mark in Figure 3a. The use of additional LED lights could enhance the water leakage edge features visualization, but the overall edge contour would look still fuzzy and hard to detect (as shown in Figure 3b).
