# Full-scale testing and analysis of 50-year old prestressed concrete bridge girders

**ABSTRACT:** The present research covers the full-scale loading tests conducted on 50-year old prestressed concrete girders. The beams were removed from an existing viaduct in Turin, Italy, and gave the possibility to setup a large experimental campaign as part of the research project named BRIDGE|50 ([www.bridge50.org](http://www.bridge50.org)). The precast prestressed concrete beams have approximately 19.2 m span length and I-shaped cross section with 14 cm cast-in situ slab. For each specimen, static tests have carried out applying monotonic and cyclic loading profiles up to the ultimate load, measuring deflections, loads and strains in several positions. The results of the tests in terms of load-deflection responses and strains are reported for each beam investigated and compared each other. The experimental findings highlight the global structural response and the outcomes will define a reference for future studies aimed to assess the residual structural performance of existing bridges.

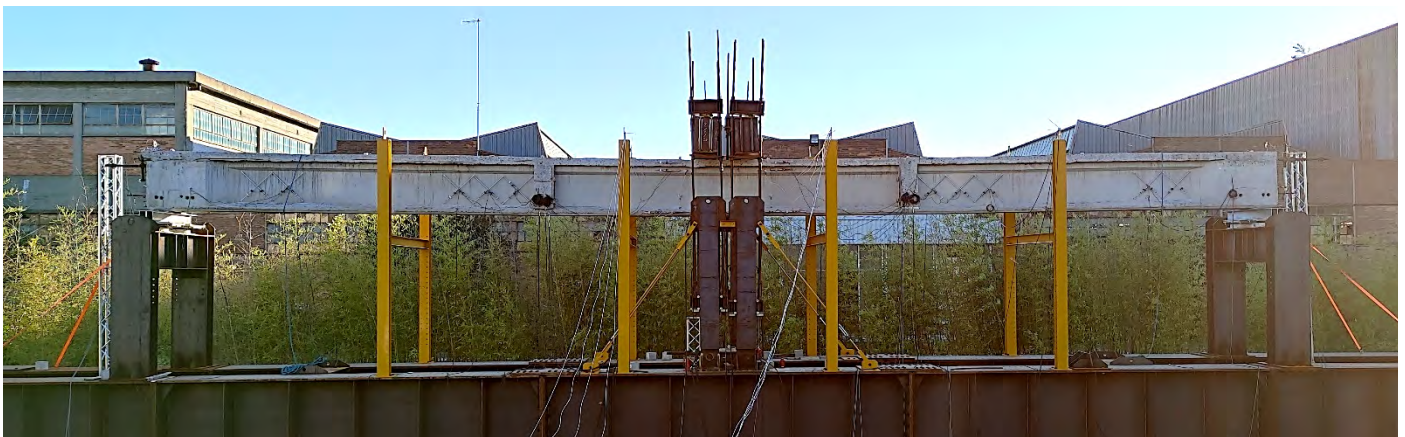
The beams composed by the precast element and the overlying slab portion were stored on supports to closely replicate the original in-service configuration in a testing site in Turin. The tests were conducted by using a steel reaction frame specifically fabricated and provided by the Interdepartmental Center SISCON (Safety of Infrastructure and Construction) of Polytechnic of Turin. The reaction steel frame allows to perform 4 point bending tests allowing variable distances between the forces applied by two couples of servo-hydraulic cylinders. The Figure 3 shows a general view of the test setup. In the tests described in this work, the two loading points were applied at 0.6 m apart to generate bending failure. Future tests will examine different types of loading schemes, in order to observe the effects of shear or the shear-bending interaction. In the present study, the load refers to the action applied by 1 actuator and therefore the total applied force should be multiplied by 4.

Figure 3. General test setup.
