# A tool for monitoring rockfall protection works and plan the maintenance: the case of the autonomous region of Valle d'Aosta

Rockfall net fences and drapery meshes constitute two of the most adopted protective structural works against rockfall hazard. During their life, they are subject to ageing, corrosion, and impact loads, with a consequent loss of efficiency or even effectiveness. Due to the variability of the environment and, more in general, to external conditions, a definition of a service life, although not unique but different product by product, is not achievable.

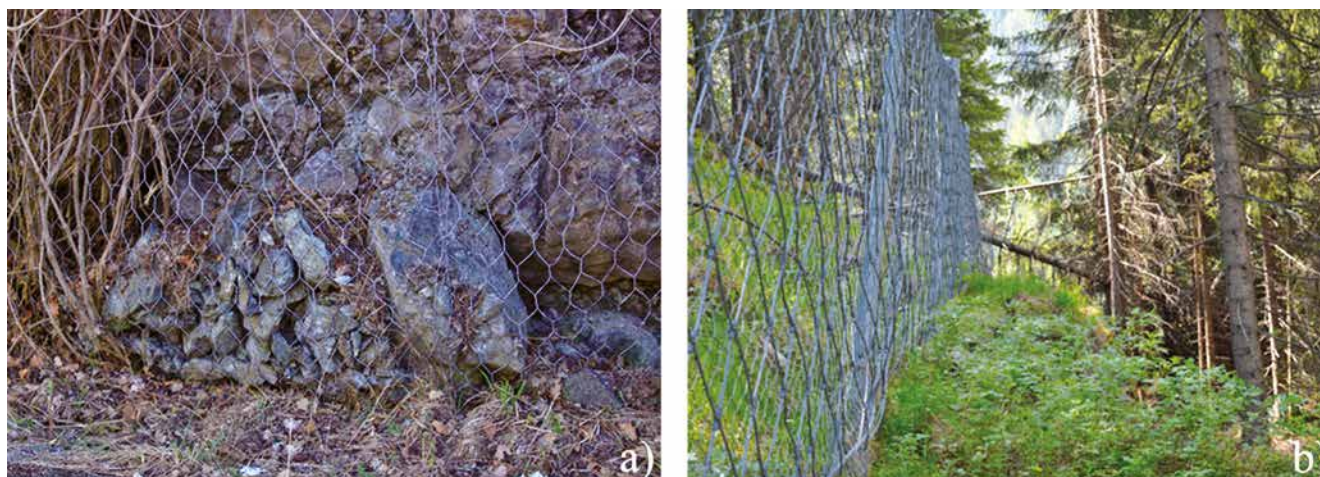
Fig. 2 – Accumulation of debris, due also to impacts with energy smaller than the design one (a), and impacts of element differing from rock blocks, i.e. trees after some severe or unexpected climatic events (b).

climatic events, represent recurring situations highlighted during inspections (Fig. 2).

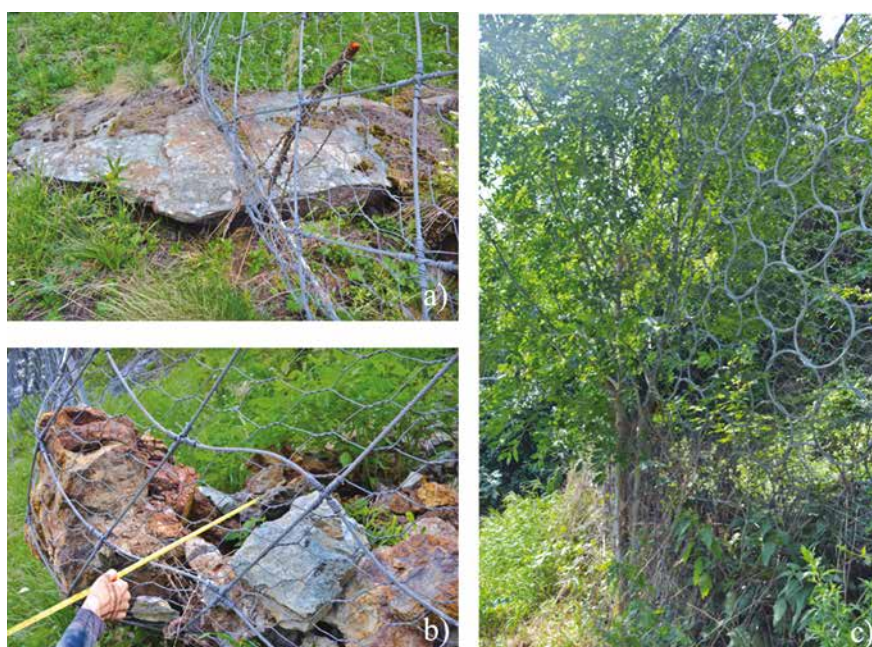
Fig. 4 – Frequent observed damages: voids at the foot of the barrier (a), debris/blocks/notches in the net (b), and elements limiting the deformation capacity of the barrier (c).

Analysing in detail those net fences that display a high need of interventions, the presence of significant void at the foot of the barrier reveals to be the major issue, together with the presence of elements limiting the deformation capacity of the barrier (Fig. 4 and

5). Both these aspects are highlighted in the 62% of the samples (and in many cases they are observed together), while in 31% the presence of debris/blocks/notches in the net is shown. Considering also  $P_{tot}$  values, this indicator is lower or equal 15% in all the cases, revealing that in the great majority the indicator  $A$  mostly affects the results. This implies that, even though high priority levels of maintenance are required, the maintenance procedures to adopt would involve only a single aspect/damage, i.e. closing the net at the bottom, removing blocks or trees

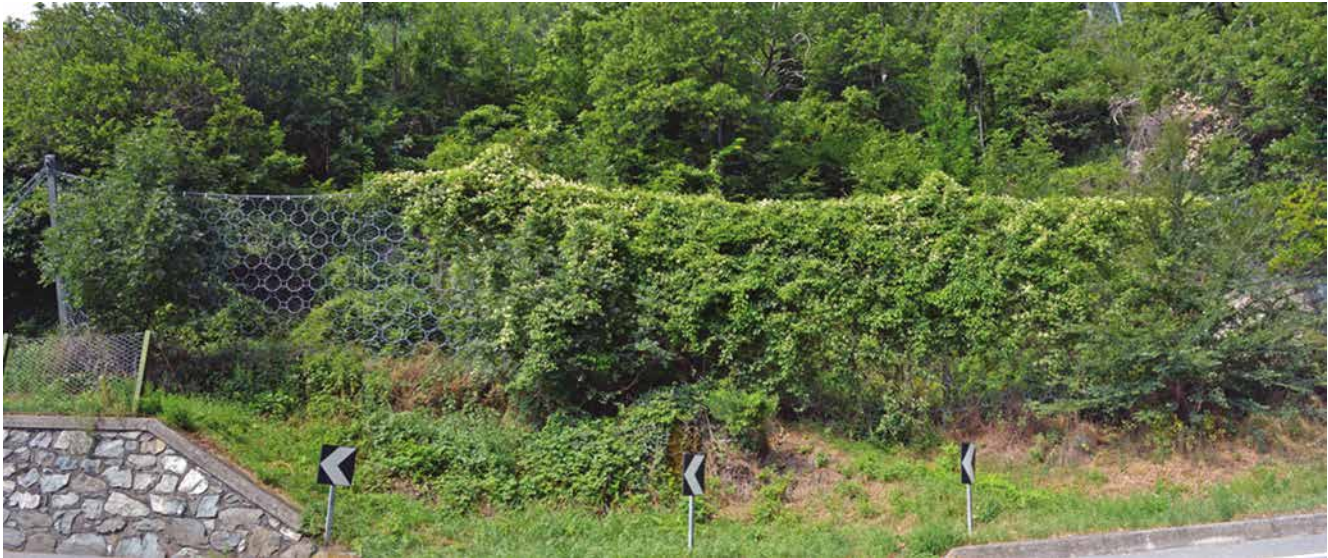
Fig. 6 – Presence of dense vegetation.

Among the potential damages which can lead to, at least, a medium or medium-high maintenance need, corrosion is the most observed, together with small voids at the bottom and little presence of elements interfering with the net. A very frequently observed potential damage, even secondary, is related to the presence of vegetation, which can make difficult to see and inspect the barrier (Fig. 6). In many cases, thus, an operation of periodic vegetation clearance is strongly suggested. If not periodically removed, the vegetation can promote the occurrence of collateral damages, e.g. corrosion due to the humid environment, and for some species, the trunk could limit the deformation capabilities of the barrier or the sliding capacity of the breaks.
