A tool for monitoring rockfall protection works and plan the maintenance: the case of the autonomous region of Valle d'Aosta

Rockfall net fences and drapery meshes constitute two of the most adopted protective structural works against rockfall hazard. During their life, they are subject to ageing, corrosion, and impact loads, with a consequent loss of efficiency or even effectiveness. Due to the variability of the environment and, more in general, to external conditions, a definition of a service life, although not unique but different product by product, is not achievable.

The paper presents the methodology, in its enhanced version, some examples are proposed, considering a survey campaign performed in Valle d'Aosta (Italy) as representative. The results of its application are reported and discussed.

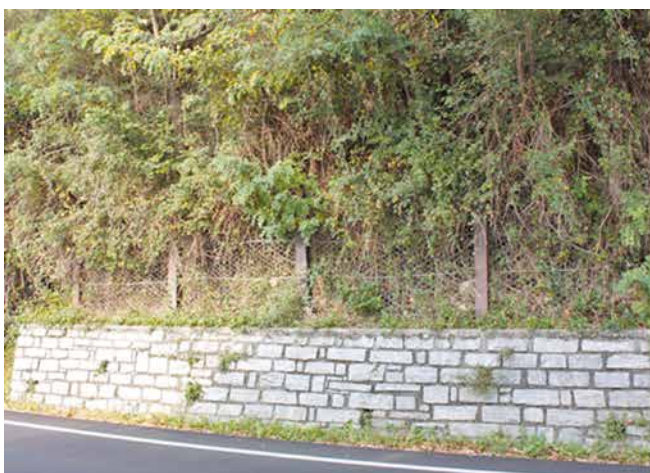
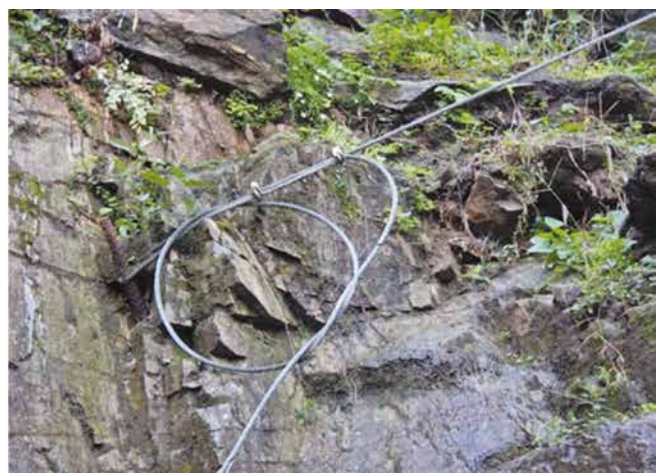
Neglecting the design aspect, several damages frequently observed relate with installation errors, and suitable or unsuitable certified technologies (Fig. 1). Focusing directly on degradation and ageing incorrect/absent maintenance procedures, among the problems, the ones related to vegetation, directly interacting with the works or otherwise influencing their performances, are the most common. Corrosion has been frequently observed in several components, even in the anchors, where disrupted. Accumulation of debris, due also to impacts with energy much smaller than the design one, as well as impacts of element differing from rock blocks, i.e. trees after some severe or unexpected

Fig. 1 – Installation errors, and unsuitable or not certified technologies.
