A tool for monitoring rockfall protection works and plan the maintenance: the case of the autonomous region of Valle d'Aosta

Rockfall net fences and drapery meshes constitute two of the most adopted protective structural works against rockfall hazard. During their life, they are subject to ageing, corrosion, and impact loads, with a consequent loss of efficiency or even effectiveness. Due to the variability of the environment and, more in general, to external conditions, a definition of a service life, although not unique but different product by product, is not achievable.

The paper presents the methodology, in its enhanced version, some examples are proposed, considering a survey campaign performed in Valle d'Aosta (Italy) as representative. The results of its application are reported and discussed.

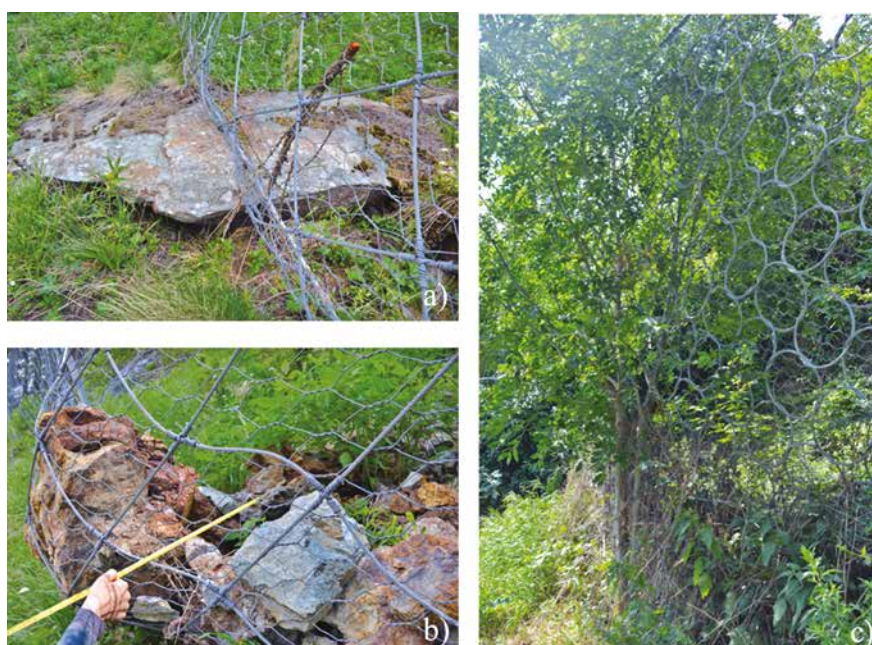
Analysing in detail those net fences that display a high need of interventions, the presence of significant void at the foot of the barrier reveals to be the major issue, together with the presence of elements limiting the deformation capacity of the barrier (Fig. 4 and

5). Both these aspects are highlighted in the 62% of the samples (and in many cases they are observed together), while in 31% the presence of debris/blocks/notches in the net is shown. Considering also P_{tot} values, this indicator is lower or equal 15% in all the cases, revealing that in the great majority the indicator A mostly affects the results. This implies that, even though high priority levels of maintenance are required, the maintenance procedures to adopt would involve only a single aspect/damage, i.e. closing the net at the bottom, removing blocks or trees

Fig. 4 – Frequent observed damages: voids at the foot of the barrier (a), debris/blocks/notches in the net (b), and elements limiting the deformation capacity of the barrier (c).

interacting with the net are the only actions required.
