Rock mass characterization by UAV and close-range photogrammetry: A multiscale approach applied along the vallone dell'elva road (Italy)

Rock Mass Characterization by UAV and Close-Range Photogrammetry: A Multiscale Approach Applied along the Vallone dell'Elva Road (Italy)

Keywords: slope stability; geostructural survey; point cloud; photogrammetry; UAV technique

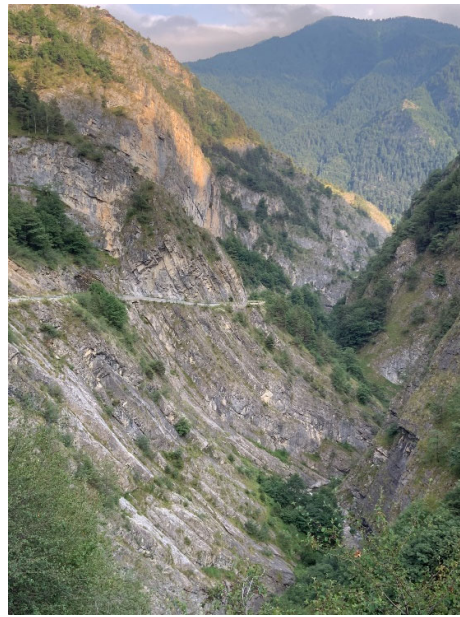
Figure 2. View of the hetometric fold: photo taken along the road looking south, and the road is visible on the right side of the slope.

The Elva Road is located in an area strongly tectonized with hectometric folds clearly visible in the panorama of Mount Bittone and delimited by a fault oriented toward N–S and passing through the right side of the valley itself (Figure 2). It is characterized (Figure 3 geological map extract) by dolomite rocks and light grey or black dolomitic limestones, in banks of considerable thickness, and interlayers of cinerites. Their formation took place in the Carnic and Noric Alps (Upper Triassic). These limestone–dolomitic carbonate rocks, cut from the road, are highly verticalized, with a high-angle westward immersion. This sedimentary rock is characterized by three systems, a highly persistent bedding plane and at least two more conjugated set joints, contained between, and perpendicular to, two continuous bedding planes. The orientation of the planes varies due to the presence of folds and faults, and for this reason different kinematic conditions are identified to also be linked to the variation of the orientation of the slopes along the road. The summit portion of the Valley near the town of Elva is instead set in the calcschists and micascists, with significant areas covered with soil that are the site of a deep gravitational slope deformation.

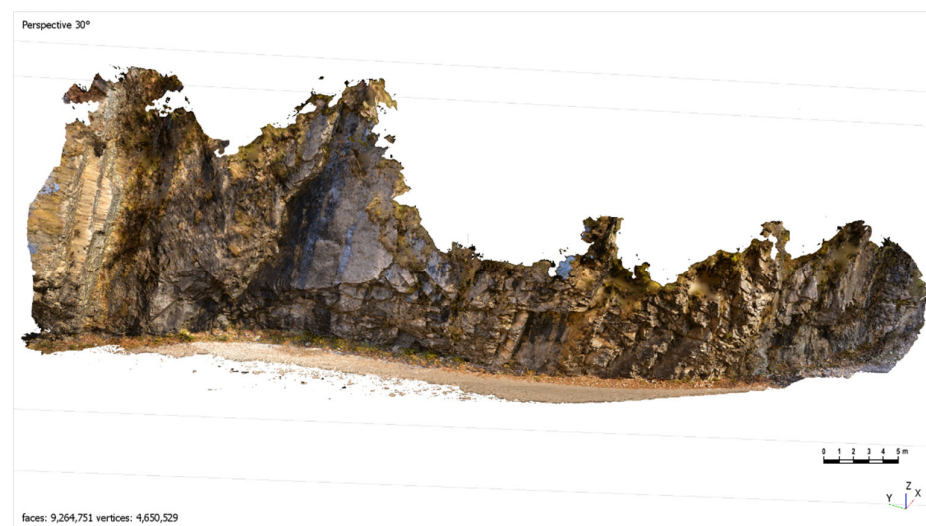
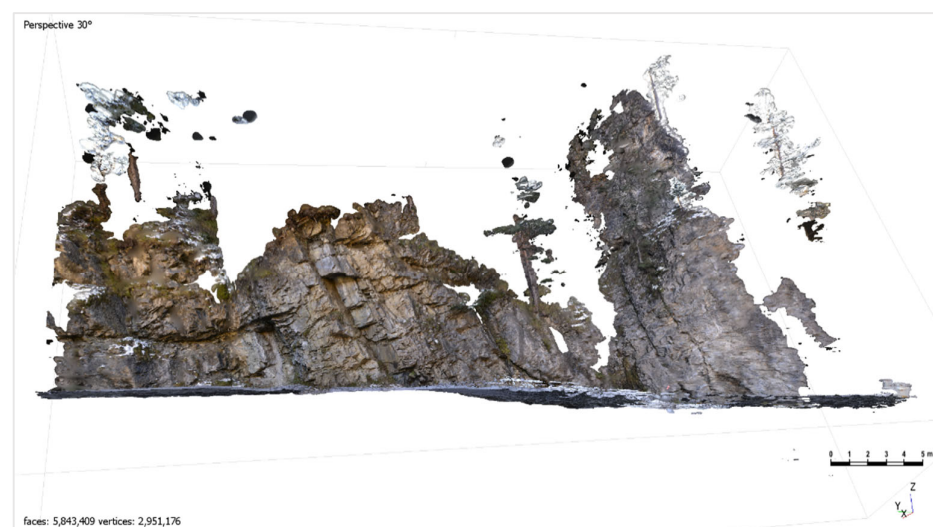
Figure 11. Three-dimensional mesh for sectors: (a) A1_b and (b) A3_b (Figure 8).

With the general survey, it was not possible to obtain a sufficient number of points, and with this aim, 20 detailed DSMs were built reproducing a portion of the rock slope with limited dimensions: about 30–40 m long and 15 m high; most of the surveyed rock masses did not include any GCPs or CPs, as reported in Table 3; for this reason, each DSM was georeferenced by recognizing and defining several natural points (e.g., markers in Figure 10) on the digital images and by obtaining their coordinates directly from the general DSM of the entire road. As an example, the results for two characteristic sectors considered are shown in Figure 11.

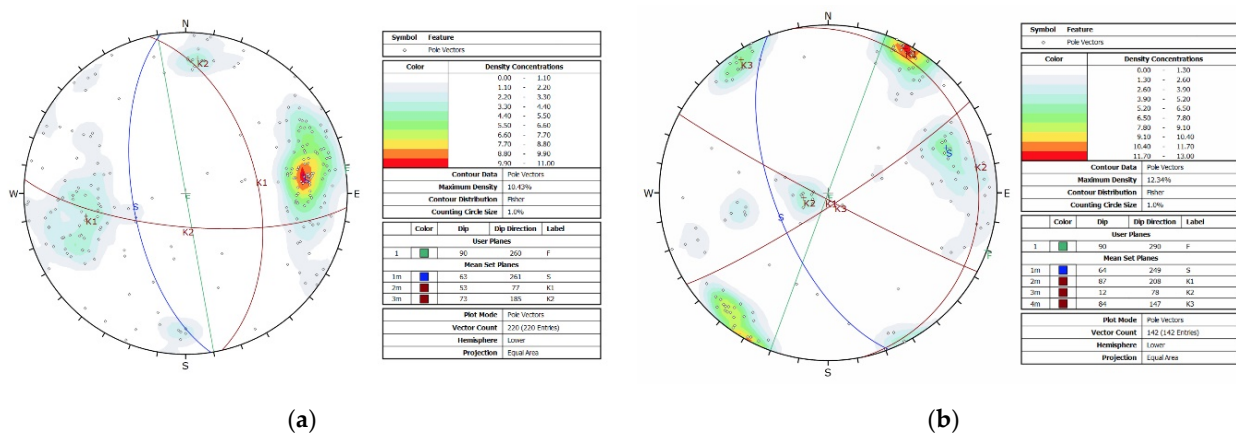
Figure 14. Stereogram for sectors (a) A1_b and (b) A3_b.

The identification of the discontinuity plans and the following kinematic analysis were carried out for each of the 20 sectors considered. In Figure 14, stereograms for sectors A1_b and A3_b are reported, while Table 6 indicates, for each sector, the number of planes detected and the mean orientation data of the discontinuity systems identified. In each sector, three main systems were identified in accordance with the geological evidence: a bedding planes (BP), the most persistent, and two conjugated systems (K1 and K2) perpendicular to the bedding plane with a limited persistence close to BP spacing. In some sectors, where the rock is more fractured, two other systems, K3 and K4, were identified.

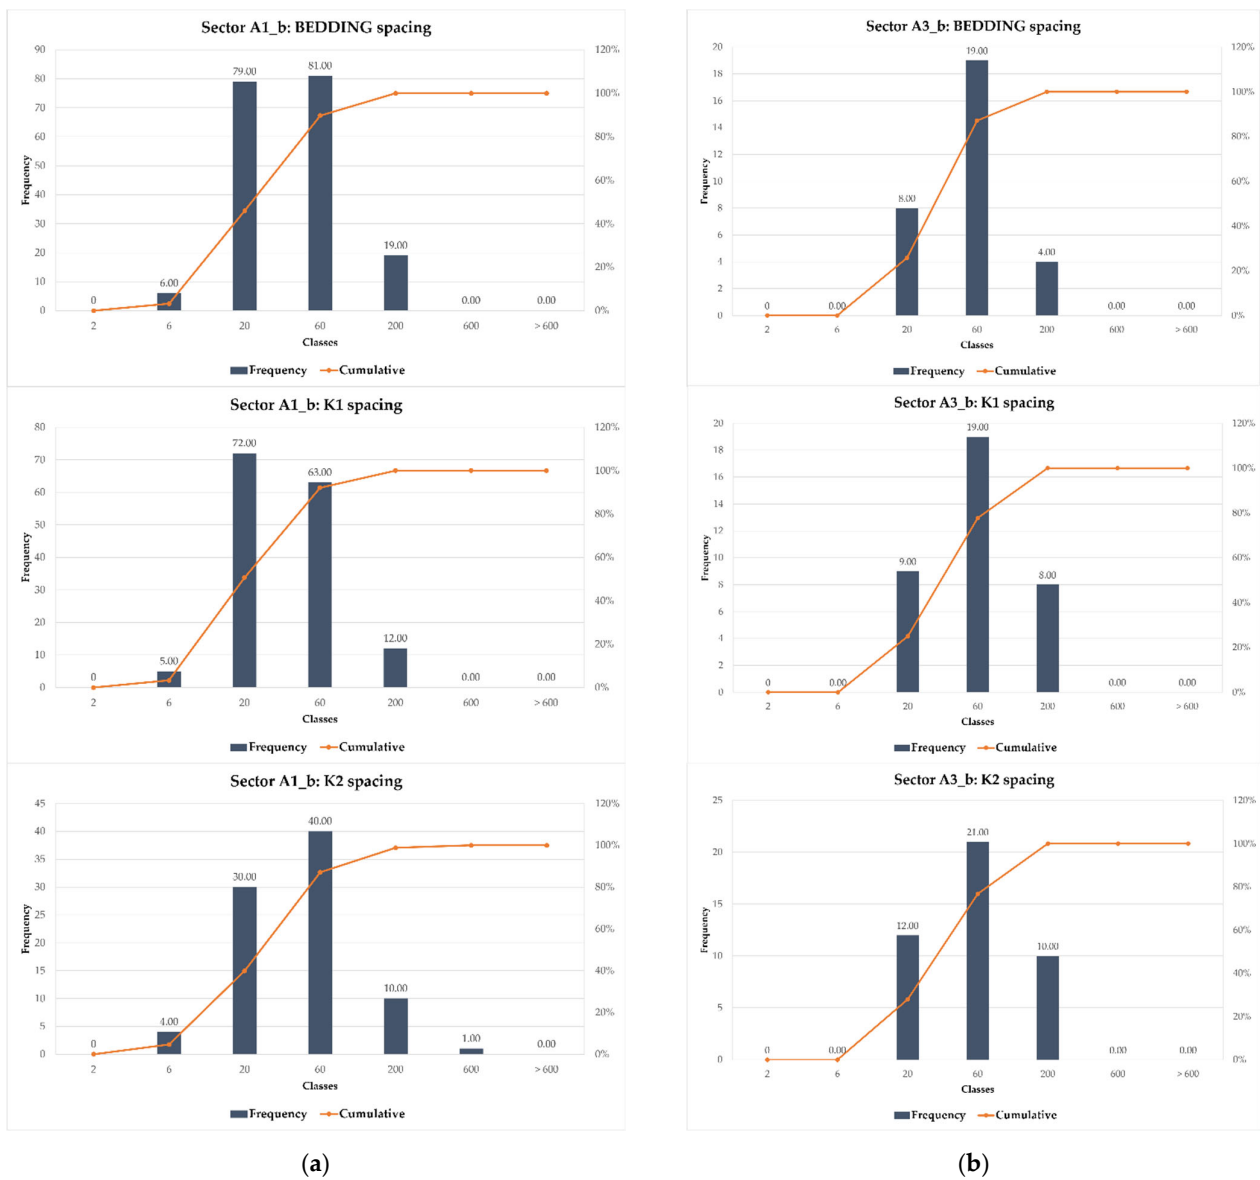
Figure 15. Frequency diagrams of the spacing data for sectors (a) A1_b and (b) A3_b.

Spacing data were analysed, system by system, through a frequency distribution analysis (Table 6), organizing the data into classes, as indicated in the ISRM [2]: less than 2 cm; from 2 to 6 cm; from 6 to 20 cm; from 20 to 60 cm; from 60 to 200 cm; from 200 to 600 cm and greater than 600 cm. Figure 15 reports the spacing frequency distribution and the cumulative frequency curve obtained for the sectors A1_b and A3_b, used as examples.

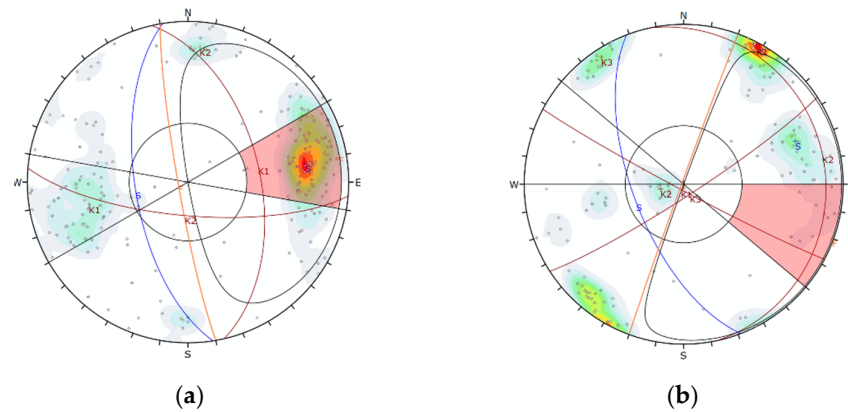
Figure 16. Markland test with Dips 7.0 for sectors (a) A1_b and (b) A3_b.

In each sector, the potential kinematic mechanisms were identified. As previously indicated, the analyses were performed by Dips7.0 [35], identifying the kinematic mechanisms that can occur, on the base of the planes and the slope orientation through the application of the Markland test [43]. Figure 16 shows the Markland test carried out for the A1_b and A3_b sectors; in Table 7 and in Figures 16 and 17, the results obtained in each sector are summarized. The prevailing kinematic mechanism is that of planar sliding but, in some cases, the discontinuity systems can form blocks, which can become unstable due to rockfall or toppling.

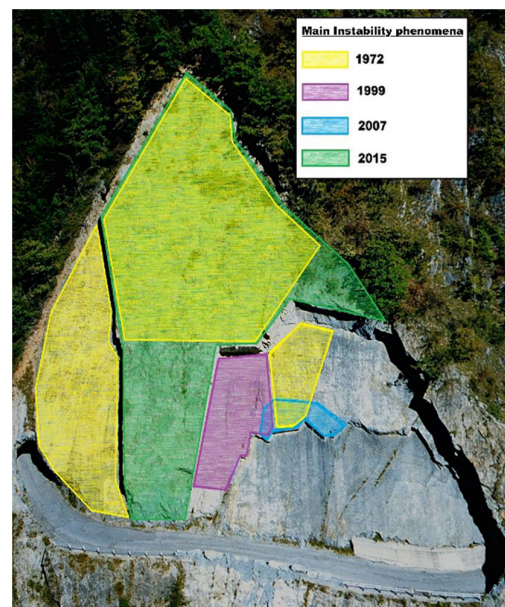
Figure 18. Chronology of the collapses in the LL sector (photo 2002).

The geometry of the road, connected with the natural stratification of the rock face, gives a dip slope morphology with the presence of disharmonious folds. Since the construction of the road and its widening, this site has exhibited phenomena of planar sliding that have progressively mobilized slabs or portions of slabs released at the foot precisely from the re-profiling of the slope made to allow the construction of the roadway. The natural slope, which was initially characterized by a morphological surface similar to the current lateral slopes that delimit the area of instability, has undergone progressive collapses of considerable magnitude that have resulted in its current morphology (Figure 18).
