**Politecnico
di Torino**

Doctoral Dissertation
Doctoral Program in Architectural and Landscape Heritage (34th Cycle)

Methodological approaches to the condition assessment of reinforced concrete architectural heritage

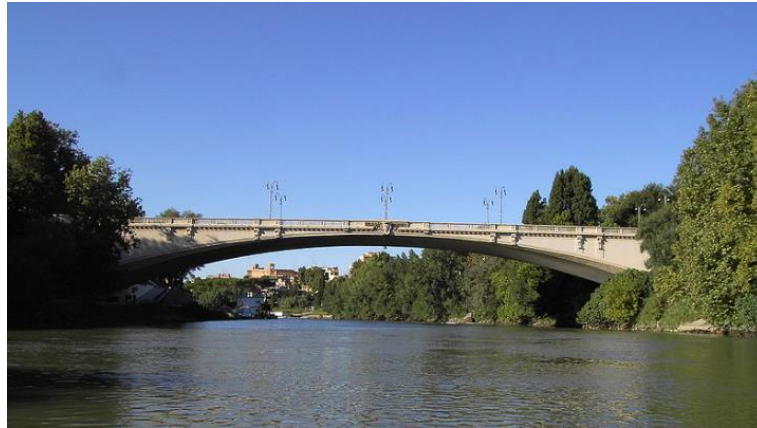
As the scientific world increasingly advanced into the study of phenomena relating to reinforced concrete, the Hennebique system spread rapidly throughout Europe and the world through a network of subsidiary companies in these early years. In Italy, in particular, the first large industrial structures of reinforced concrete were grain silos, built between 1899 and 1901 in Genoa by Hennebique’s main Italian agent Giovanni A. Porcheddu and the company he established in Turin. In 1911, for the celebration marking 50 years of Italian unification, the company also built the first large reinforced concrete bridge in Italy, the Risorgimento Bridge (Figure 5). Hennebique designed the bridge based on his intuition of the static

behavior of structural concrete incorporating technical innovations such as the high-bond ribbed bars patented by Porcheddu (Iori, 2001) (Levi & Chiorino, 2004).

Figure 5: The Risorgimento Bridge in Rome, Italy.
(https://en.wikipedia.org/wiki/Ponte_del_Risorgimento)

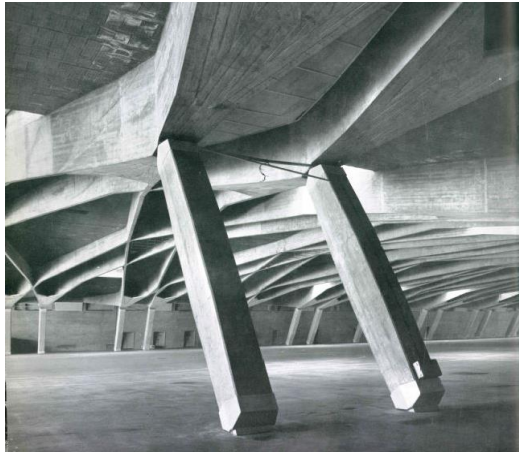
In 1944, Italian engineer R. Morandi registered his first patent for prestressing tendons by means of low voltage electricity and, over the following years, he registered many others patents (Iori, 2003). Morandi has made a big contribution in introducing prestressed concrete in Italy, designing many bridges with this technique. Among his numerous projects, characterized by impressive shapes, the Maracaibo Bridge (Venezuela, 1957), and the underground exhibition pavilion in Turin (1959), that utilized prestressed concrete frames (Levi & Chiorino, 2004). Morandi's pavilion of Turin Exhibition Center (Figure 12) will be considered as a case study application in this thesis.

Figure 12: Underground exhibition hall in Turin, Italy

Morandi's approach in the underground pavilion, consisted of combine different elements in balanced relationship, is also found in others his constructions, such as the Via Olimpica bridge in Rome (1958-1960). Despite the different use, the structural conception was the same: balanced beams on supports, whit the beam ends tensioned from below using a tie element (Ingold & Erb, 2018).

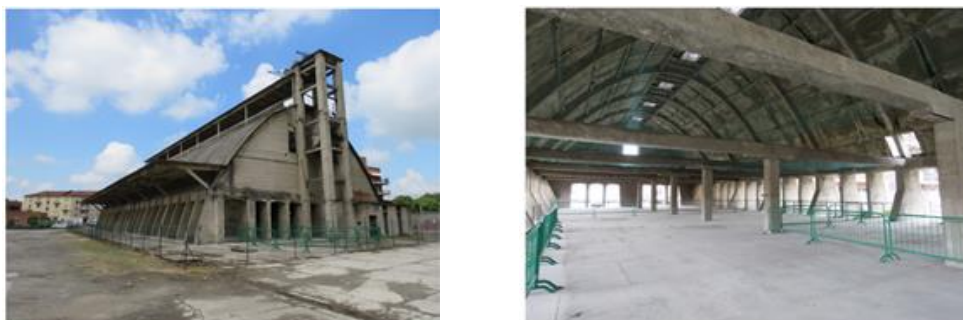
The Paraboloide is the first structure in Italy to be built with a thin concrete shell parabolic-shaped. This structural typology subsequently spread throughout the whole country (Modica & Santarella, 2015). The building has a rectangular plan with a tower in concrete positioned on the north-east side. Parabolic arches supported by concrete buttresses constitute the principal structure. Reinforced concrete tie-beams counteract the thrusts coming from parabolic arches. Reinforced concrete pillars contrast the deflection of the ties. The arches support a system of ribs on which thin shell elements rest (Figure 17).

Figure 17: Paraboloide of Casale Monferrato: external (left) and internal (right) views

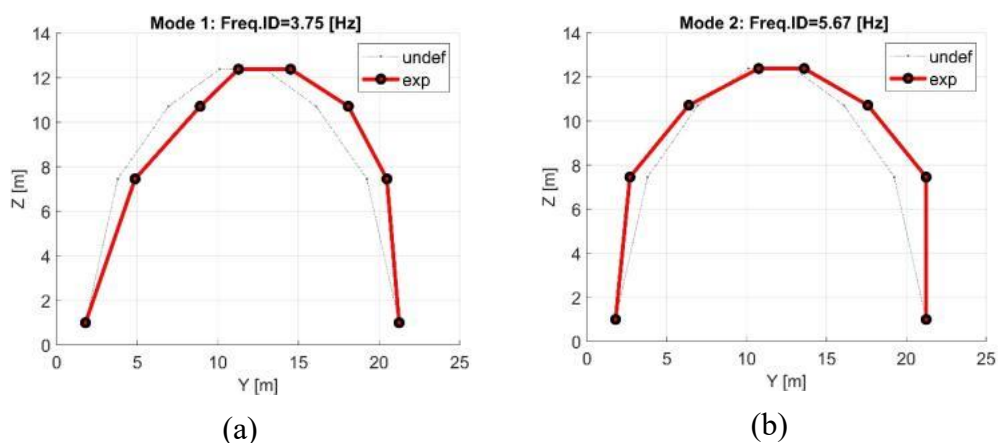
Figure 21: Horizontal components plots of the main identified modes of the Paraboloid: (a) first mode; (b) second mode (Lenticchia, Miraglia, Quattrone, & Ceravolo, 2021)

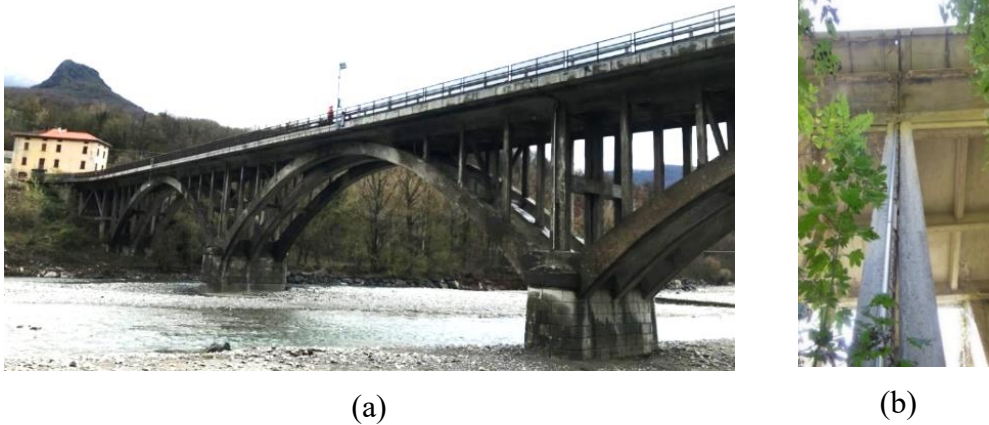
(Ceravolo, et al., 2019) have presented the vibration-based condition monitoring resulted from a testing campaign conducted on a historical reinforced concrete arch bridge, the Lamberti bridge. The Lamberti bridge was built in 1933 in the Tuscan-Emilian Apennines over the Ceno river (in Italy). The bridge is constituted by three spans of 38 m long each, which are supported by three arches each (Figure 23a).

The spans are disconnected by joints at the level of both the deck and the vertical elements (Figure 23b).

Figure 23: Lamberti bridge over the Ceno river (a); joint connecting two spans (b)

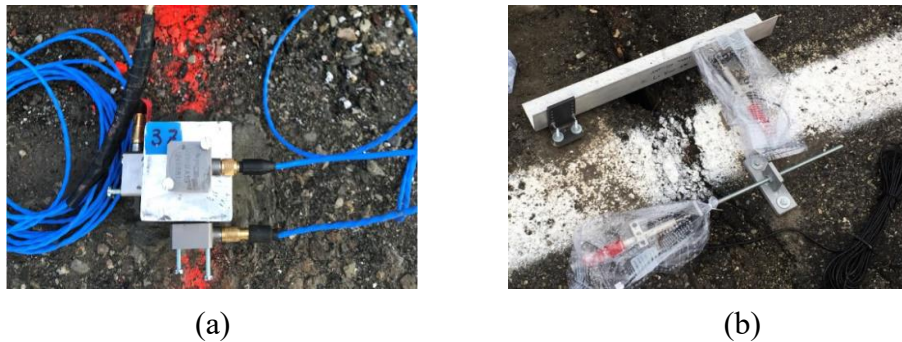
The dynamic tests were performed on November 2018 with an acquisition system consisted of mono-axial piezoelectric accelerometers and Linear Variable Displacement Transducers (LVDT) for dynamic displacement measurements (Figure 24). LVDTs are highly sensitive electromagnetic devices adopted to measure slight displacements over time.

Figure 24: Mono-axial accelerometers (a); LVDT at joint (b)

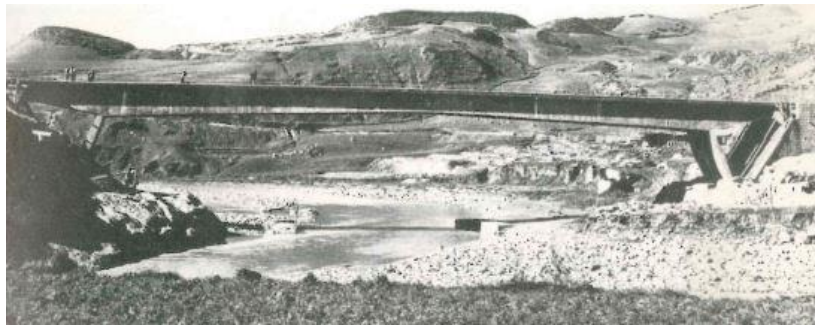
Various structures were conceived and built by Morandi with balanced beam scheme: the bridge over the Cerami in Enna (1953-1954), the overpass of the Via Olimpica in Rome (1958-1959), the bridge over the Vella in Sulmona (1960-1962) and finally the underground pavilion for the Turin Exhibition Center (1958-1959), which is the focus of this PhD thesis. In the case of the bridge over the Cerami, the first to be built with this methodology, it can be observed that the minimum vertical encumbrance of the beams was obtained by subjecting the terminal tie rods to a pretension capable of induce a useful moment in the span to compensate the moment of the beam considered in a simply supported scheme Figure 32. The tie rods are made of high strength steel, inside fibre cement sheaths Figure 33.

Figure 32: Bridge over the Cerami, Enna, 1953-1954: general view (Boaga, 1984)

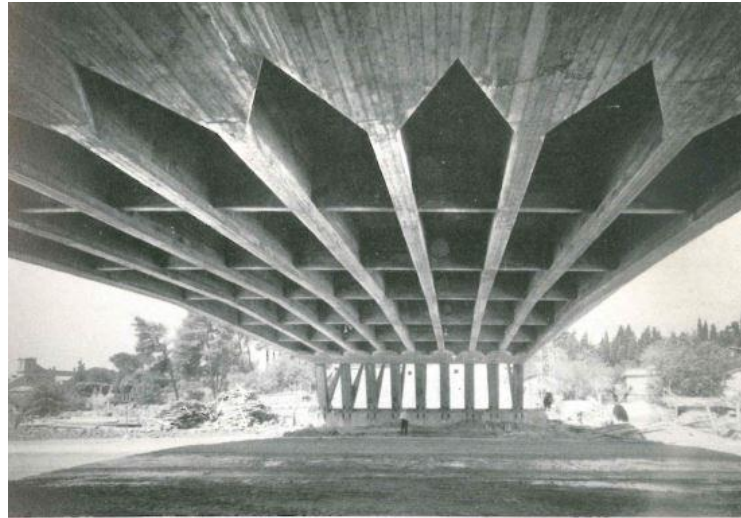
Subsequent works, such as the Via Olimpica overpass in Rome, represent the culmination of the most advanced solutions with balanced beam with which Morandi express the whole theory of prestress technique (Figure 34 and Figure 35).

Figure 34: Via Olimpica overpass, Rome, 1958-1959: bottom view (Boaga, 1984)

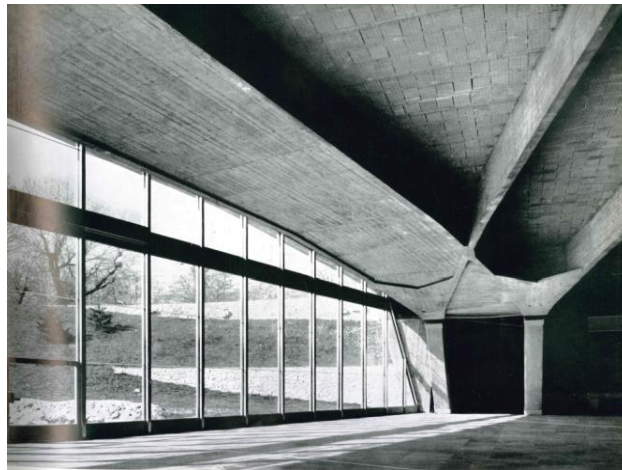
The external ribs of the pavilion constitute the terminal portions of the rhomboidal mesh of the structure and they could have suffered torsional deformations. In order to avoid this problem, Morandi enclosed the external pair of ribs between two reinforced concrete floors capable of generating a closed stiffening box system (Figure 52). Figure 53, Figure 54, Figure 55 and Figure 56 report some extracts and construction details of the external ribs from the original drawings in Morandi's documents.

Figure 52: View of the closed stiffening box system between for the external pair of ribs (Boaga, 1984)

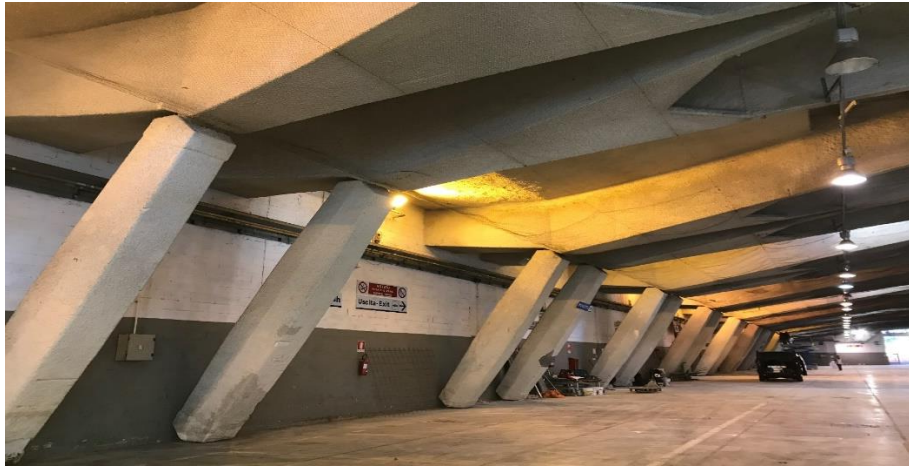
In the 90's, when the pavilion was converted from an exhibition hall to an underground parking, non-structural inner walls made of cellular concrete were inserted as fire walls. The presence of the fire walls relegates the shorter strut beams to the inside of the side galleries, hiding the visual entirety of the static scheme of the pavilion (Figure 58).

Figure 58: Internal view of the pavilion after the insertion of the fire walls

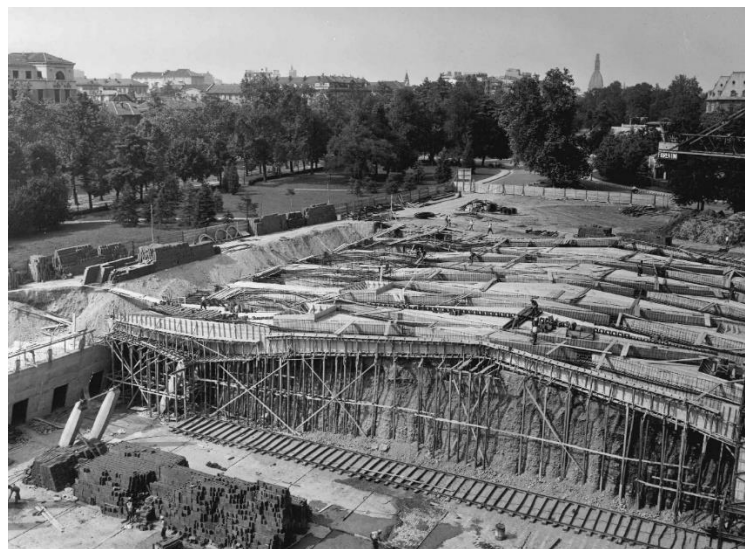
The construction phases aimed at the realization of Pavilion V of Turin Exhibition Center lasted only six months; in fact, they began in April '59 and ended in October of the same year. The supervision of the works was entrusted to engineer Ravelli, while the contract for the construction was entrusted to the Roman company "fratelli Giovannetti", which had already collaborated with Morandi. The construction phases were developed in a precise and accurate manner and under the supervision of Morandi. In the first instance, Morandi used the existing ground as a support for the formworks for the construction of the floor and the various rhomboidal mesh ribs (Figure 59) and then, in a subsequent phase, excavated the embankment under the roof (Figure 60). The ribs were made through the assembly of prefabricated segments characterized by holes for the passage of cables. The floors were casted starting from the two ends to continue to the center.

Figure 59: View of the construction site of Pavilion V of Turin Exhibition Center, 1959

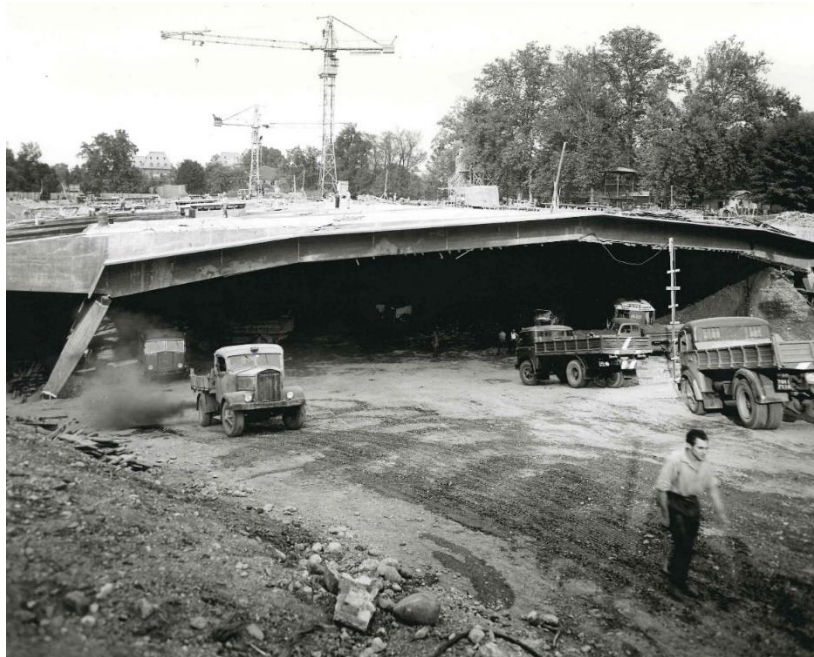
Figure 60: View of the construction site of Pavilion V of Turin Exhibition Center, 1959

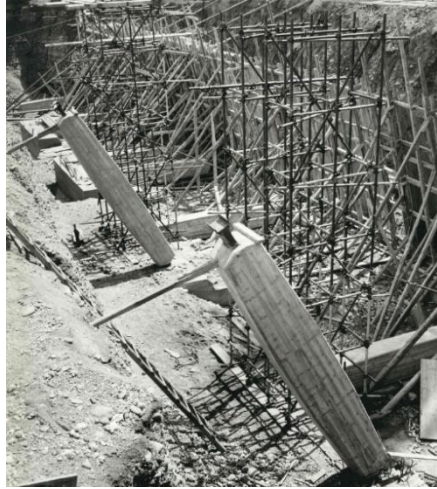
Figure 61: Photography of Pavilion V construction site: longer strut beams

Thanks to the material specifications and to the construction site photographs has been possible to associate each laboratory certificate found with the structural element of the Pavilion V to which it belonged, referring also to the dosage of cement and the date of packaging. The first certificate found was the n°6304, dating back to May '59. It was assumed that this certificate could belong to the longer strut beams (Figure 61). In temporal succession were found the certificates n°6891-7456-7649 dating back to June / July '59, attribute to the retaining walls (Figure 62). Finally, certificates n°7853-8015-8267 were found, dating back to July / August '59. It is assumed that these certificates may belong to ribs and shorter strut beams (Figure 63).

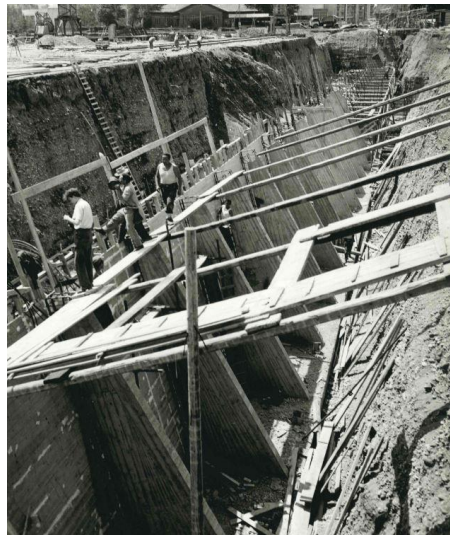
Figure 62: Photography of Pavilion V construction site: retaining walls

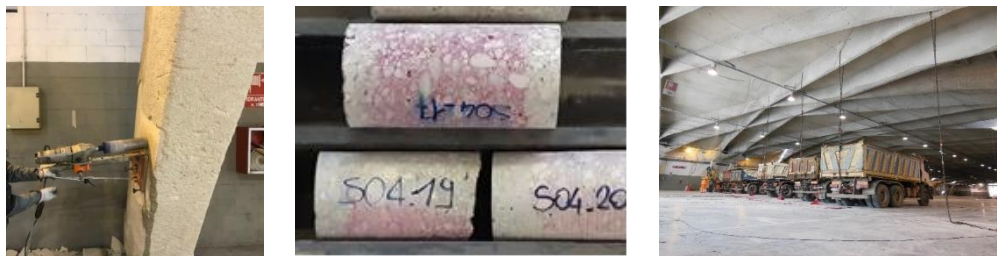
Finally, mechanical tests have been executed to evaluate the compressive strength of the different elements of the structure: samples were extracted from foundations, retaining walls, ribs, and longer strut beams (see Figure 66 left). Each sample was analyzed with phenolphthalein to determine the progression of the carbonation front (Figure 66 center) and then subjected to a compression test. The specimens were extracted and tested according to UNI EN 12504-1:2009 (Testing on concrete in structures – Part 1: Cored specimens – Taking, examining and testing in compression) and UNI EN 12390-3:2009 (Testing hardened concrete – Part 3: Compressive strength of test specimens). The total number of specimens extracted and tested was 32, divided as follows: 5 from the foundations; 3 from the retaining walls; 6 from the longer strut beams; 18 from the ribs. The depth and the diameters of the cores was between $(97.57 \div 218.34)$ mm and $(93.73 \div 104.40)$ mm, respectively. The ratios depth/diameter was between $0.98 \div 2.11$ (MASTRLAB DISEG, 2019). Table 2 summarizes the depth, diameters, ratios depth/diameter, compressive strengths, and carbonation depths of the cores.

The testing campaign also included static tests on two different ribs, to assess the bearing capacity of the structure under the characteristic combination of actions (see Figure 66 right). The load tests have been carried out using 7 hydraulic jacks with a maximum capacity of 100 kN, connected in parallel to an hand pump equipped with a pressure sensor and a load cell. Each jack has been connected to the structure by means of a steel chain, passed through a hole made in the rib (maximum diameter of 80mm and position determined following both pacometric and endoscopic inspection aimed at avoid interference with cables and reinforcements), and contrasted by fully loaded three-axle trucks (approximately 300kN). Displacement potentiometric transducers (novotechnik, model TR0050) have been used for the measurement of the displacements.

Figure 66: Pavilion V: Extraction of a concrete sample from a longer strut beam (left); carbonation tests on the samples of the ribs (center); view of the static tests with trucks connected to the ribs through jacks (right) (MASTRLAB DISEG, 2019)

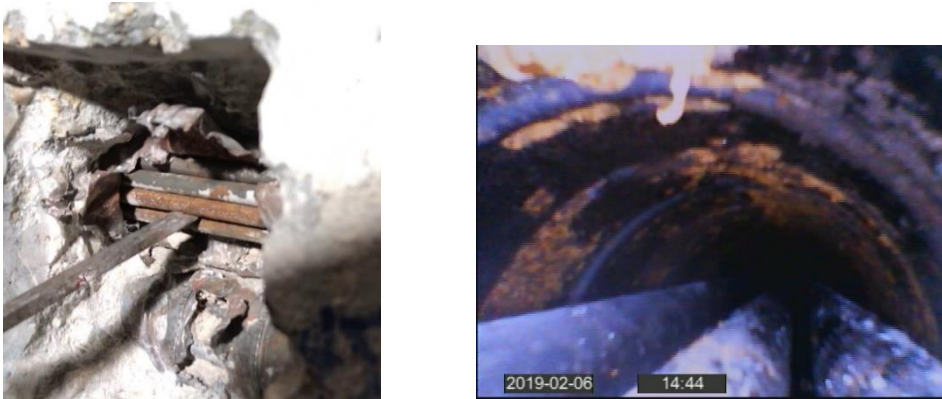
Figure 71: Visual inspection of post-tensioning tendons in the ribs (left), and endoscopy inspection inside a duct of the rib (right) (MASTRLAB DISEG, 2019)
