Corrosion effects on the capacity and ductility of concrete half-joint bridges

Keywords: Concrete Bridges, Concrete structures, Half-joint, Corrosion Damage, Numerical Analysis, OpenSees

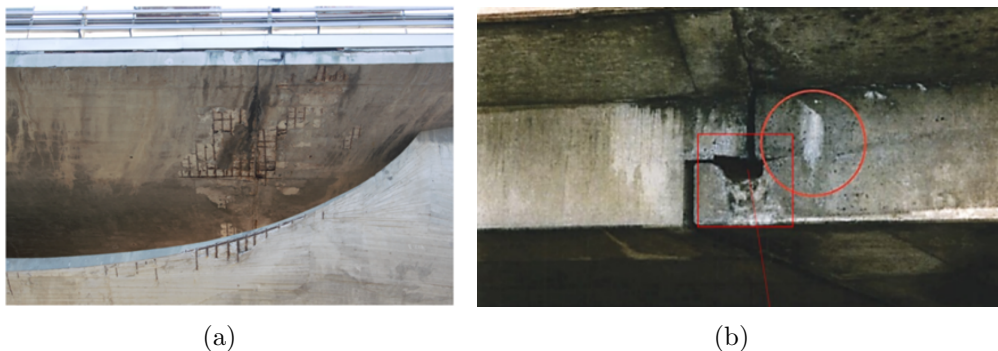
Figure 1: (a) Detail of the deterioration of the half-joint in the Musmeci bridge [13]. (b) Deterioration of the half-joint due to corrosion before collapse, [14].

inspections carried out on these bridges highlighted the half-joint deterioration. For example, in a study by Nicholson T., the examinations conducted in Australia on two bridges proved the relation between water infiltrations and corrosion of the reinforcement bars and concrete deterioration [9, 10, 11]. Other inspections executed in the Medway bridge in England revealed a 50% reduction of the rebar cross-sections [12]. Another remarkable example of half-joint deterioration is the bridge over the Basento River (Italy), designed by Musmeci and built between 1971 and 1976, see Fig.1(a). The half-joints are reinforced with diagonal and horizontal bars, with 30mm diameter, and vertical ones equally spaced with 10mm diameter. The current state of the bridge exhibits evident signs of deterioration, especially in the half-joints, see Fig.1(a). Damage to the bridge is related to inadequate maintenance and repair of drainage systems. This fact led to corrosion of the reinforcement bars with consequent concrete cracking and spalling of the concrete cover [13].

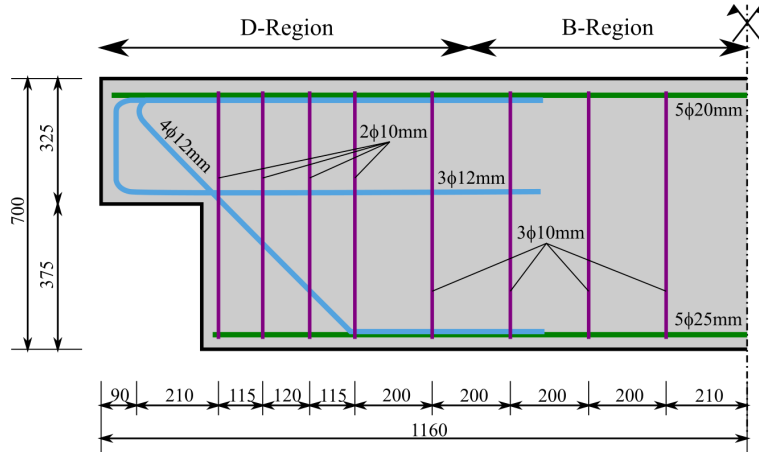
Figure 4: Geometry of the Gerber joint, NS_REF specimen [28].

U-bars and diagonal bars have also been used to comply with the classic Strut and Tie models. In addition, there are stirrups for absorbing shear stresses [29]. Fig.4 shows the geometry of the joint [28].

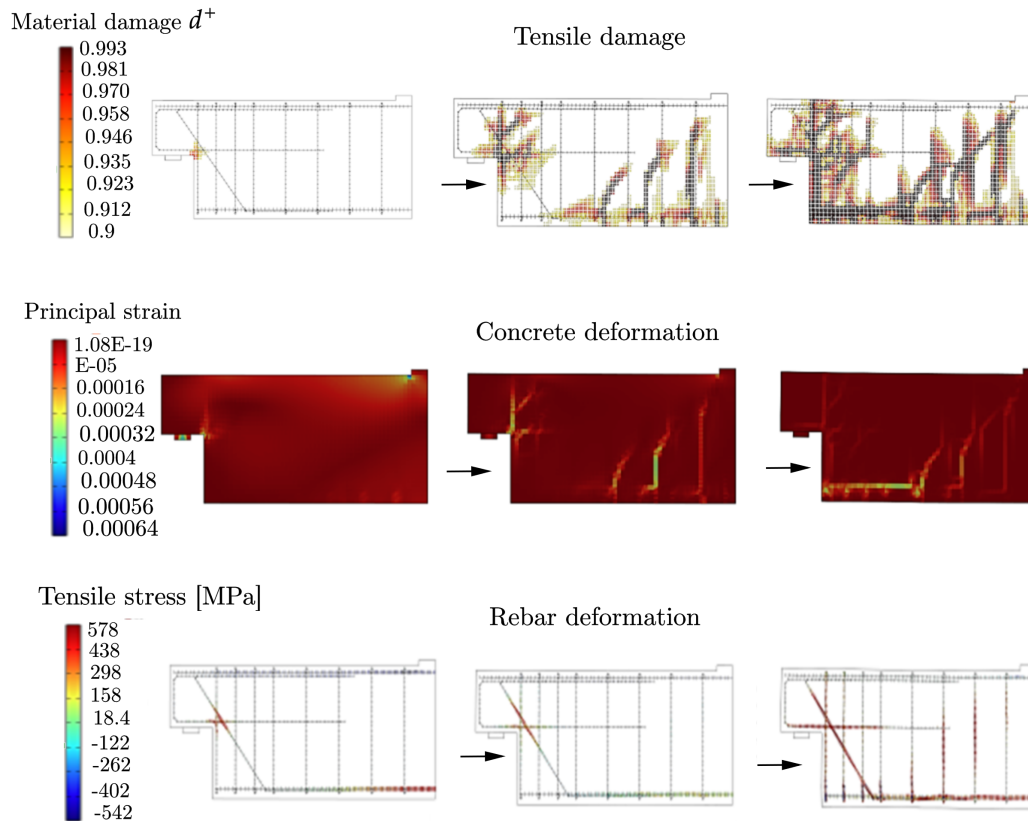
Figure 9: Progress of damage in terms of tensile damage index, concrete deformation and stress in the rebars.

This paragraph presents the results of the analysis in case of no corrosion: tensile damage (localization of cracks), deformation of the concrete, and stresses in the reinforcement bars. Fig.8 compares the experimental and numerical estimates for the force-displacement curve by varying the mesh size and discretization step. The agreement with the experimental data is very satisfactory with minor relative error of the peak force and tangent stiffness. The results are shown from the initialization of the cracking process to the damage progress and failure, see Fig.9:

- **Tensile damage:** the cracks start to propagate from the inside edge and extend over the entire cross-section. The most critical cracks, however, are those present in the recessed area, which go towards the upper edge of the beam.
- **Minimum deformation of the concrete:** it should be verified that it does not exceed the critical value of 0.35%, below which failure would

occur due to the crushing of the concrete, causing a brittle collapse of the joint. The analysis shows that the critical value is never reached at any point. Therefore the failure can be considered ductile.

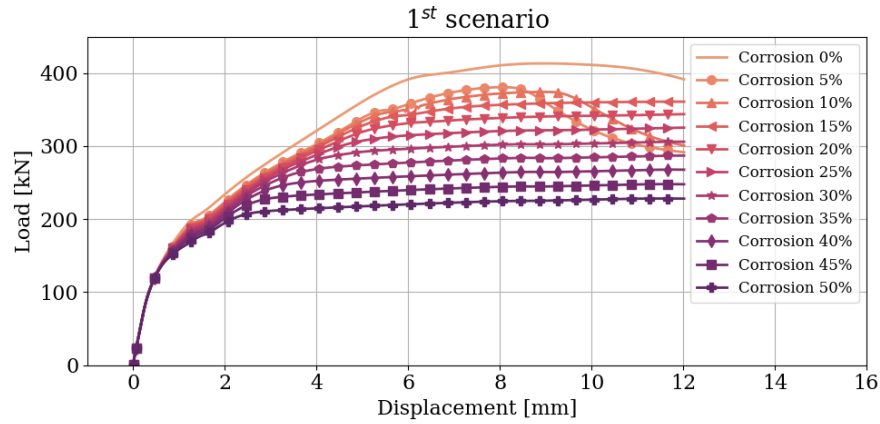
Figure 11: Load-displacement curves as the level of corrosion varies: (a) Reduction of the re-bars cross-section; (b) Reduction of the cross-section and ductility and strength losses.

The authors estimated the force-displacement curve for each level of corrosion from 10 to 50% with a 5% discretization. Fig.11 shows the force-displacement curves in two different scenarios: (a) Reduction of the re-bars cross-section; (b) Reduction of the cross-section and ductility and strength losses.

- 10% corrosion:** The force-displacement curve related to a 10% corrosion level in Fig.11(a) exhibits a first elastic section with no damage. The first crack arises by the nib, evidenced by the almost horizontal section in the plot. The cracks propagate up to a peak resistance equal to 374 kN corresponding to 9.4 mm, 7% lower than the integer specimen. A softening section follows the horizontal part with consequent failure of the joint. Fig.12 proves that the nib concentrates the cracks. They progress until reaching the upper edge of the beam, where they connect to the other ones.

- **30% corrosion:** The increase in the corrosion level determines a more ductile behaviour, with a first elastic section followed by a plastic branch until reaching a pseudo-plateau at 300 kN (Fig.11(a)). The

initial crack grows until the end of the beam is separated. The first three stirrups and the horizontal and diagonal bars have reached the yield point and exceeded the ultimate limit at some points. Therefore, the resistance drop in Fig. 11(b) depends on the collapse of the re-bars.

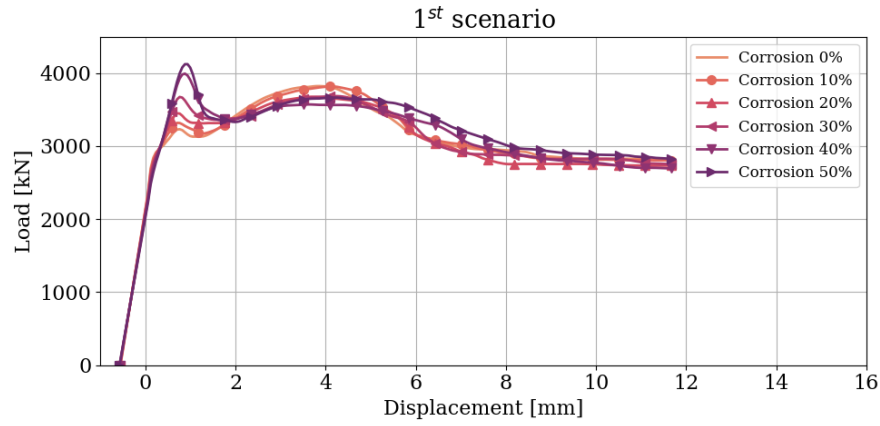
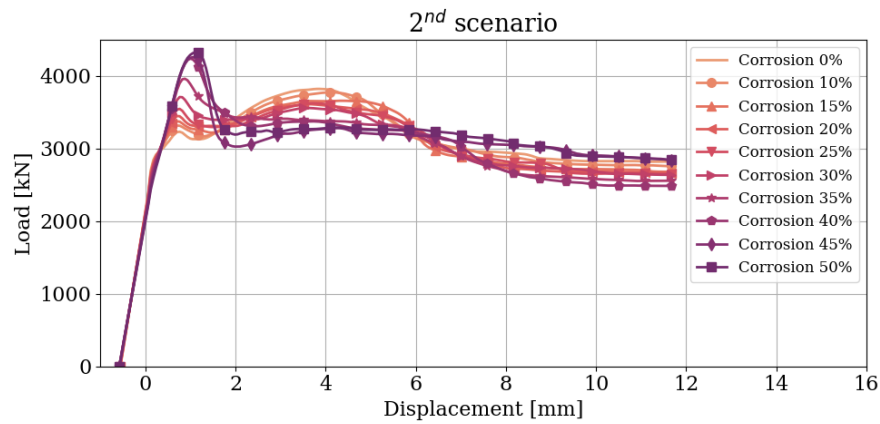
Figure 18: Load-displacement curves as the level of corrosion varies: (a) Reduction of the re-bars cross-section; (b) Reduction of the cross-section and ductility and strength losses.

Fig.17 illustrates the damage pattern for increasing levels of corrosion in the two scenarios: (1st) cross-section reduction and (2nd) cross-section reduction and steel degradation. The corresponding force-displacement curves for the two scenarios are shown in Fig.18.

- **10% corrosion:**The load-displacement curve does not display observable variations compared to the case without corrosion. After the elastic phase, a first local peak is reached at nearly 3400 kN, followed by

a slight strength drop with subsequent recovery up to the global peak of 3800 kN (Fig.18(a)). The curve then exhibits a minor softening until the plateau at 2800 kN. The crack pattern is mainly located by the cross-section variation, as shown in (Fig.17). The concrete defor-
