Land Planning and Extreme Snow Events: The Case of Buthier Avalanche in Aosta Valley - IT

The article reports the example of the indispensable update of hazard mapping used to reduce the snow avalanche danger with urban constraints in Cogne – Aosta Valley, in north-eastern of Italian Alps.

On 15th December 2008, an event induced by extreme weather and snow conditions occurred exceeding the known limits of the avalanche basin: the paper shows how the Avalanche Warning Service of Aosta Valley had to investigate in order to estimate the return period of the event and to update hazard maps. Due to the lack of information, the study was carried out coupling the historical and dendrochronological investigations of the woods embodied in avalanche basin and destroyed by the event.

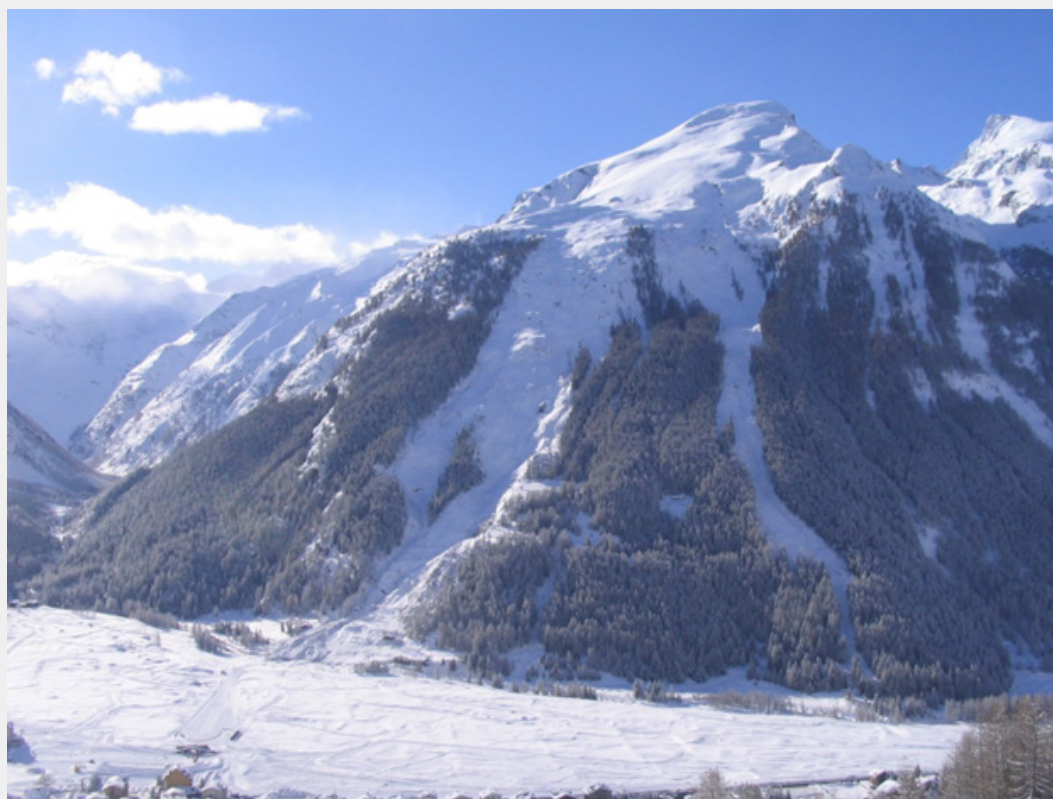
**Figure 2:** Aerial view of the Buthier avalanche released on December 15th, 2008. At the same time, the closer Pointe de l'Ouille avalanche released too (to the right in the picture): it also causes extensive damage to the forest (photo: forestry station of Aymavilles – Aosta Valley).

smell of resin filling the countryside. The cause of the sound was revealed only when the fog was cleared, uncovering the Mont Herban with a large wound of the forest at its northeastern side (Figure 2).

The avalanche released just below the Mont-Herban peak – east/north-east face, at 2970m a.s.l. and 35° of inclination – and flowed on the grassy slopes up to 2300m meeting the edge of the coniferous forest. From here, the mixed avalanche continued breaking down and uprooting many pines and coniferous trees. The presence of two watersheds in the forest affected the avalanche partially limiting the lateral expansion. The snow flow was splitted allowing trees grown between the two watersheds to remain intact: a strip of wood, as a wedge-shape with 350m length and a range of 10m-40m width was saved from the avalanche destruction. The two main avalanche streams re-joined closed to the meadows of Buthier, at about 1570m, where the inclination of the slope decreases and the avalanche velocity slowed down leaving snow deposition with most of the uprooted trees. During its descent, the avalanche passed very close to the buildings of the Buhier village at 1560m, crossed the Valnontey creek and, finally, stopped in the meadows of Sant’Orso.

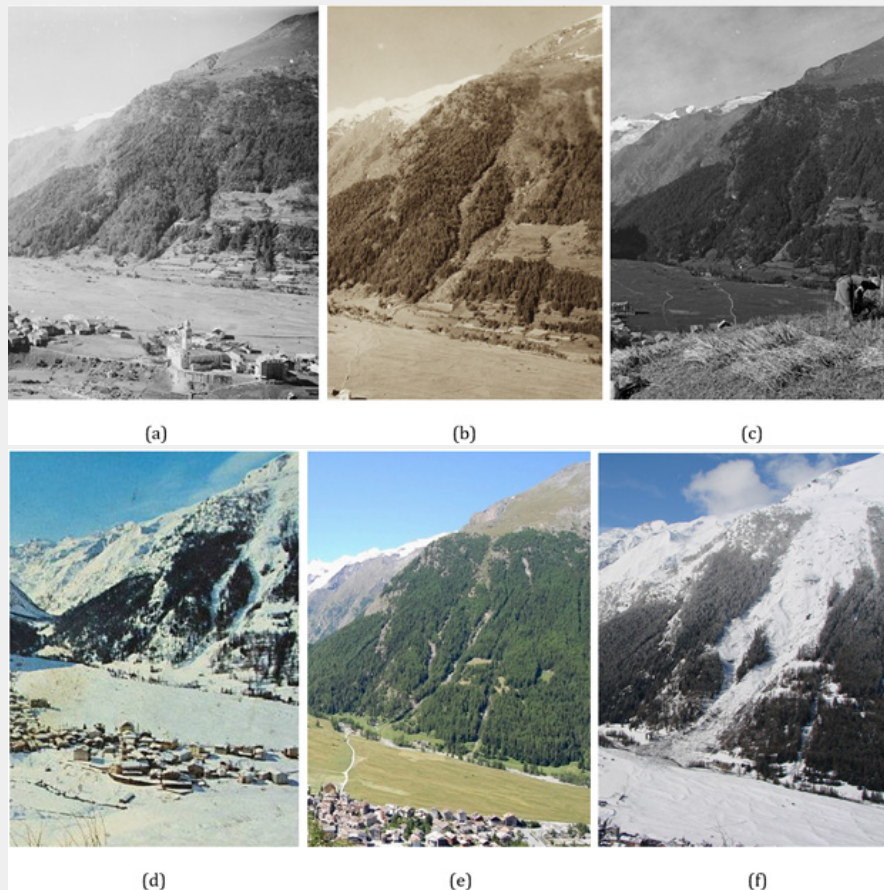
**Figure 7:** The six images to evaluate the frequency and size of the avalanche phenomenon starting from the beginning of the twentieth century analyzing the width of the forest cover.

- (a) 1915 (photo: BREL Archive - Fonds Fisanotti);
- (b) 1925-1935 (photo: BREL Archive - Fonds Domaine);
- (c) 1963 (photo: BREL Archive - Fonds Willien);
- (d) 1970-1975 (photo: private collection A. Roveyaz);
- (e) 2008 (photo: E. Borney) and
- (f) 2009 (photo: E. Borney).

Thanks to the following six images (Figure 7), the frequency and the size of the avalanche phenomenon starting from the beginning of the twentieth century has been reconstruct by analyzing the width of the forest cover.

By observing the sequence of the six photographs, we note that central strip of forest saved from the event of December 2008 appears also in historical photos of 1925-1935 (Figure 7b) and 1970-1975 (Figure 7d), but is larger than the event of December 15th, 2008 witnessing how past events were less destructive. This is also confirmed by the observation of the lateral limits of the forest affected by the historic avalanches which appear to be less extensive than those achieved by the last 2008 event. Focusing on the images where the forest is damaged (Figure 7b, 7d & 7f)

and on the left edge of the intact forest, it is easy to conclude that the event of December 15th, 2008 was clearly larger than the previous ones. In order to verify this conjecture, during the spring, an extensive dendrometric survey [11-13] was carried by using the Pressler auger, sampling various plants survived in the small core of larch (LC51E) and in staked ones at in the damaged forest (Figure 8). The samples were suitably processed to make the growth rings more visible and thus facilitate age counting on each plant.

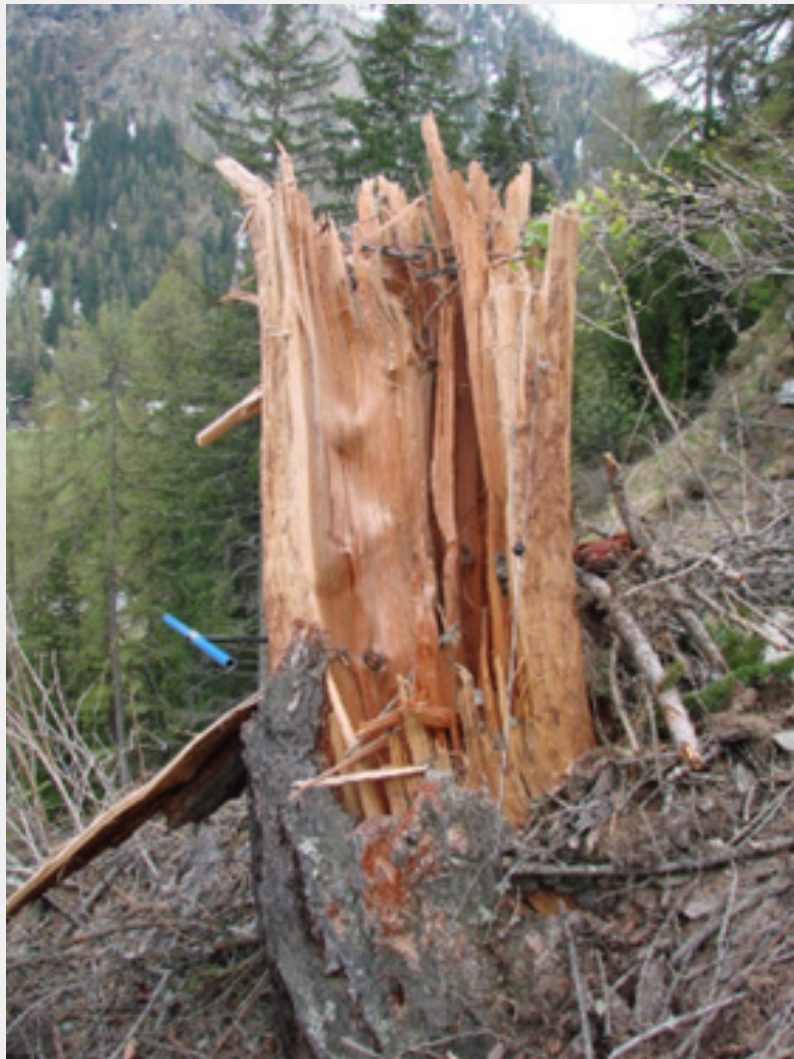
**Figure 8:** The larch (*Larix decidua* Miller) crushed by the avalanche on December 15th, 2008 (sample n. 5). It was located closed to the Buthier village. The age of the plant is about 140 years old.
