Large-Scale Experimental Static Testing on 50-Year-Old Prestressed Concrete Bridge Girders

Keywords: prestressed concrete; existing bridges; deck girders; large-scale tests; structural capacity

2.1. Corso Grosseto Viaduct

2.2. BRIDGE|50 Research Project

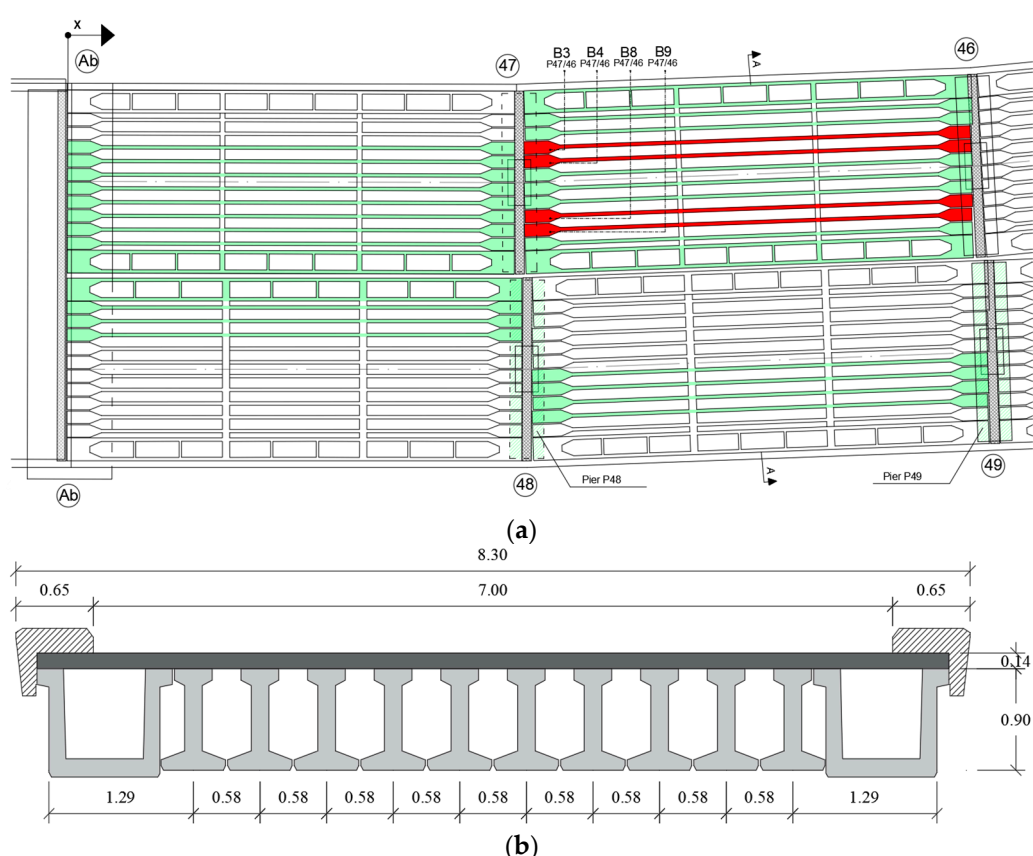
Figure 2. (a) Top view; (b) cross-section of the PC deck (in meters).

The deck of each span consisted of 10 precast PC I-beams and 2 U beams all connected by a cast in situ slab, with transverse beams at third points of each span. Figure 2 shows a technical drawing of the top view and cross-section of the viaduct. The elements retrieved for the project are depicted in Figure 2a in green, whereas the elements tested, whose results are reported in this paper, are painted in red.

A proper identification code reported in Figure 2 was assigned for each structural member to record the element position on the original location.

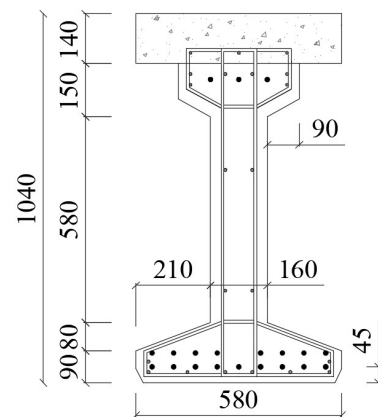
Figure 3. I-beam cross-section (in mm).

The girders had an average span length of 19.2 m. According to the design documentation [26], the girders were pretensioned using 17 strands along the bottom flange, distributed on two rows, and 3 strands on the top flange with a nominal diameter of 12.7 mm, as reported in Figure 3. In the bottom flange, three strands from 0 to 5 m and two from 0 to 3 m starting from the end sections were unbonded using ducts. The shear reinforcement consisted of $\varnothing 8$ mm stirrups with 250 mm spacing. The stirrups were also used to connect the precast beam with the cast in situ top deck slab.

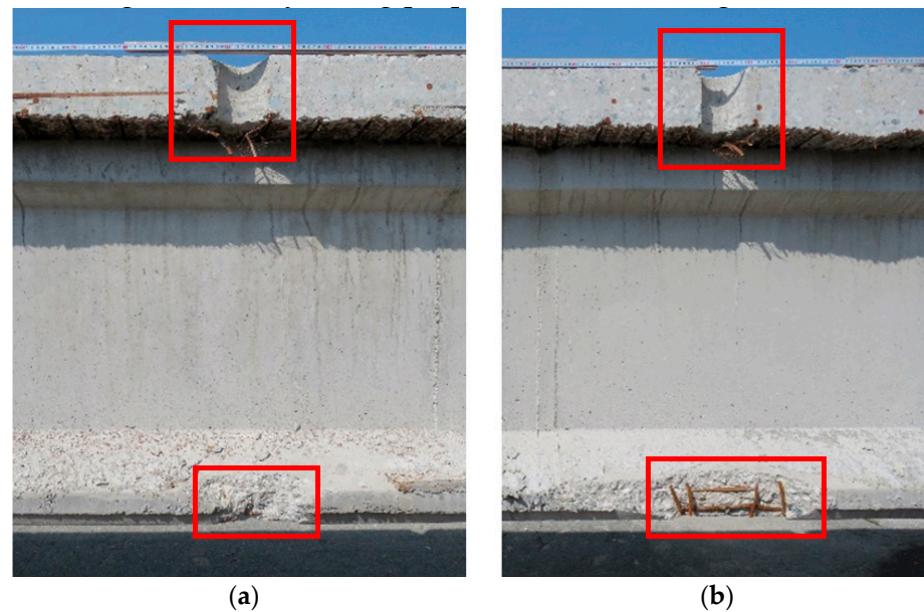
Figure 5. Typical damage due to lifting operations: (a) damage at 4 m and (b) damage at 15 m from the beginning of the PC girder.

scheduled, starting with beams showing a low level of damage of the cast in situ slab generated by lifting preparation [31,32] (Figure 5).

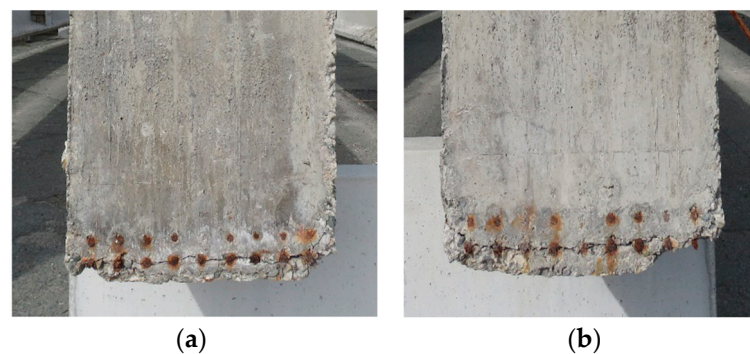
Figure 6. Cracks on the end of the (a) B3-P47/46 and (b) B4-P47/46 beams.

The B3-P47/46 and B4-P47/46 girders showed 5 mm wide horizontal cracks at the edges caused by corrosion activity that transversally crossed the strands (Figure 6). The visual inspections revealed no other corrosion-induced damages. The presence of such kind of damage can be ascribed to the presence of structural joints.

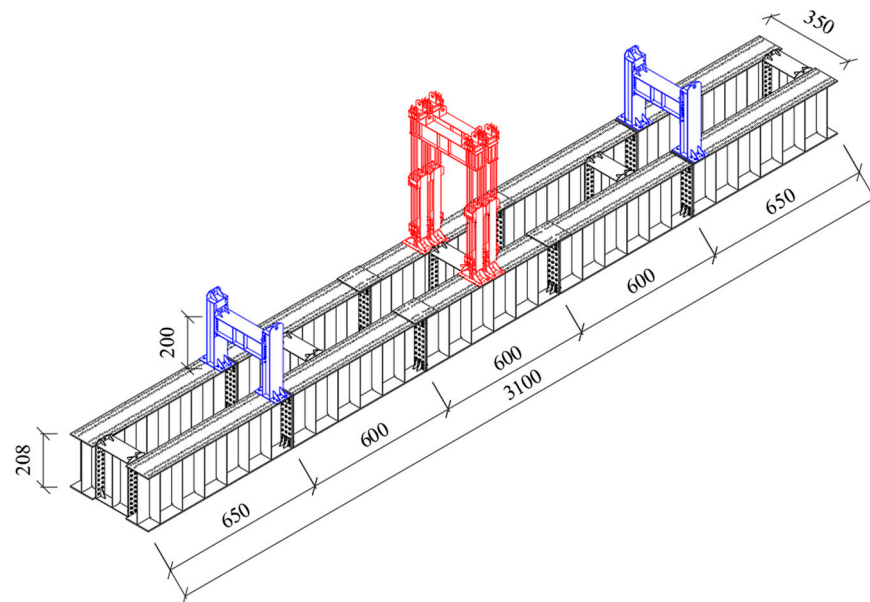
Figure 7. Technical drawing of the reaction steel frame in black, supporting frames in blue and loading frames in red (in cm).

A large steel reaction frame was designed to investigate the structural behavior and load-carrying capacity of the girders with different loading configurations (Figure 7). The test bench was provided by the Center SISCON of Politecnico di Torino for testing structures with a span of up to 30 m.

The PC beams under testing were positioned on the supporting frame (blue color in Figure 7), where specifically designed bridge bearings replicate the simple support static scheme. The hinge and roller have a support plate of 400×400 mm and allow for $\pm 4^\circ$ of rotation; the roller allows a longitudinal displacement of ± 150 mm. The base plate of the bearings is bolted to the supporting frames, which in turn are bolted to the main frames (black color in Figure 7). The latter consist of two main longitudinal steel beams, each composed by 5 I-shaped welded steel segments. These segments were built by welding a 2 m high web to 1 m wide flanges with plates stiffeners spaced 1 m. The longitudinal beams are transversally connected by 5 I-shaped elements 1.5 m long. The loading system (red color in Figure 7) is constituted by two couples of hydraulic jacks hosted into steel member hinged to the steel frame with single capacity of 1200 kN and a maximum stroke of 750 mm. The hydraulic jacks, contrasting on the steel member, act on the pushing system, which transfer the load to a steel transverse beam through six 32 mm steel bars. The transverse steel beams were used to transfer the load from each couple of hydraulic load cylinders to the specimen under testing. Both the supporting frame and the loading system can be installed through a bolted connection along the longitudinal beams with a step of 10 cm in order to obtain different loading schemes. The hydraulic testing system allows for the performance of force-controlled loading tests at a controlled loading rate.

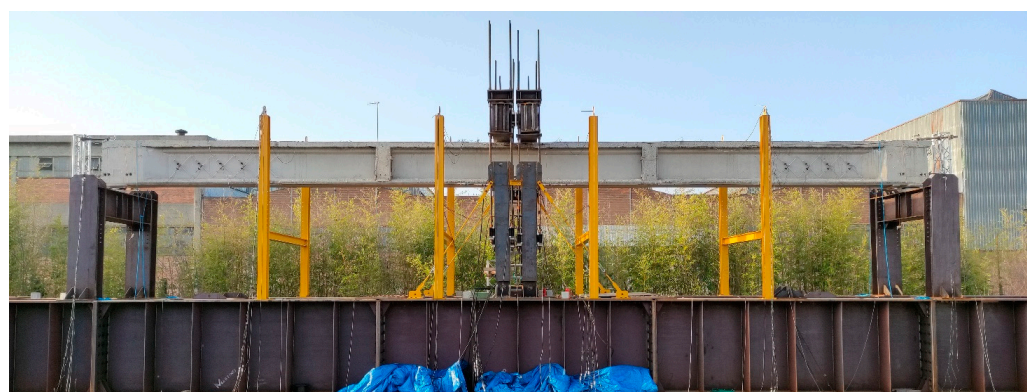
Figure 8. Three-point bending test configuration.

The span length of the flexural tests reported in the present work was 19 m and the two couple of hydraulic jacks were located 0.6 m away from the midspan to conduct the loading tests in a three-point bending type configuration (Figure 8), aimed at investigating the bending resistance of the girders.

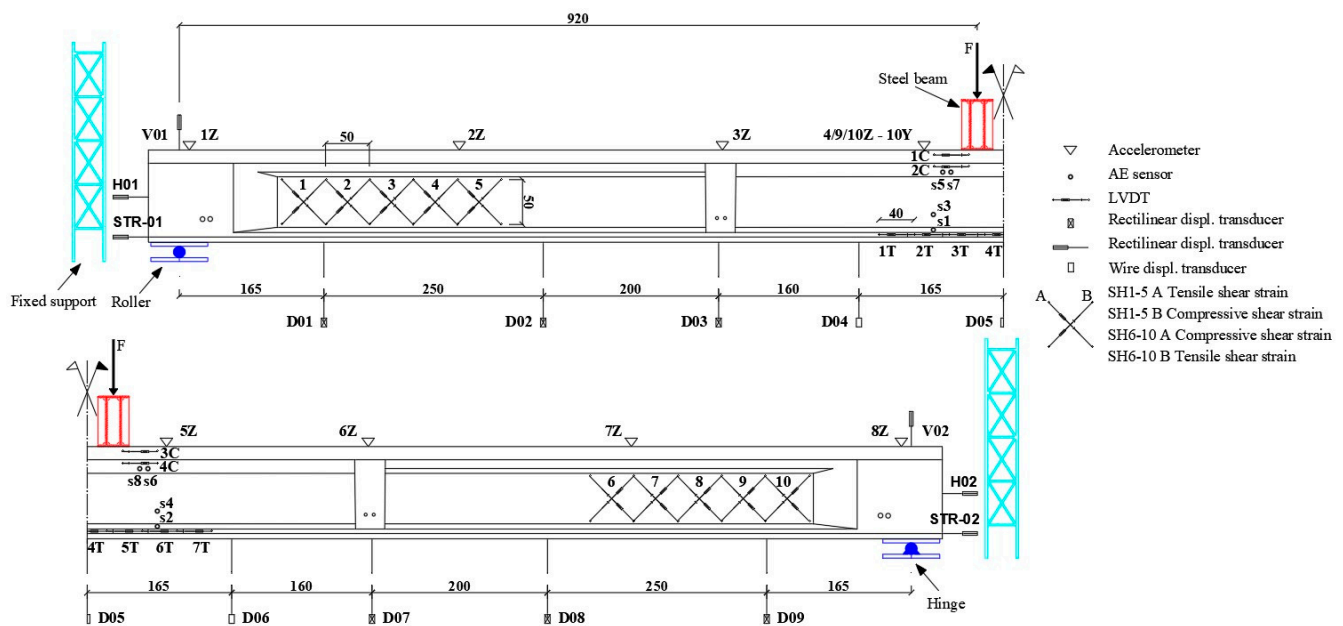
Figure 9. Test setup and layout of the monitoring system installed on the PC girder during the load test (in cm).

The applied load was measured by load cells on the actuators to read the actual applied load and check the symmetric loading condition. The layout of the sensors for beam B3-P47/46 is reported in Figure 9. The linear variable displacement transducers (LVDTs) were mounted onto two different configurations of the aluminium frame with the aim of measuring the average strain referred to the measurement base: the LVDTs close to the supports are oriented at 45° with a base of 700 mm, whereas the LVDTs in the bending zone were installed with a horizontal direction around the midspan and have a base of 400 mm. The test setup for the first girder B3-P47/6 is shown in Figure 9.

From the second test on the girder B8-P47/46, three out of five pairs of LVDTs were moved close to the transverse beam to intercept a more pronounced cracking pattern evidenced during the first test. For test B9-47/46 (the beam without the cast in situ slab), six out of seven LVDTs were used to measure strains to the bottom flange in bending zone (1T–6T) and two LVDTs in top flange of precast beam (1C and 2C) were moved to the same vertical alignment of 1T and 6T (see Figure 9). Indeed, two strain gauges were used to compare LVDTs measurements in 2C and 1T position. For all the girders, the vertical deflection was measured by nine displacement potentiometer transducers connected to the bottom of the girders (see from D01 to D09 in Figure 9). Furthermore, displacement transducers were installed at the ends of the girders to measure vertical and horizontal displacements, settlement at the supports and the slipping of one unbonded strand at each end. During the tests, the data were collected at a 10 Hz sampling frequency and synchronized.

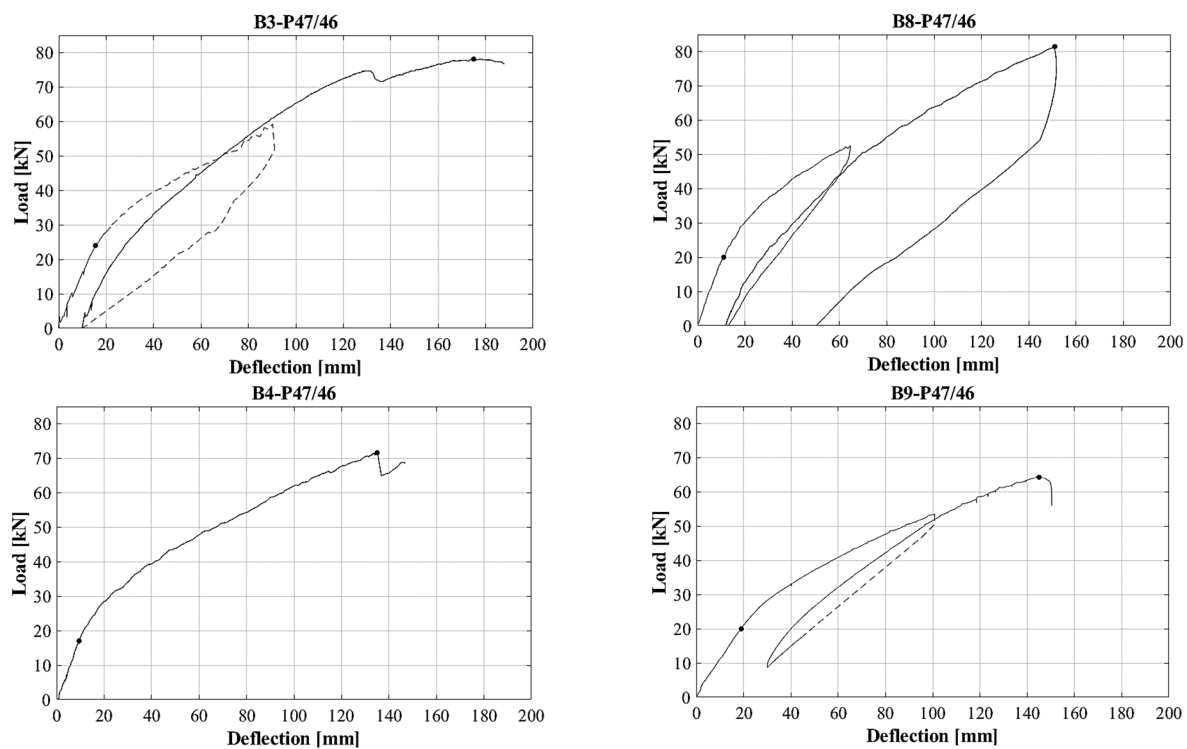
Figure 10. Load versus midspan deflection with dots located at the estimated first cracking and peak loads for each girder.

In the present paper, the most representative outcomes of the structural response are reported and discussed. The girders were tested by adopting a static loading with a rate of 2.6 kN/min. In the following figures, the reported load refers to the force transmitted by one of the four actuators; therefore, the total load can be obtained multiplying the value reported in the following diagrams by 4. It should be noted that the actual load applied to the girder, other than its self-weight, should be calculated by adding the loading frame weight (estimated as 11.82 kN per actuator) to the recorded applied load. The dashed curves in the load–deflection curves in Figure 10 indicate measurements that are not reliable following to unexpected setup technical problems. The first test was aimed at controlling the parameters reported in the following paragraphs using a two-phase loading test. As mentioned above, due to technical problems and then for comparison purposes, the second test was set in an identical two-phase protocol; the third test reports a one-phase loading test to study the outcomes from a monotonic procedure in comparison with the previous two; finally, test number four was performed to analyze the properties of the PC beam without the contribution of the cast in situ slab to the structural performance of the specimen. In the case of B9-P47/46, the second loading phase started before reaching complete unloading; it started at a load level lower than the first cracking load.

The deflection of girders under loading is a significant parameter; it can be used for the calibration of structural models able to properly assess the stiffness and resistance characteristics. Figure 10 shows, for each girder, the load–deflection curve obtained at the midspan of the girders (position D05 according to Figure 9) during each loading phase. From the slope of the curves, it is possible to observe the linear elastic response branch up to flexural cracking followed by crack propagation stage up to failure. Referring to the first, second and third load test (Table 1) on specimens composed by precast beam and cast-in situ slab, all curves show similar flexural stiffness and a cracking load of 24, 20 and 17 kN, respectively. The B3-P47/46 specimen reached its maximum capacity before collapsing with a load of 78.2 kN, related to an applied bending moment of 1438.9 kNm at midspan. The maximum applied loads for B8-P47/46 was 81.1 kN, corresponding to a bending moment of 1492.2 kNm. The B4-P47/46 specimen was loaded up to a failure load of 71.4 kN, corresponding to a bending moment of 1313.8 kNm. The B9-P47/46 PC beam collapsed after reaching a maximum load of 64.6 kN, corresponding to a bending moment of 1188.6 kNm. At the maximum applied load, B3-P47/46, B8-P47/46, B4-P47/46 and B9-P47/46 exhibited maximum midspan deflections of 167 mm, 150 mm, 135 mm and 145 mm respectively. The curve of the B3-P47/46 beam shows a load reduction at 75 kN associated to a holding phase required for the visual inspection stage of the cracking pattern. The drop recorded in the response of the B4-P47/46 beam at 72 kN can be associated to a first crushing of the cast in situ slab.

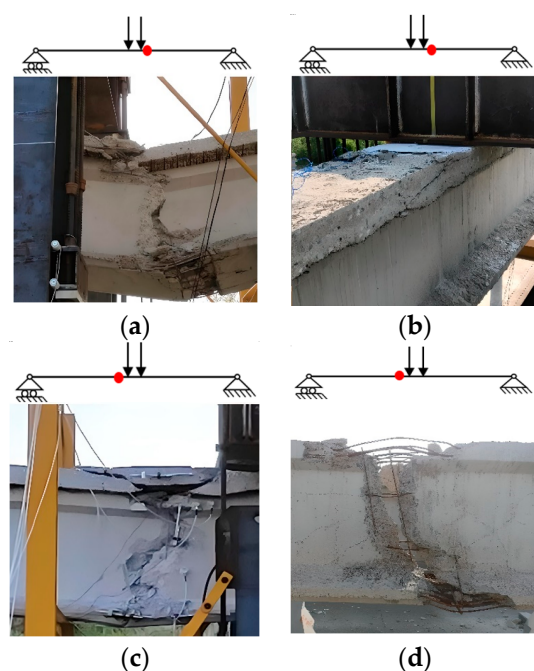
Figure 11. Failure zone details for: (a) B3-P47/46, (b) B8-P47/46, (c) B4-P47/46, (d) B9-P47/46 and the corresponding position.

All girders collapsed in a non-ductile mode with a bending failure mechanism due to concrete crushing in the top compression zone. Figure 11 shows the failure zone for all the tested girders in detail.

The maximum midspan deflections up to collapse recorded for all the tests reveal a ratio less than 1/100 of the span that is typically addressed to PC beams. The crushing of the cast in situ concrete slab for the B3 and B8 and B4-P47/46 girders and of the top flange of the B9-P47/46 girder was reported, highlighting a non-ductile rupture behavior. The girder B4-P47/46 shows a double peak revealing an initial crushing of the cast in situ slab, followed by the crushing of the top slab of the PC beam at a lower load that determined the global collapse (Figure 11c). In all the four tests, the crush of the slab occurred close to the loading system and not at the maximum bending moment section, probably due to the confining action exerted by the transverse steel beams; indeed, a diagonal crack on the most compressed zone departed from the bottom flange of the same steel beam, as can be observed in Figure 11. In Figure 10, the non-ductile performance of the girders is apparent, with no evidence of yielding of the prestressing steel. The girders tested, after adopting the two-loading phases, did not show residual damages such as visible cracks at the end of the unloading, except for a residual deflection due to non-recoverable deformations. Moreover, no significant difference in terms of maximum loads was registered. On the other hand, the two-phase tests adopted for B3-P47/46 and B8-P47/46 and also for the B9-P47/46 girders allowed us to evaluate the decompression loads disregarding the value of the tensile strength of concrete. The crack opening values reported in Section 4.2 can be compared to the results of specific tests on strands and concrete in order to estimate the prestressing losses more accurately. For reinforced concrete beams, cracks directly affect the moment of inertia of the cross-section and the flexural stiffness decreases accordingly. For PC beams, as highlighted by the load–displacement curve of the two-phase load tests, there are no evident signs of stiffness reduction in the second loading phase, due to the beneficial effect provided by prestressing. Referring to the first loading phase, a lower flexural stiffness was observed for the girder B9-P47/46, due to the removal of the cast in situ slab. In addition, a residual deflection can be seen for specimens loaded with two loading phases due to non-recoverable deformation also caused by the first load phase at a level higher than the cracking load. At collapse, no signs of corrosion were detected on the exposed prestressing strands, confirming the good protection exerted from the concrete cover at the time of the test. The peak load registered for the B9-P47/46 girder was

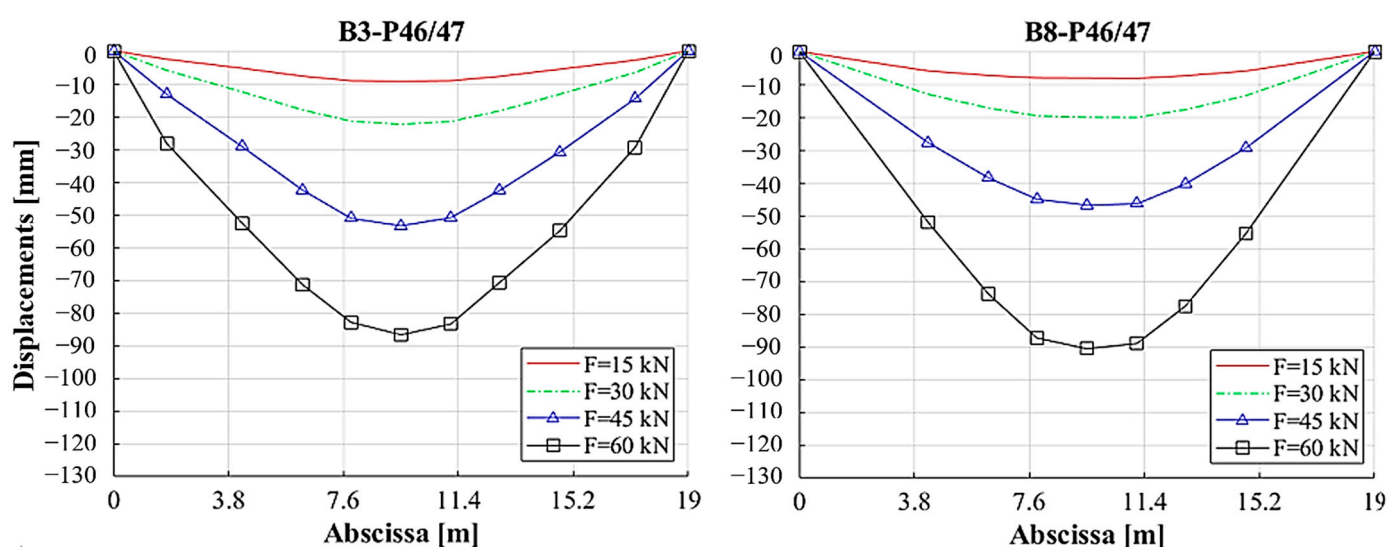
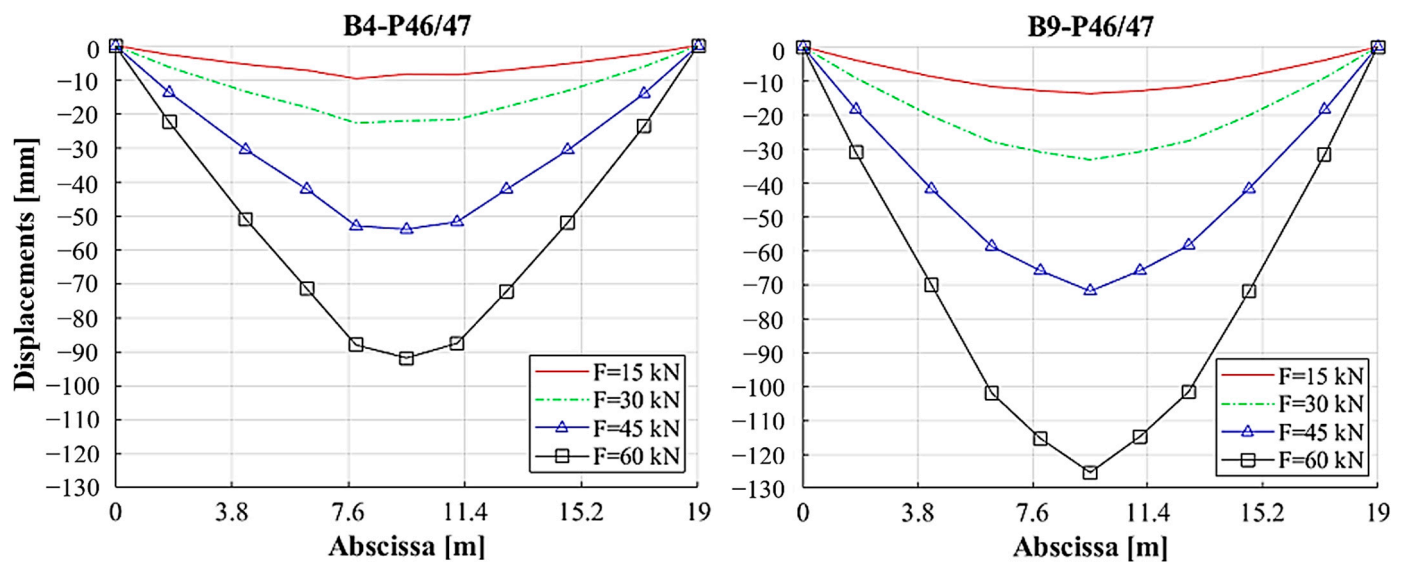
Figure 12. Longitudinal deformed shape of girders at 15, 30, 45 and 60 kN.

Figure 12 shows the deflection of each girder at the elastic stage (15 kN) and at the post cracked phases (30, 45 and 60 kN). For girders tested with two loading phases, the load at 60 kN refers to the second loading phase. The deflection was measured in the position of sensors from D01 to D09, according to the layout reported in Figure 9. As expected, the girder B9-P47/46, from which the cast in situ slab was removed, experienced a higher deflection due to a reduced flexural stiffness compared to the other girders. The deflections of the first three beams are similar for low load levels and become slightly different with increasing load.

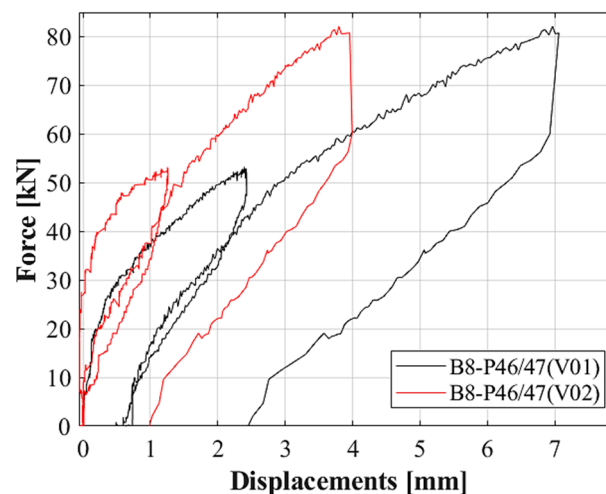
Figure 13. Vertical displacements of the support for the B8-P47/46 beam.

In order to remove vertical displacements from the deflection of the beams due to support settlement, transducers were placed in the support zone (devices V01 and V02 in Figure 9). During the load tests, not relevant settlements were measured at the support level, but their values were taken into account. As an example, the vertical displacements recorded for the B8-P47/46 beam are reported in Figure 13.

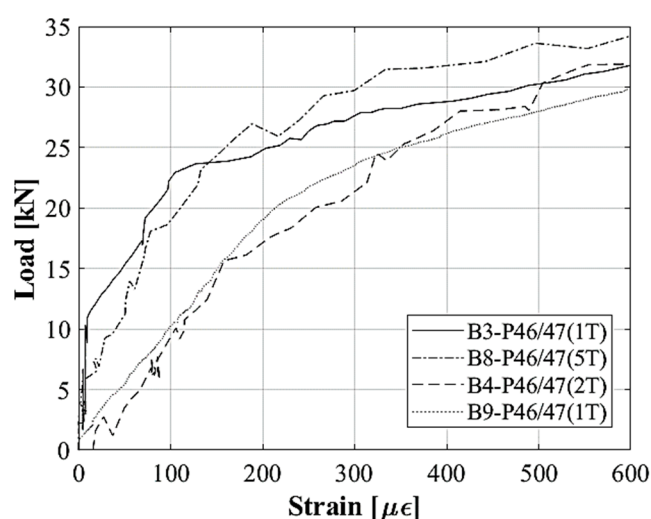
Figure 14. Applied load versus tensile strain.

The first cracking load was estimated from the load–strain curve recorded by the LVDTs placed at the bottom flange of the PC specimens in the zone of tension. Figure 14 shows the plot of load versus tensile strain, regarding LVDTs, which recorded the minimum cracking load. To highlight the variation in the slope of the curves, a diagram up to 35 kN is shown. For the B3-P47/46, B8-P47/46, B4-P47/46 and B9-P47/46 beams, cracks began to open at an estimated applied load of 23 kN, 25 kN, 16 kN and 20 kN, respectively.

It can be observed that each curve starts with a linear trend. Once the applied load is sufficient to cause cracking, the nonlinearity begins and a change in the slope occurs. Figure 15 shows the mapping of the crack pattern recorded at the end of the load tests using markers by manual procedure and then reported in digital format. Typical flexural cracks were detected around the loading zone at the midspan in the region under the transverse steel beams. Cracks formed outside the midspan region present an influence of the shear effect and reveal an inclination toward the loading area. The top region of all the girders shows the crushing of the concrete in compression, which led to the failure. The subsequent collapse involved the whole section as a rigid rotation between two segments of the beam when the applied loading force was not promptly released.

The first cracking estimated by the LVDTs placed in the bottom flange showed some variability among the girders. It is important to observe that the beam B9-P47/46 shows a value of 20 kN, which is also the result of the removal of the cast in situ slab for both its absence in the resistance mechanism and its weight in terms of loading. This first cracking could be also deeply affected by the actual residual prestressing and, in turn, it can be a parameter for its evaluation. The compressive strains reveal a large deformation at the level of the most compressed element of the girder (the cast in situ slab or the top flange) and the analytical evaluation of the neutral axis position allows us to infer that the maximum strain at the top fiber was obviously larger. No valuable slip was measured in the experiments between the concrete at the edges of the girders and the selected unbonded strands, and this reveals an efficient stress transmission and a proper transmission length within this loading scheme. Other strain measurements confirm the outcomes of crack formation and the resisting mechanism evidenced during the loading test up to collapse.

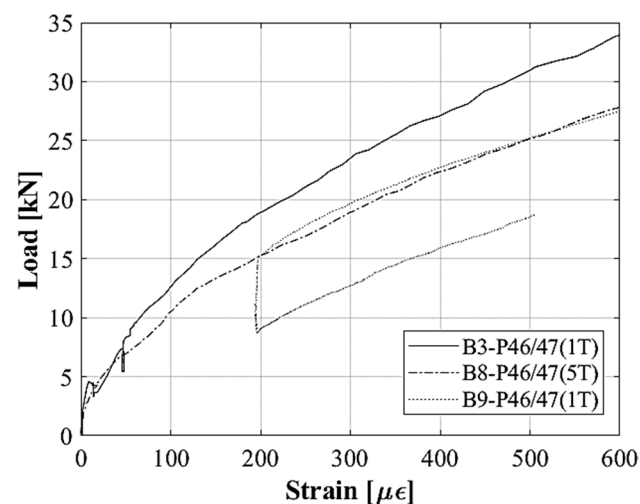
Figure 16. Applied load versus crack reopening.

As mentioned in Section 2.3, the decompression load can be used to estimate the prestress loss. Figure 16 shows the load versus strain for the analysis of crack reopening recorded for specimens loaded in the two phases. During reloading, cracks remain closed due to the prestressing force and only elastic strains are recorded. Once the applied load is sufficient to reopen the cracks, it was no longer transferred across them and a sharp change in slope was observed. The transition from compression to the tension state of orthogonal stress to the crack profile at the bottom flange of the beam can be estimated independently from the tensile strength of concrete and, therefore, can be a more reliable base to estimate the prestressing force. The diagram highlights a change in slope at 16 kN, 11 kN and 15 kN for the B3-P47/46, B8-P47/46 and B9-P47/46 beams, respectively. For the B9-P46/47 curve, the unloading phase can be observed, followed by reloading starting from 9 kN.

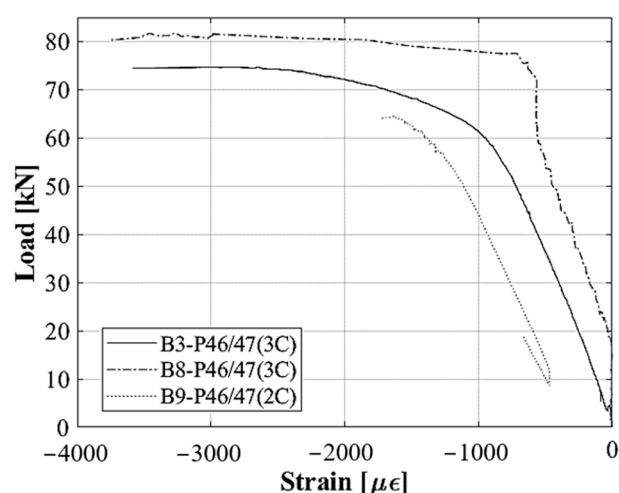
Figure 17. Applied load versus top compressive strain.

The compressive strain recorded in the top region of the girders is a parameter to study the distribution of strain along the cross-section during the load test and can provide key information on the structural response of the girders during the load test. The continuous strain measurements obtained for the B3-P47/46, B8-P47/46 and B9-P47/46 beams in the top compressed region are presented in Figure 17. The maximum compressive strain recorded at the half of the thickness of the cast in situ slab of the composite sections of B3-P47/46 and B8-P47/46 was $-3.6‰$ and $-3.8‰$, respectively. For the B9-P47/46 beam, the compressive strain recorded at the half of the thickness of the top flange at failure load was $-1.7‰$.

For the B8-P47/46 curve, an anomalous behaviour at the beginning of the test was recorded, characterized by a constant strain value with increasing load, and probably linked to a locking of the LVDT supporting frame.

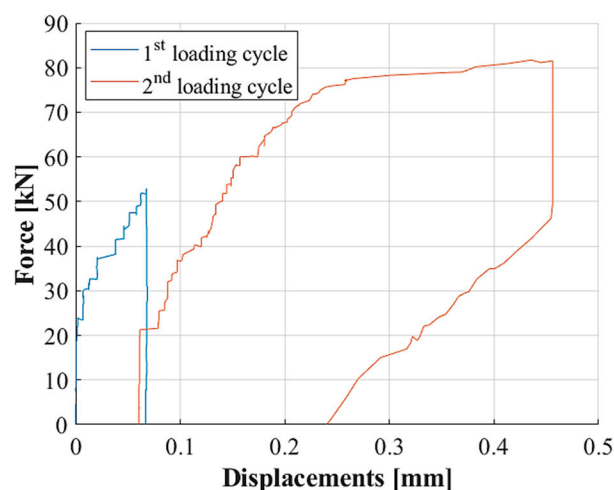
Figure 18. Force–strand slip curves for STR-02 of B8-P47/46.

The prestressing force in PC structures is transferred from strand to the concrete due to bond at the strand–concrete interface. If the bond strength degrades over the years, the transfer of effective prestress is affected. In order to evaluate the possible slip of prestressing strands during the load test, the relative displacement between concrete at the end of the beam and the strand unbonded for the first 3 m with the sensors in positions STR-01 and STR-02 (Figure 9) was measured. During the load tests, no significant slipping of the strands was recorded. As an example, the displacements recorded by the sensor STR-02 of the B8-P47/46 beam are reported in Figure 18. The slipping of the strand can be observed starting from a load of 24.05 kN. The maximum value of the slip recorded at failure load is 0.46 mm.

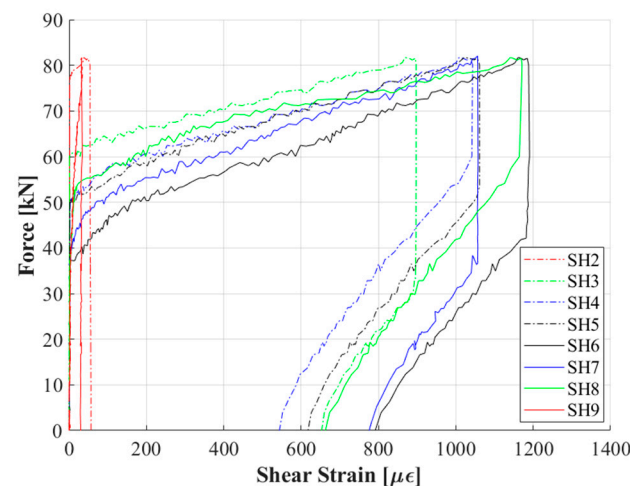
Figure 19. Tensile shear strain of the B8-P47/46 beam.

were designed and installed to record shear strains in relevant positions. Figure 19 shows the measurements recorded by the transducers' reading tensile effect belonging to the B8-P47/46 beam. The dashed–dotted lines refer to the sensors installed on the left side of the beam (position A in Figure 9); the solid lines represent the strain recorded on the right side (position B in Figure 9). A correspondence between the dashed and solid lines can be observed, with the exception of SH6 and SH8, which show a slight increase on the right side compared to the left one. Furthermore, a reduction in strain is recorded by moving from the midspan to the support zone.

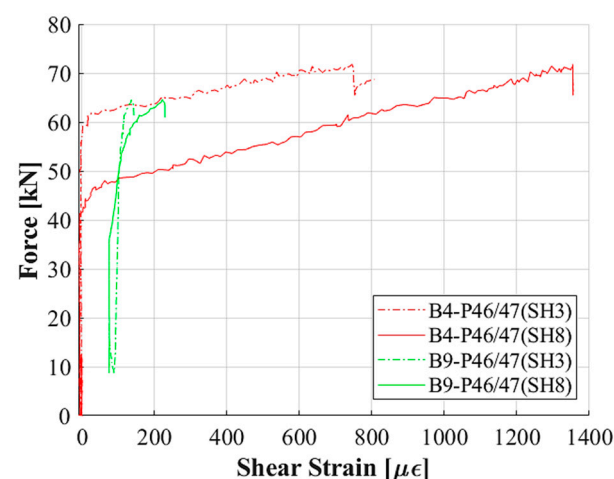
Figure 20. Force–tensile shear strain for SH3 and SH8 for the B4-P47/46 and B9-P47/46 beams.

Figure 20 shows a comparison of the tensile shear strains at positions SH3 (A) and SH8 (B) of B4-P47/46 with the cast in situ slab and the B9-P47/46 beam without the cast in situ slab. Lower shear strains are reported for the B9-P47/46 specimen compared to B4-P47/46; this could be due to the different resistance mechanism when approaching the maximum load.

These results are in line with the crack pattern recorded after the load tests shown in Figure 15. Indeed, the beam B4-P47/46 shows both flexural and shear cracks, whereas the beam B9-P47/46 reveals only few vertical cracks typical of a bending failure mechanism.
