Conservation of Earthen Bricks in Architecture: An Experimental Campaign to Test Treatments on Vernacular Built Heritage / Mattone, Manuela; Fratini, Fabio; Luvidi, Loredana; Rescic, Silvia. - In: HERITAGE. - ISSN 2571-9408. - 6:2(2023), pp. 1541-1566. [10.3390/heritage6020083]

Conservation of Earthen Bricks in Architecture: An Experimental Campaign to Test Different Treatments on Vernacular Built Heritage

Keywords: earthen architecture; earthen bricks; conservation issues; protective products; test methods

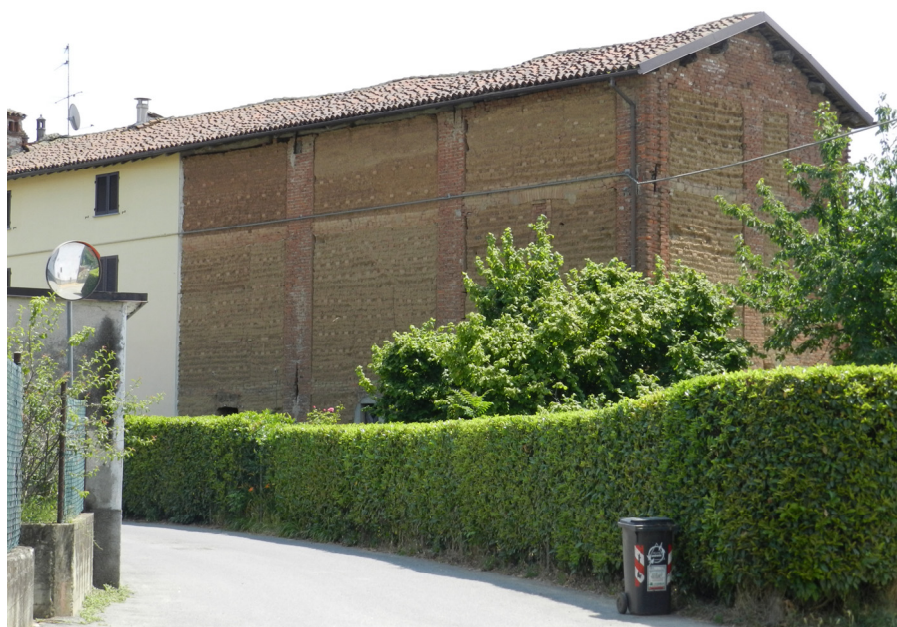
Figure 4. Vernacular earthen architecture in the Alessandria province, Piedmont, Italy (by Mattone, 2020).

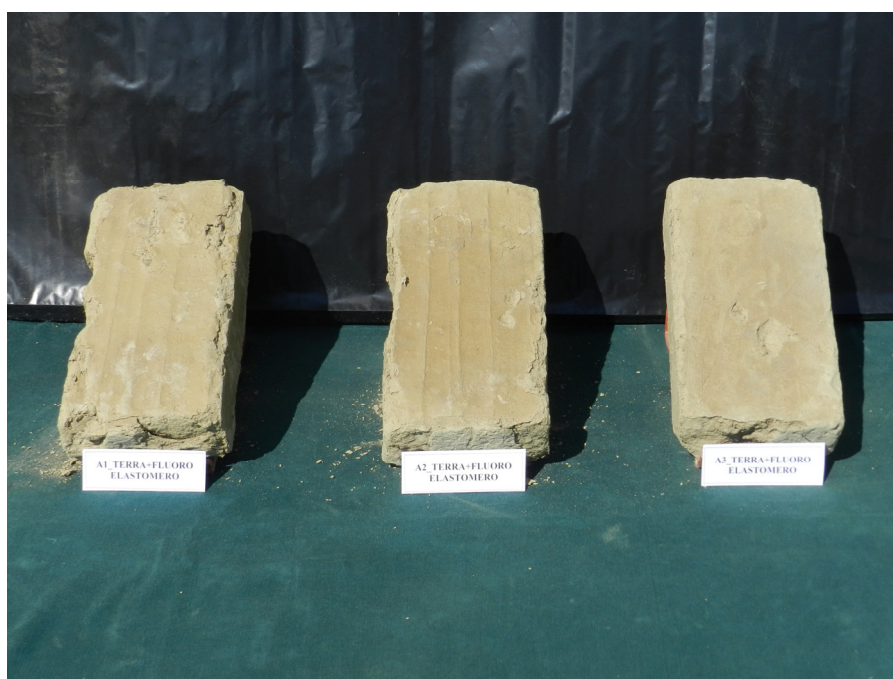
Figure 5. Earthen bricks: Specimens made with local earth (from Alessandria, Italy) and treated with a fluoroe elastomer (Tecnoflon N215).

The dimensions of the earthen bricks used for the experimentation were $26 \times 13 \times 6$ cm. Not fissured bricks with relatively regular surfaces were chosen. They were previously cleaned with a chisel stonemason and a brush, removing all traces of plaster, mortar, and any vegetal residues (Figures 5 and 6).

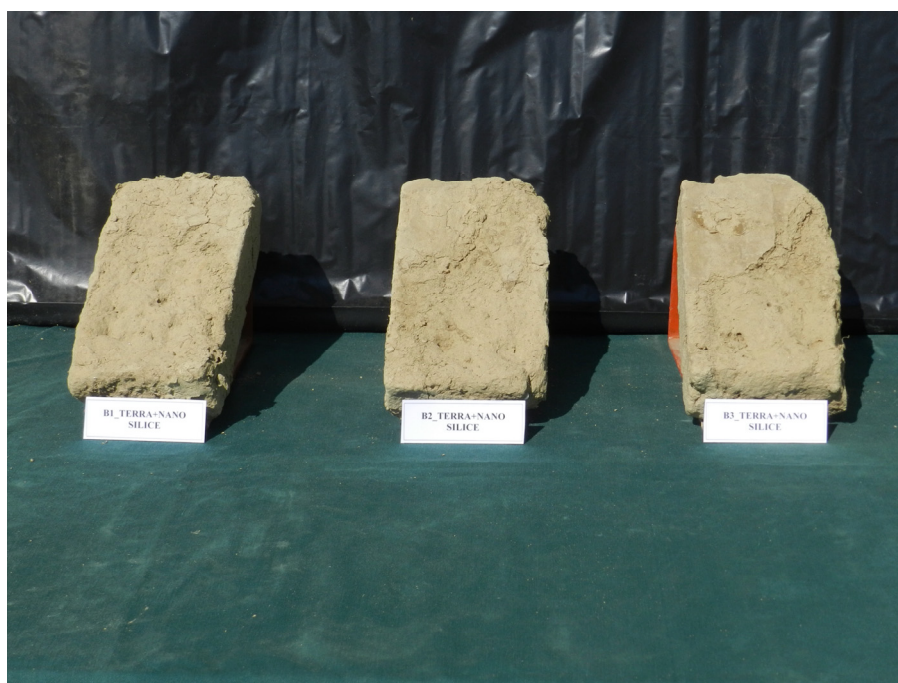
Figure 6. Earthen bricks: Specimens made with local earth (from Alessandria, Italy) and treated with nano-silica (Nano Estel).

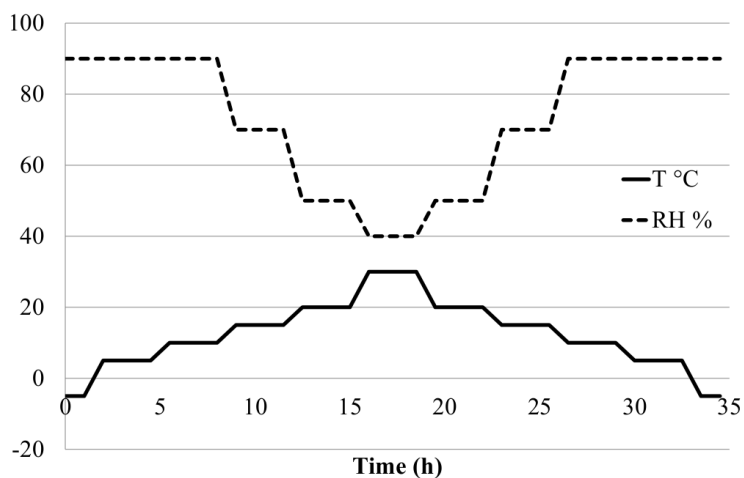
Figure 7. Diagram representative of the TH cycle (credit: Rescic).

The not treated and treated earthen bricks were exposed to artificial ageing in an Angelantoni Challenge 500 Climatic Chamber. The thermo-hygrometric conditions were simulated experimentally based on the cycle represented in Figure 7. This cycle was carried out by reprocessing original data recorded by “Rete di Monitoraggio Meteoroidrografica” of ARPA Piedmont in the Alessandria Lobbi weather station over ten years. The data were averaged, and one-year behaviour was converted to an RH cycle of 35 h ranging from -5°C to 30°C and from 40 to 90% RH. The cycle was repeated 50 times. Colorimetric change, weight, and contact angle measurements were performed before and after accelerated ageing.

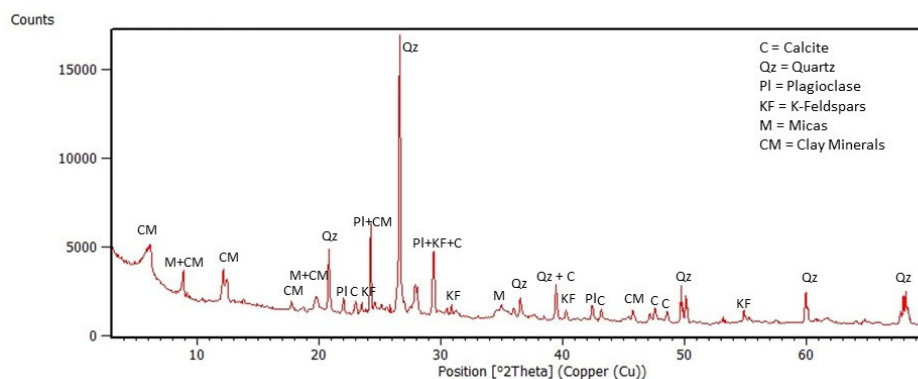
Figure 8. XRD diagram of the main mineralogical composition of the earthen not treated brick (credit: Rescic).

The grain size distribution of the earthen material (sand 24%, silt 45%, clay 31%) taken from the farmhouse under demolition was obtained through sieving. The main mineralogical composition of the earthen bricks, performed by X-ray diffraction, is as follows: quartz, feldspars, calcite, micas, and clay minerals (Figure 8).

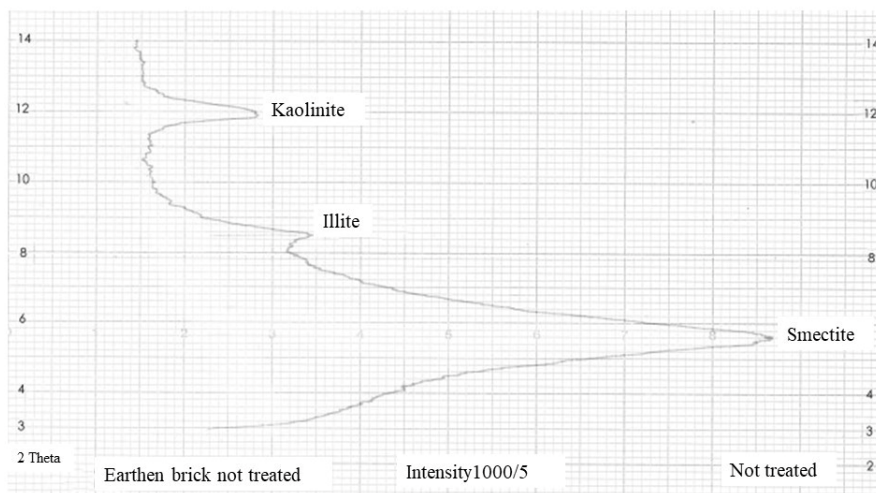
Figure 9. XRD diagram of the clay mineral fraction: Not treated sample.

The semi-quantitative composition of the clay fraction was as follows: kaolinite 35%, illite 20%, and smectite 45% (Figures 9–11).

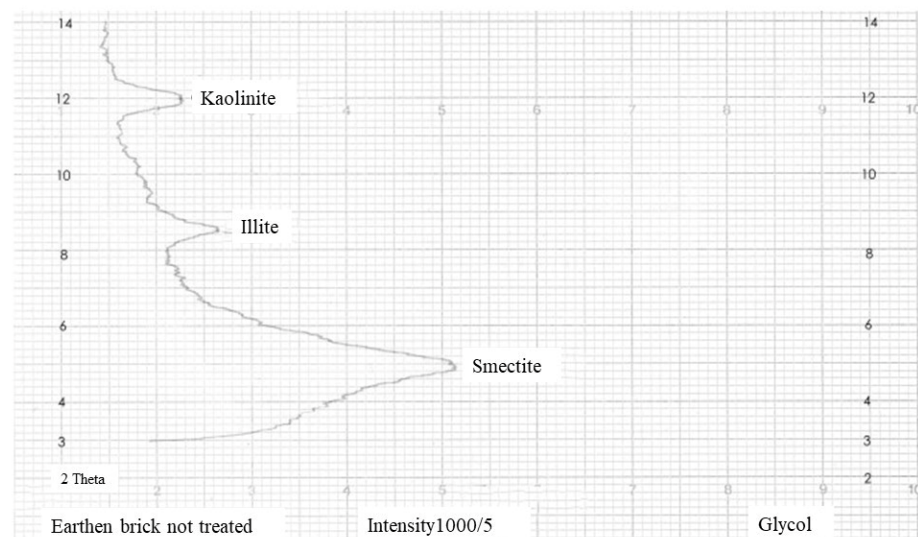
Figure 10. XRD diagram of the clay mineral fraction: glycol sample

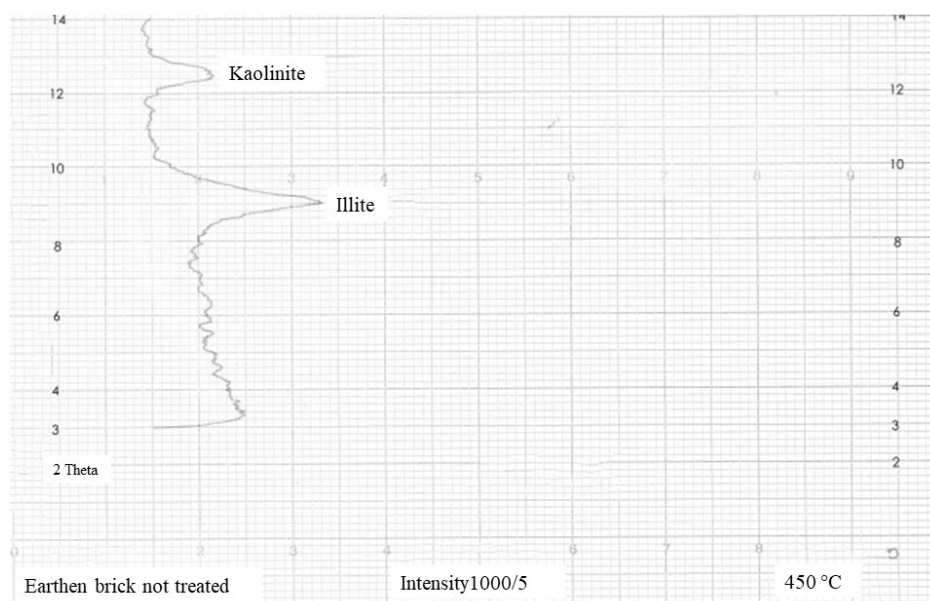
Figure 11. XRD diagram of the clay mineral fraction: sample at 450 °C

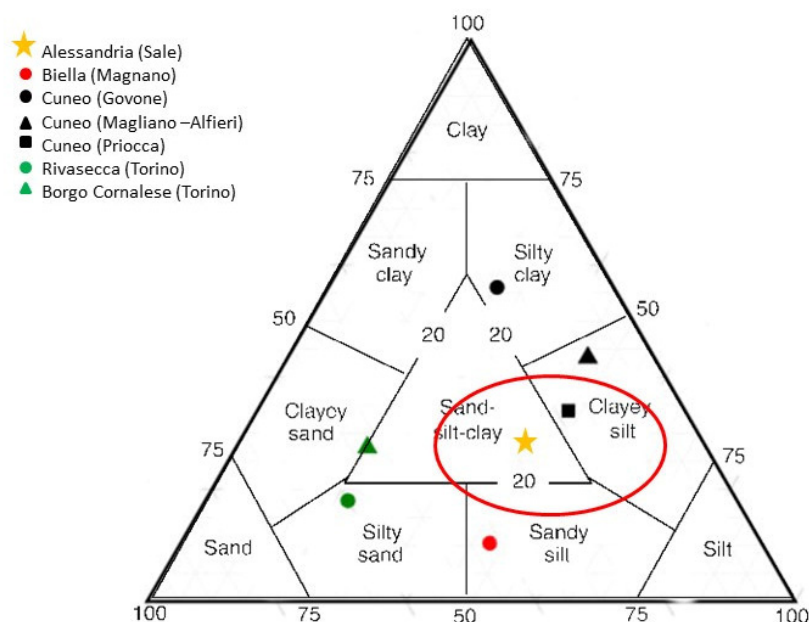
Figure 13. Diagram of the grain size composition of the earthen brick from Sale (Alessandria) compared with others from the Cuneo, Biella, and Turin provinces; within the red circle is the area of acceptability for adobe reported by CRATERre.

In fact, these bricks were characterised by a greater presence of the finest fraction (silt), as can be seen from the diagram shown in Figure 13, where the optimal granulometric distribution area is indicated as defined by CRATERre (Figure 13) [52].

The bricks from Sale and Priocca (Figures 12 and 13) lie in this area, while those of Govone and Magliano-Alfieri are more clayey. Another similarity with the bricks from the Cuneo area concerns the mineralogical composition of the clay fraction with the presence of illite-smectite and smectite expandable lattice minerals [53]. These data suggest that the results obtained from the present experiment could also be useful for applications on bricks of earthen material from the Cuneo area.

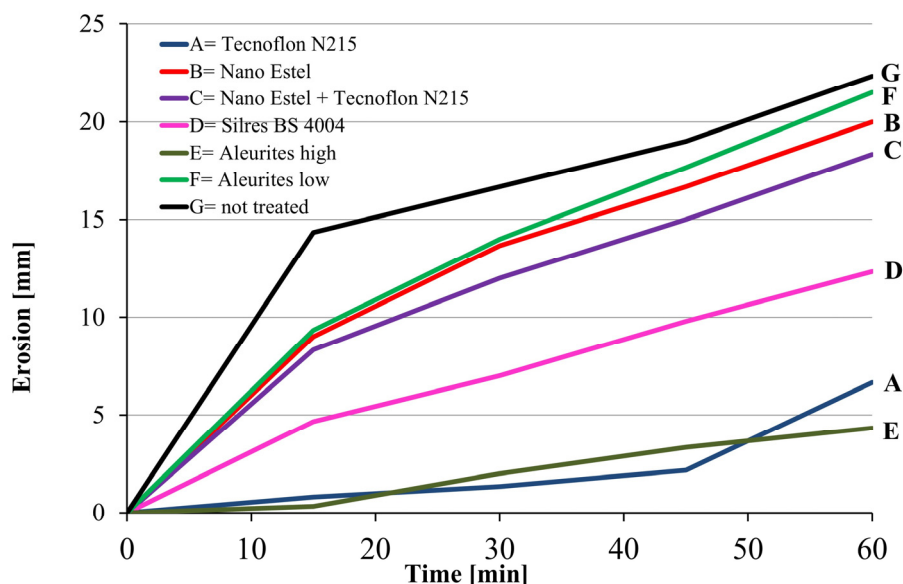
**Figure 14.** Spray erosion test diagram (credit: Mattone).

The results of the spray erosion tests are shown in Figure 14.

The results of the spray erosion test allow for the following considerations:

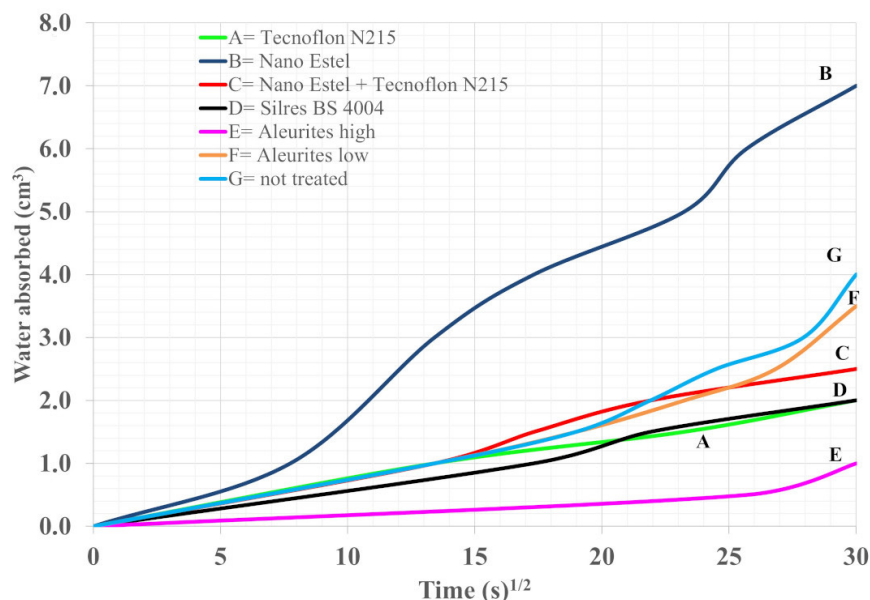
Figure 15. Water absorption diagram.

The results of the water absorption test with the Karsten method are shown in Figure 15.

- Earthen brick B (Nano Estel) showed the worst results compared to the not treated brick (G). It absorbed the maximum amount of water (i.e., 7 cm³) and began to absorb from the first minute. This result is not unexpected for two reasons: nano silica is a consolidating but not a protective product, and second, it is applied in an aqueous solvent. The aqueous solvent could have caused partial melting of the earth with a reorganization of the matter that favoured the creation of a porous network more accessible to liquid water [47];

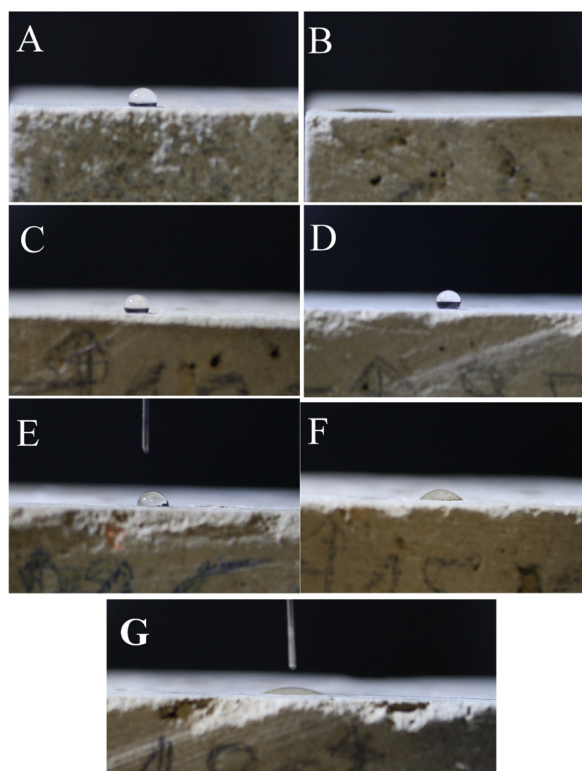
**Figure 16.** Contact angle of the earthen brick samples treated (A–F) and not treated (G). (A = Tecnoflon N215; B = Nano Estel; C = Nano Estel + Tecnoflon N215; D = Silres BS 4004; E = Aleurites high; F = Aleurites low; G = not treated) (credit: Rescic).

The conservative treatment products that performed best in this test were Tecnoflon N215(A), Nano Estel + Tecnoflon N215 (C), and Silres BS 4004 (D), namely, the products with well-known hydrophobic properties.

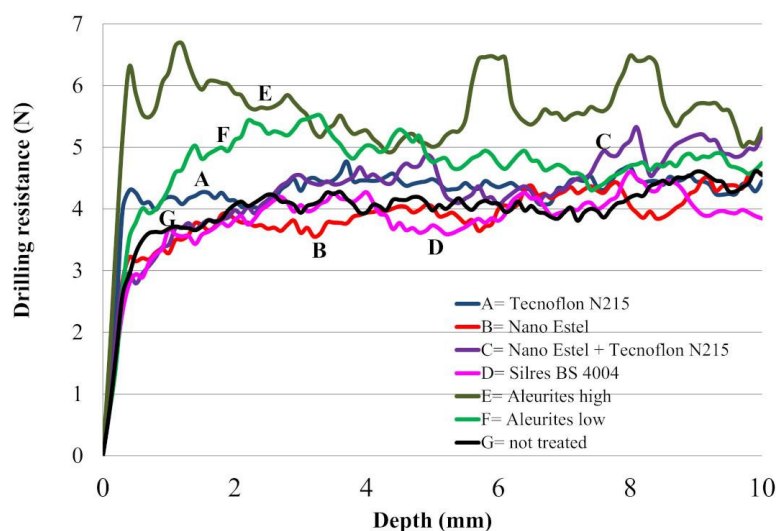
**Figure 17.** Drilling resistance profiles (A = Tecnoflon N215; B = Nano Estel; C = Nano Estel + Tecnoflon N215; D = Silres BS 4004; E = Aleurites high; F = Aleurites low; G = not treated) (credit: Rescic).

The results reported in Table 9 and Figure 17 show that:

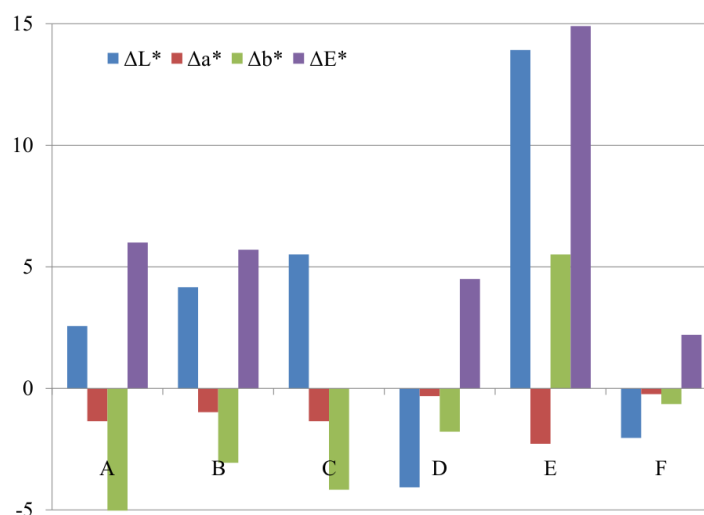
Figure 18. Average values of the variations in the chromatic parameters of the different treatments (A = Tecnoflon N215; B = Nano Estel; C = Nano Estel + Tecnoflon N215; D = Silres BS 4004; E = Aleurites high; F = Aleurites low; G = not treated) (credit: Luvidi).

All treatments, except for D and F, showed a total variation in colour perception (ΔE) appreciable with the naked eye ($\Delta E > 5$). In particular:

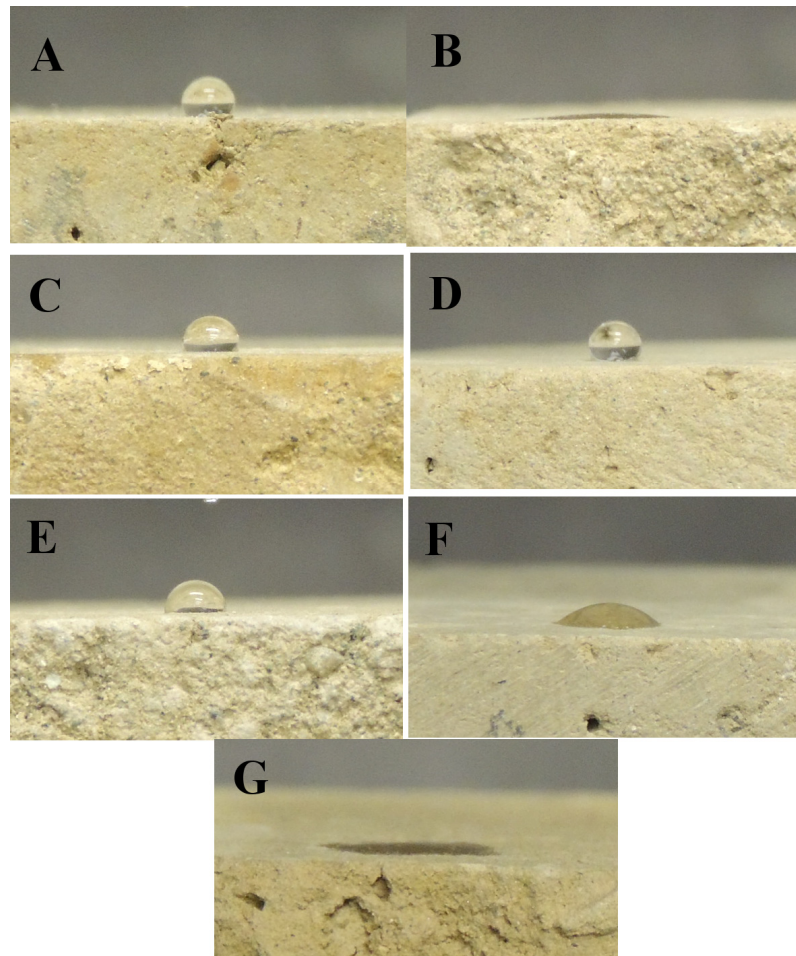
**Figure 19.** After ageing, contact angle of the earthen brick samples treated (A–F) and not treated (G). (A = Tecnoflon N215; B = Nano Estel; C = Nano Estel + Tecnoflon N215; D = Silres BS 4004; E = Aleurites high; F = Aleurites low; G = not treated) (credit: Rescic).

The untreated earthen brick appeared to be the only one with a slight worsening in its natural capacity of hydrophobicity, with a contact angle reduction and an increased absorption rate. The contact angle and the corresponding water absorption rate for all other treatments remained practically unchanged.
