Conservation of Earthen Bricks in Architecture: An Experimental Campaign to Test Treatments on Vernacular Built Heritage / Mattone, Manuela; Fratini, Fabio; Luvidi, Loredana; Rescic, Silvia. - In: HERITAGE. - ISSN 2571-9408. - 6:2(2023), pp. 1541-1566. [10.3390/heritage6020083]

Conservation of Earthen Bricks in Architecture: An Experimental Campaign to Test Different Treatments on Vernacular Built Heritage

Silvia Rescic ¹, Manuela Mattone ^{1,2}, Fabio Fratini ¹ and Loredana Luvidi ^{3,*}

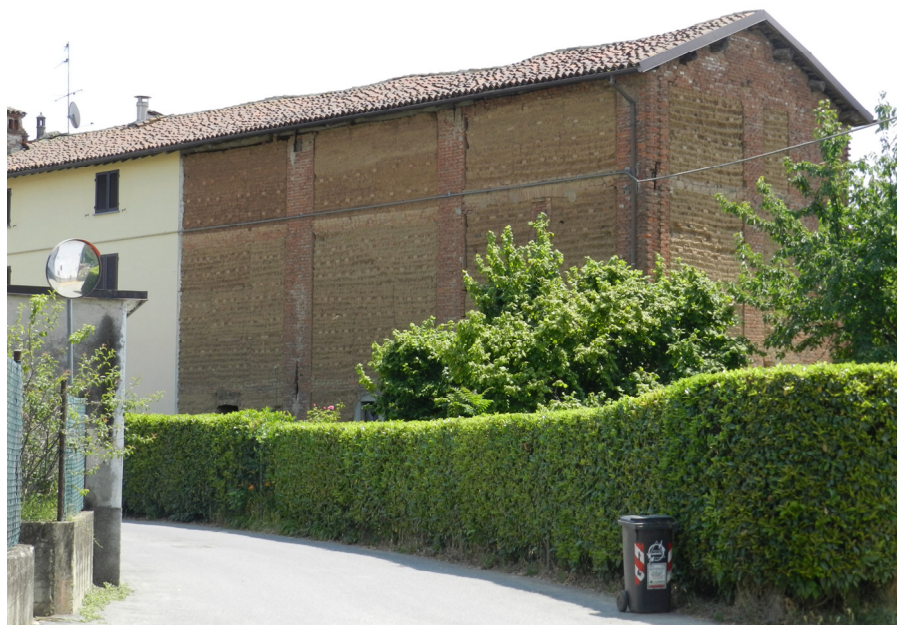
Figure 4. Vernacular earthen architecture in the Alessandria province, Piedmont, Italy (by Mattone, 2020).

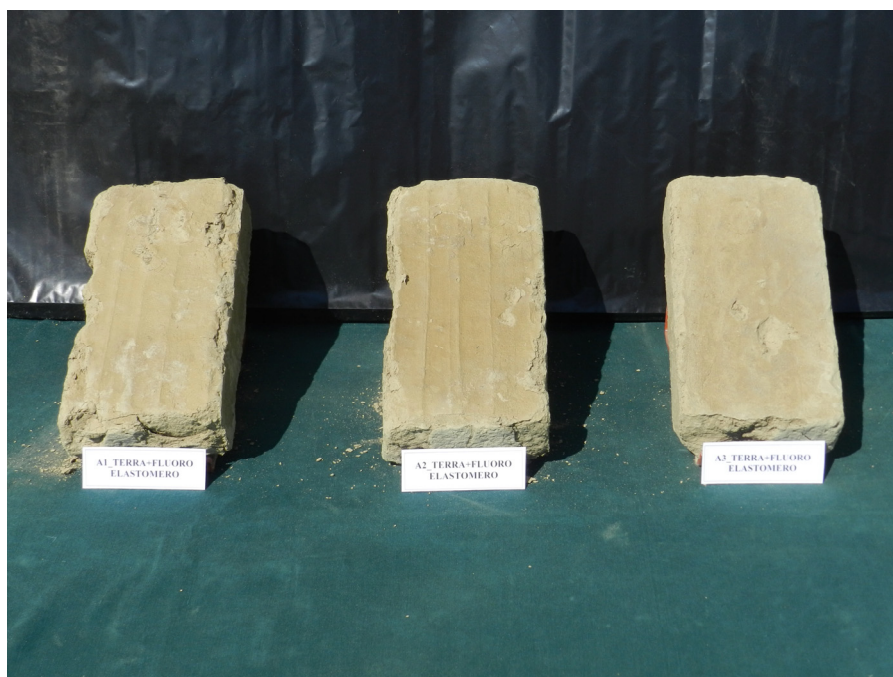
Figure 5. Earthen bricks: Specimens made with local earth (from Alessandria, Italy) and treated with a fluoroe elastomer (Tecnoflon N215).

The dimensions of the earthen bricks used for the experimentation were $26 \times 13 \times 6$ cm. Not fissured bricks with relatively regular surfaces were chosen. They were previously cleaned with a chisel stonemason and a brush, removing all traces of plaster, mortar, and any vegetal residues (Figures 5 and 6).

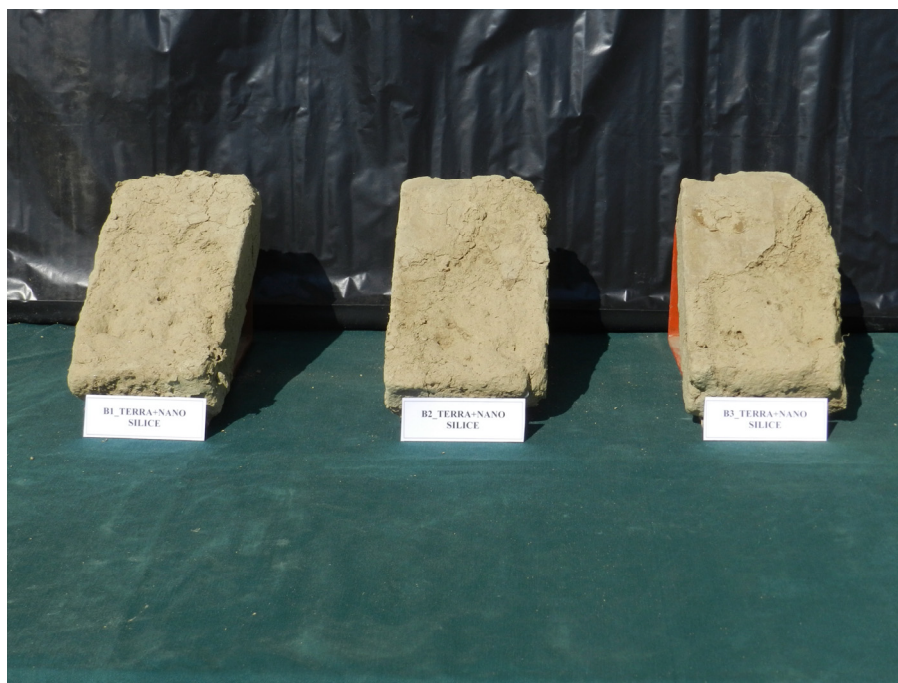
Figure 6. Earthen bricks: Specimens made with local earth (from Alessandria, Italy) and treated with nano-silica (Nano Estel).

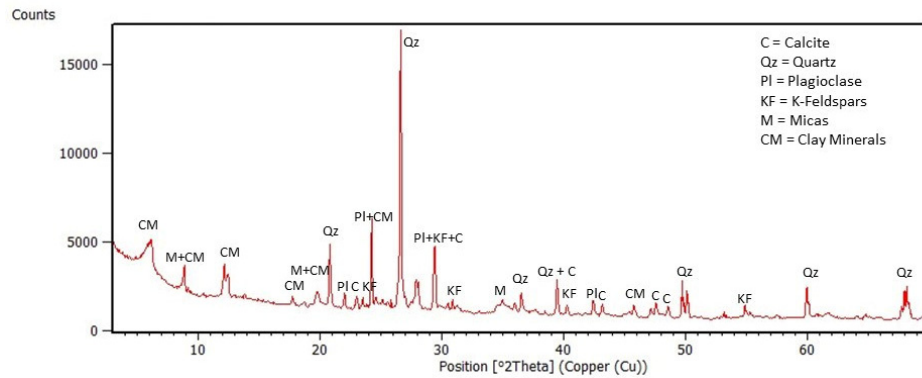
Figure 8. XRD diagram of the main mineralogical composition of the earthen not treated brick (credit: Rescic).

The grain size distribution of the earthen material (sand 24%, silt 45%, clay 31%) taken from the farmhouse under demolition was obtained through sieving. The main mineralogical composition of the earthen bricks, performed by X-ray diffraction, is as follows: quartz, feldspars, calcite, micas, and clay minerals (Figure 8).

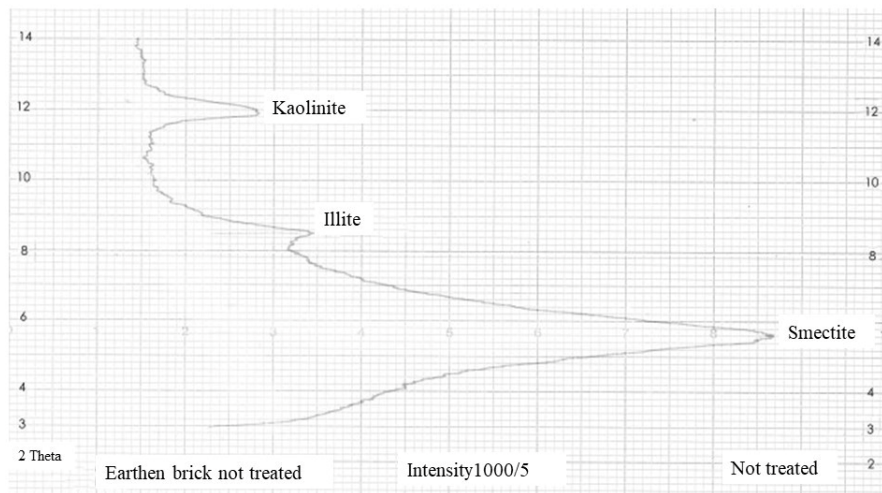
Figure 9. XRD diagram of the clay mineral fraction: Not treated sample.

The semi-quantitative composition of the clay fraction was as follows: kaolinite 35%, illite 20%, and smectite 45% (Figures 9–11).

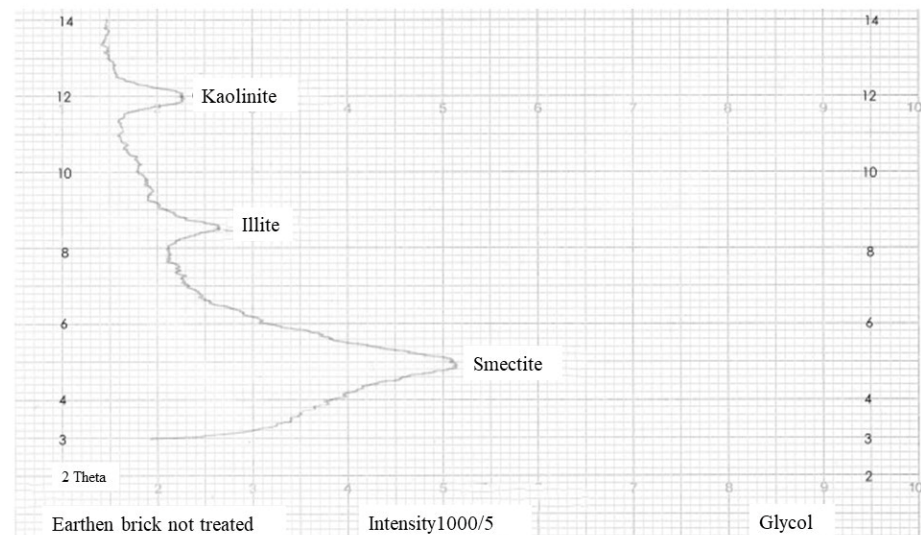
Figure 10. XRD diagram of the clay mineral fraction: glycol sample

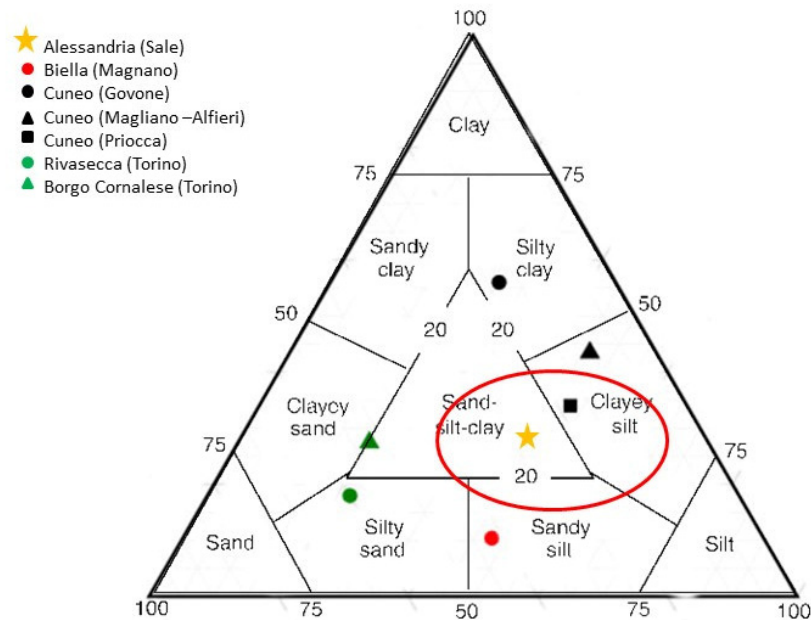
Figure 13. Diagram of the grain size composition of the earthen brick from Sale (Alessandria) compared with others from the Cuneo, Biella, and Turin provinces; within the red circle is the area of acceptability for adobe reported by CRAterre.

In fact, these bricks were characterised by a greater presence of the finest fraction (silt), as can be seen from the diagram shown in Figure 13, where the optimal granulometric distribution area is indicated as defined by CRAterre (Figure 13) [52].

The bricks from Sale and Priocca (Figures 12 and 13) lie in this area, while those of Govone and Magliano-Alfieri are more clayey. Another similarity with the bricks from the Cuneo area concerns the mineralogical composition of the clay fraction with the presence of illite-smectite and smectite expandable lattice minerals [53]. These data suggest that the results obtained from the present experiment could also be useful for applications on bricks of earthen material from the Cuneo area.

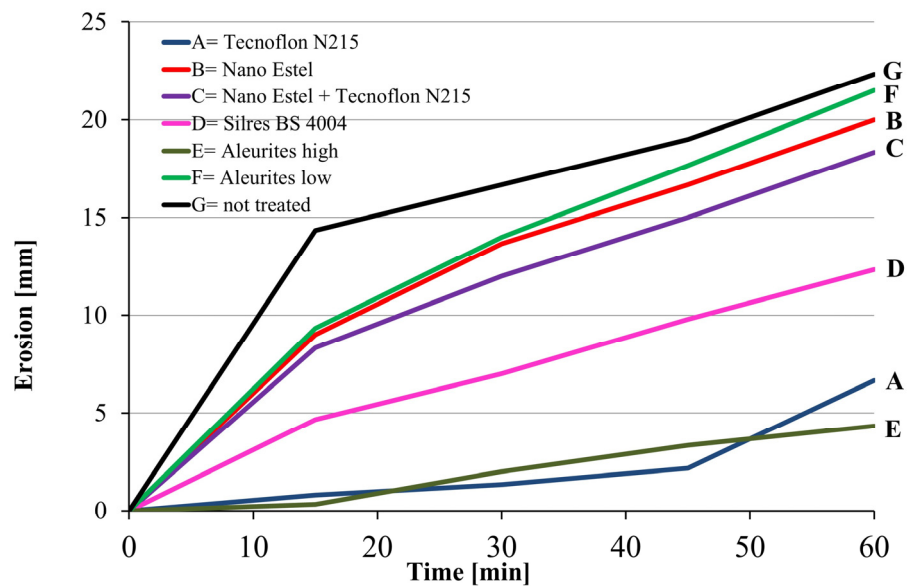
**Figure 14.** Spray erosion test diagram (credit: Mattone).

The results of the spray erosion tests are shown in Figure 14.

The results of the spray erosion test allow for the following considerations:

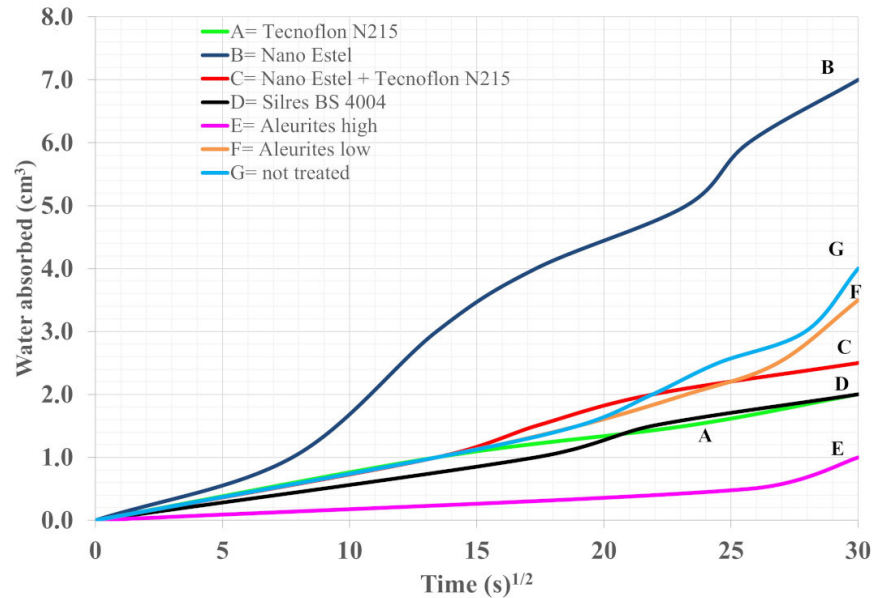
Figure 15. Water absorption diagram.

The results of the water absorption test with the Karsten method are shown in Figure 15.

The results of the water absorption test allow for the following considerations:

- Earthen brick B (Nano Estel) showed the worst results compared to the not treated brick (G). It absorbed the maximum amount of water (i.e., 7 cm³) and began to absorb from the first minute. This result is not unexpected for two reasons: nano silica is a consolidating but not a protective product, and second, it is applied in an aqueous solvent. The aqueous solvent could have caused partial melting of the earth with a reorganization of the matter that favoured the creation of a porous network more accessible to liquid water [47];

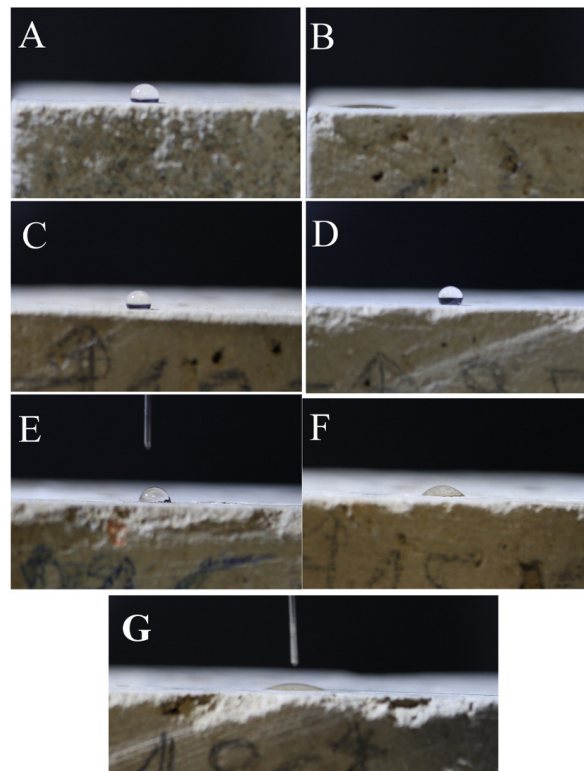
Figure 16. Contact angle of the earthen brick samples treated (A–F) and not treated (G). (A = Tecnoflon N215; B = Nano Estel; C = Nano Estel + Tecnoflon N215; D = Silres BS 4004; E = Aleurites high; F = Aleurites low; G = not treated) (credit: Rescic).

The conservative treatment products that performed best in this test were Tecnoflon N215(A), Nano Estel + Tecnoflon N215 (C), and Silres BS 4004 (D), namely, the products with well-known hydrophobic properties.

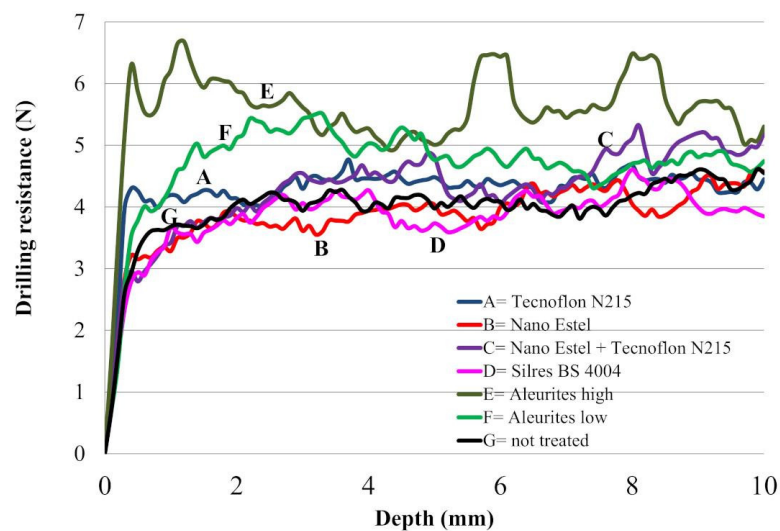
**Figure 17.** Drilling resistance profiles (A = Tecnoflon N215; B = Nano Estel; C = Nano Estel + Tecnoflon N215; D = Silres BS 4004; E = Aleurites high; F = Aleurites low; G = not treated) (credit: Rescic).

The results reported in Table 9 and Figure 17 show that:

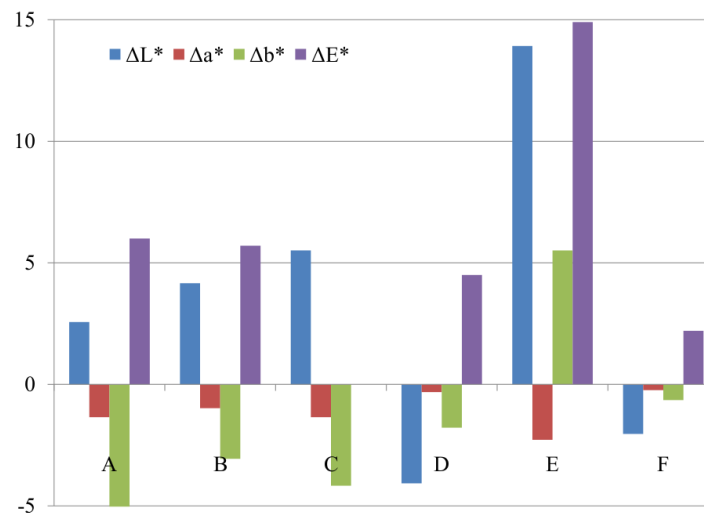
Figure 18. Average values of the variations in the chromatic parameters of the different treatments (A = Tecnoflon N215; B = Nano Estel; C = Nano Estel + Tecnoflon N215; D = Silres BS 4004; E = Aleurites high; F = Aleurites low; G = not treated) (credit: Luvidi).

All treatments, except for D and F, showed a total variation in colour perception (ΔE) appreciable with the naked eye ($\Delta E > 5$). In particular:
