**Universidade de Évora - Instituto de Investigação e Formação Avançada**

Tese de Doutoramento

**Innovative Conservation Techniques for Bio-deteriorated and  
Soiled Ornamental stone in Urban Areas: Laser versus  
Plasma Vapour Cleaning**

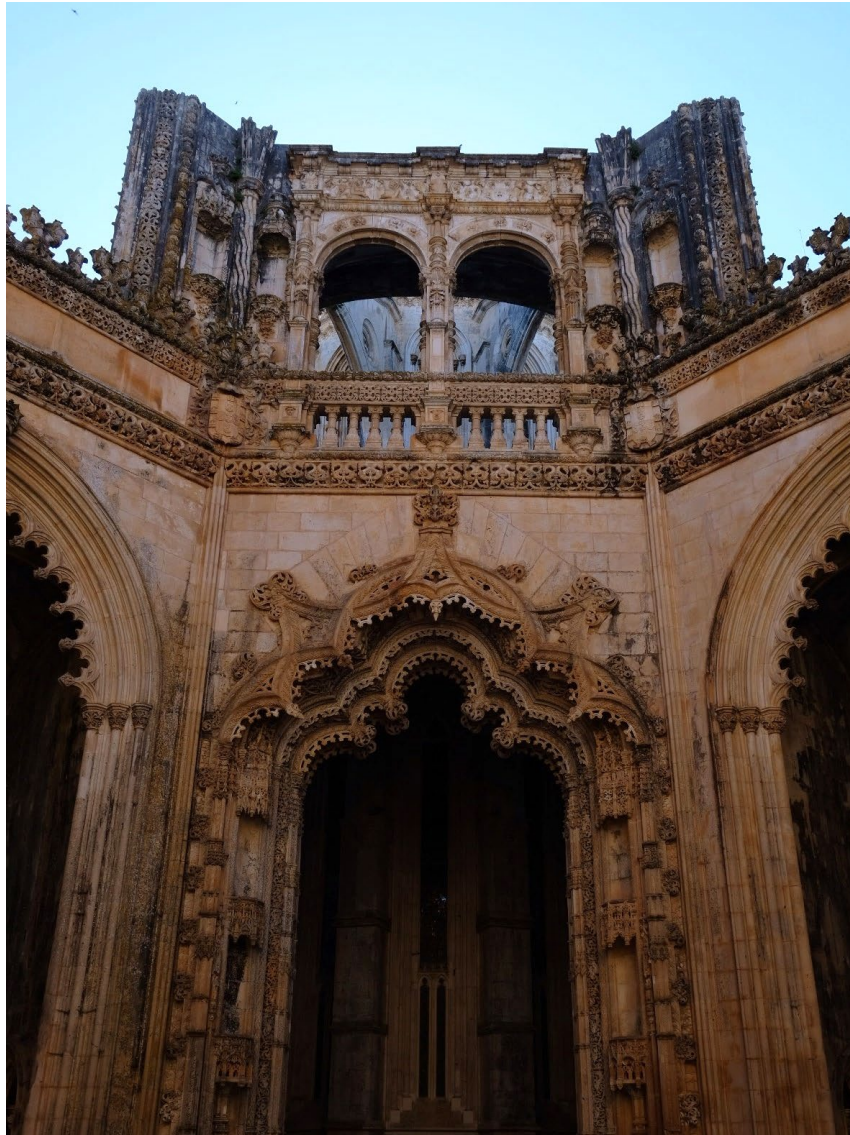
Figure 2.1. Facade and ornaments with orange patina at the Imperfect Chapel, Batalha Monastery

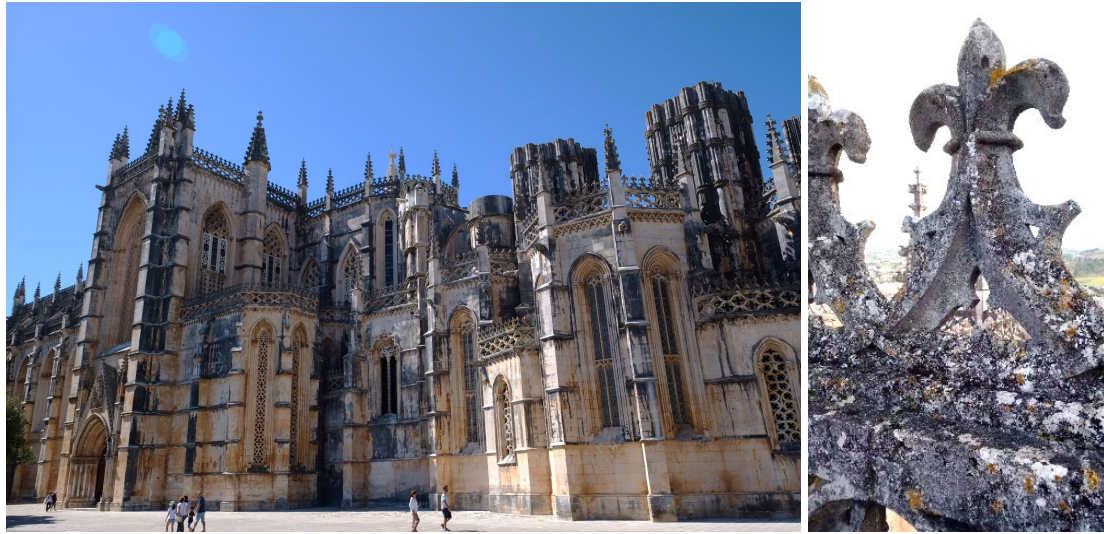
Figure 3.1. **(left)** The external wall of Batalha Monastery, covered by dark brown/gray biofilms and crusts; **(right)** Balustrade on the roof of the monastery showing thick biofilms and lichenous crusts.

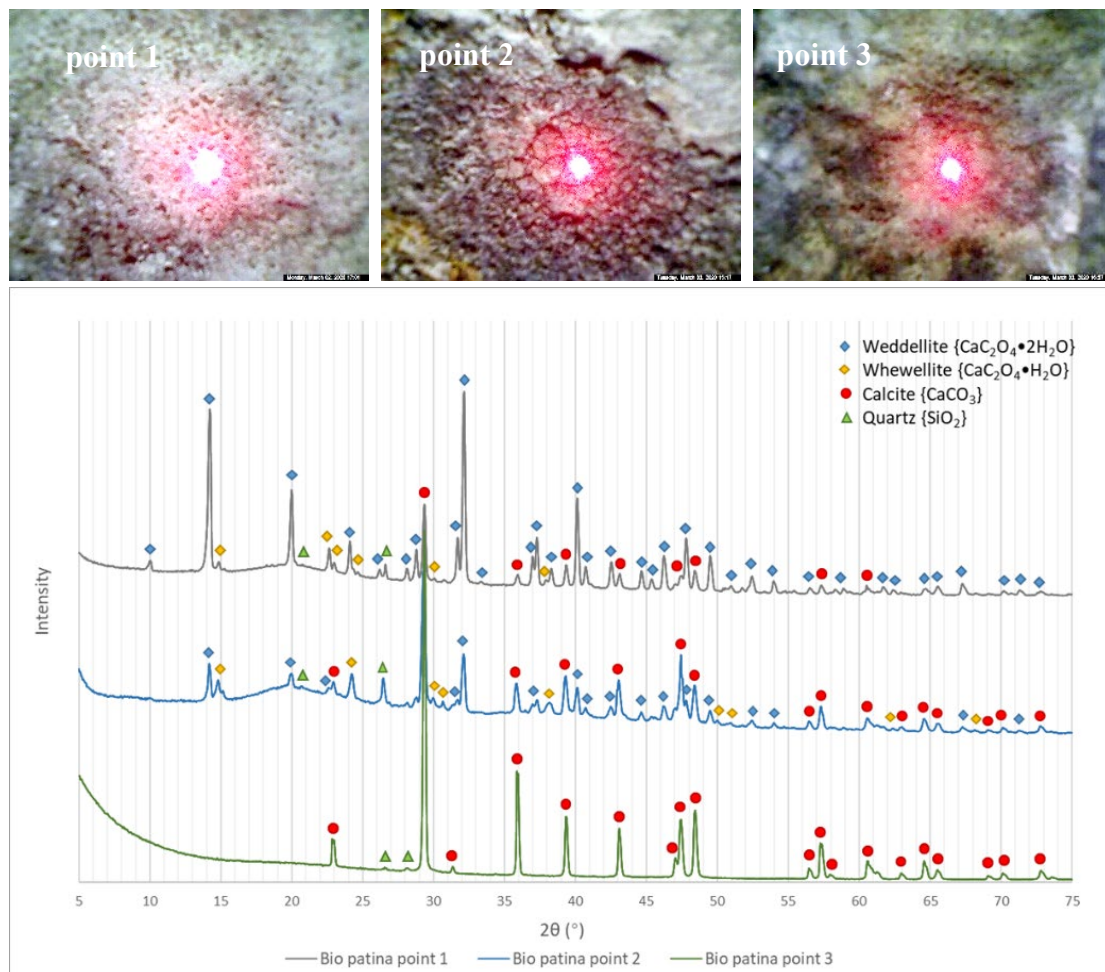
Figure 3.4. XRD result of the bio-colonized stone surface.

greenish (the latter possibly suggesting the presence of cyanobacteria, i.e., blue–green algae). Diffractograms corresponding to white and black areas show the presence of Ca-oxalate mineral peaks of weddellite and whewellite, while in green areas, only calcite and quartz of the limestone substrate are detected. The building stone used in the construction of the Batalha Monastery was in fact an oolitic limestone with a mineralogical composition characterized by more than 97% calcite with minor amounts of quartz [129].

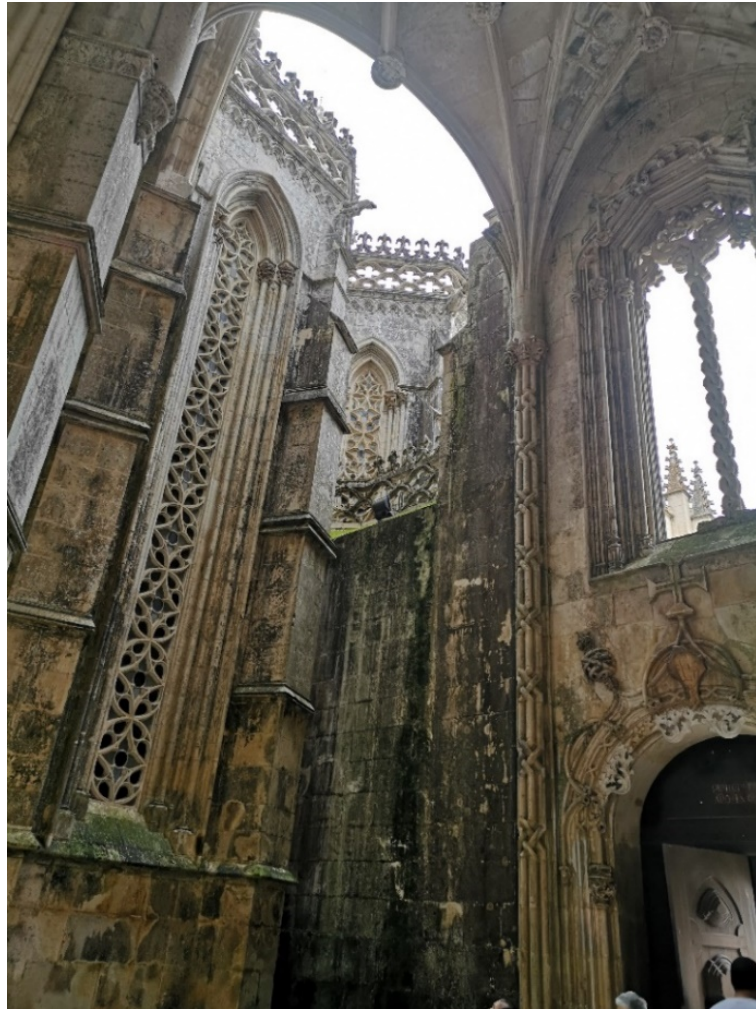
Figure 4.1. Bio-degradation on the inner wall of the “imperfect chapels” of the Batalha Monastery.

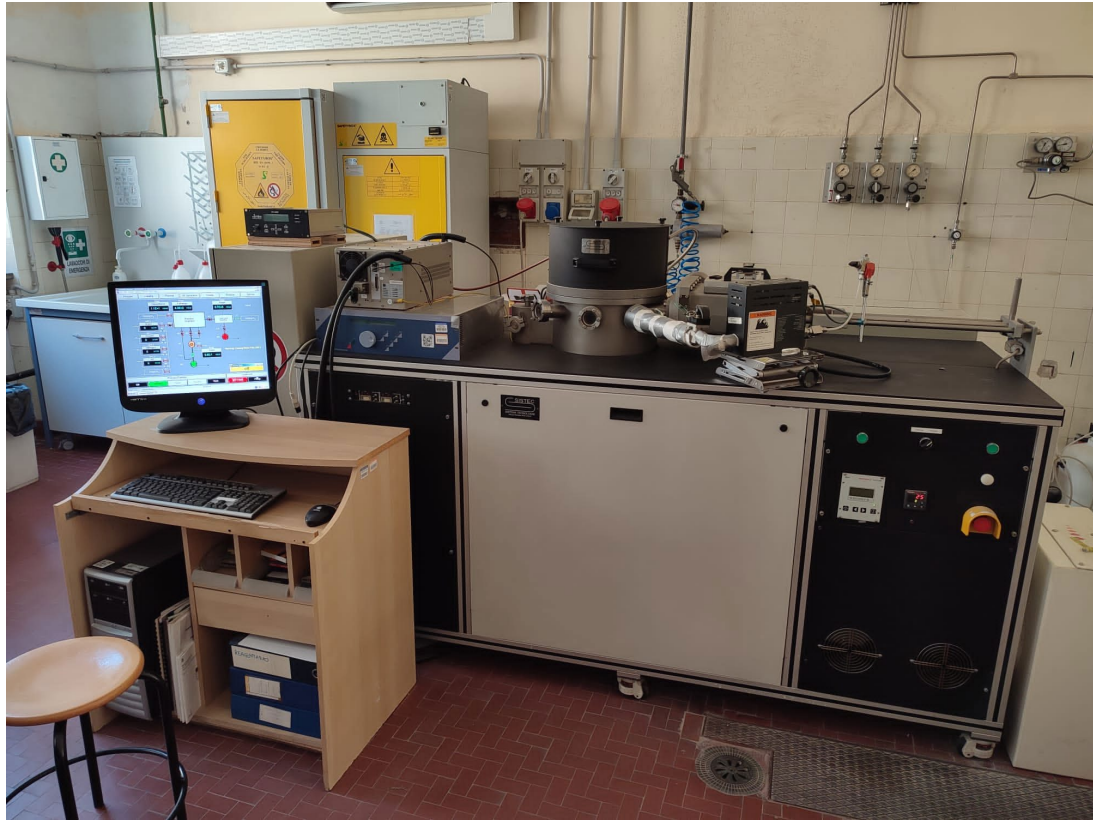
Figure 4.2. Photo of the coupled parallel-plate plasma reactor and schematic of the instrument structure.

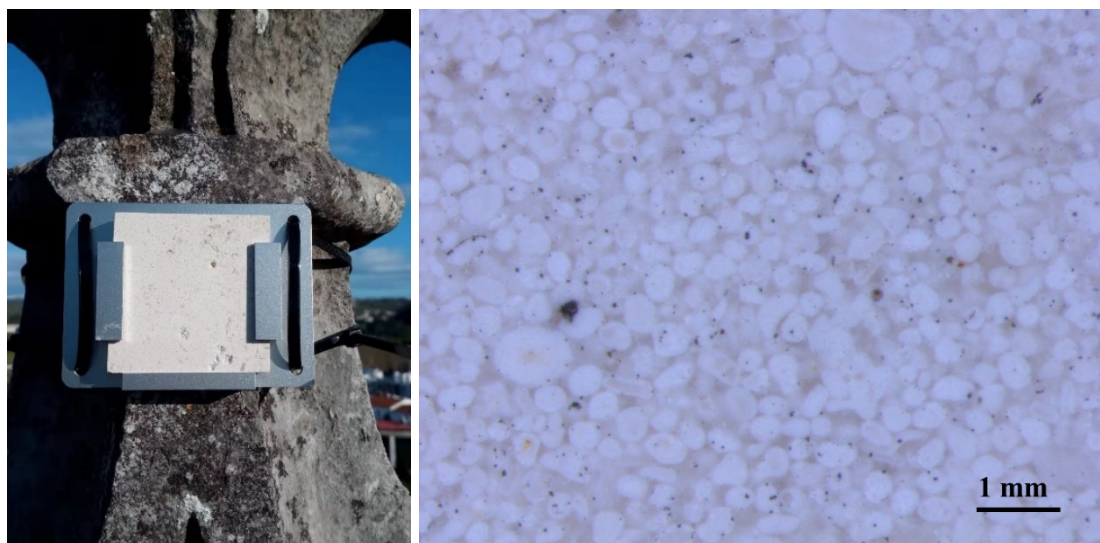
Figure 5.2. Natural exposed sample (left) and its surface under OM (right).

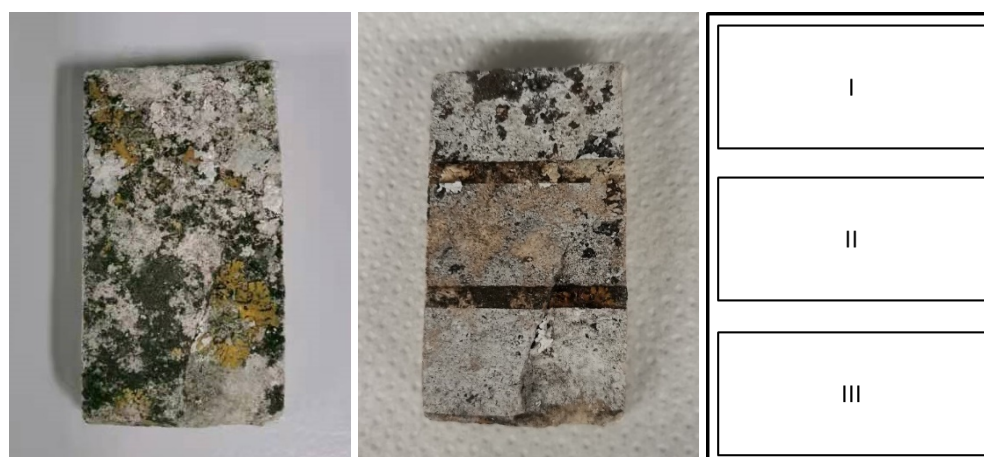
Figure 5.12. Sample tablet for ps-IR laser treatment: before cleaning (left), after cleaning (middle), and three zones with different treatment parameters (right), see also Table 5.3.

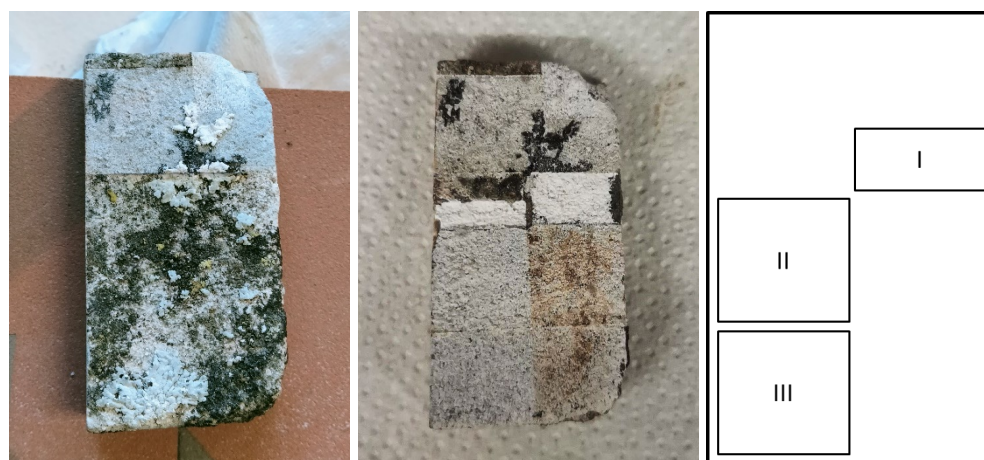
Figure 5.15. Sample tablet for ns-IR laser treatment: before cleaning (left), after cleaning (middle), and three zones with different treating parameters (right).

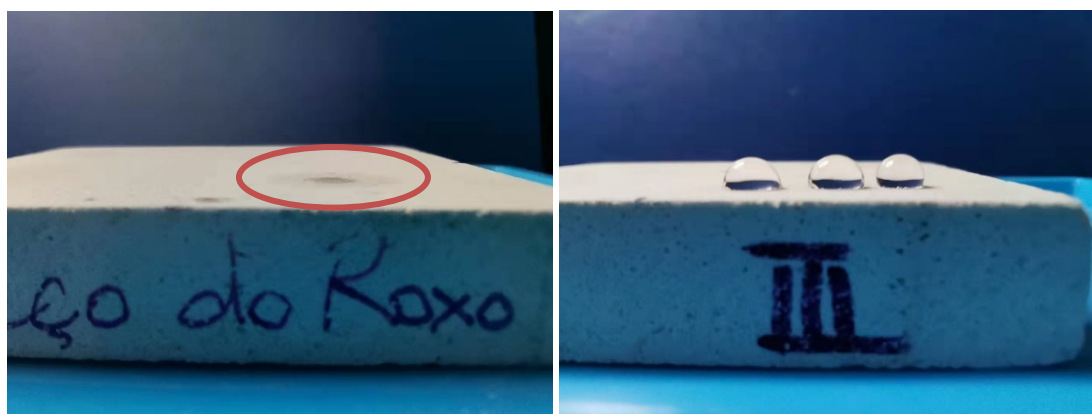
Figure 5.22. Water droplets on the sample treated by fs-UV laser (CDR8): a. on the region without laser treatment, water absorbed immediately by the bulk and left only water stains (in red circle); b. water droplets remained on the laser treated surface; c. the water contact angle of the laser treated surface; d and e. confocal microscopy of this hydrophobic surface area, 2D and 3D view respectively (scale 40  $\mu\text{m}$  to -40  $\mu\text{m}$ ).

Unexpectedly, limestone tablets were found to retain hydrophobicity up to six months after the fs-UV laser treatment (see Figure 5.22). The water contact angle was measured by dripping  $\sim 0.05$  ml water on the stone surface using a syringe; the untreated original limestone tablet, although polished using 600# sand paper, presented no water repellent properties due to its high natural porosity: the water drop wetted the sample immediately and was absorbed by the tablet within a few seconds once in contact with the surface (Figure 5.22 a). In the case of the fs-UV laser treated sample, the water droplet remained at the surface (Figure 5.22 b). Measured by IMAGEJ software, the contact angle of the water droplet could reach up to  $\sim 100.3^\circ$ , demonstrating the surface had been modified from super-hydrophilic (contact angle  $< 5^\circ$ ) to hydrophobic (contact angle  $> 90^\circ$ ), see Figure 5.22 c.

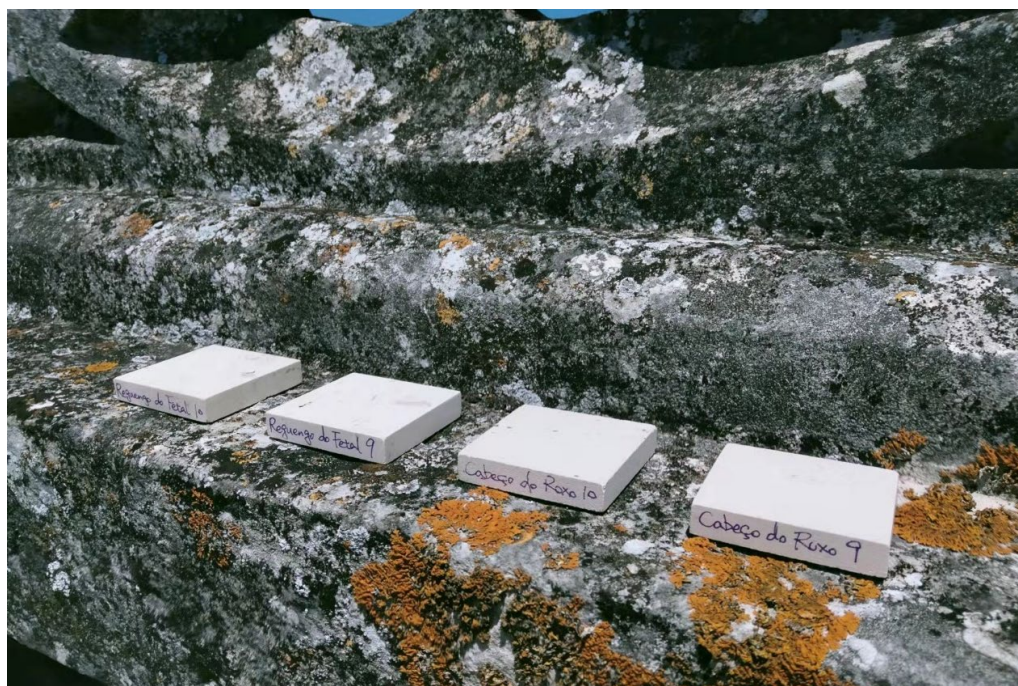
Figure 6.3. Sample tablets placed on the monastery roof (from left to right, the 1<sup>st</sup> and 3<sup>rd</sup> are deposited with SiO<sub>x</sub> film, the 2<sup>nd</sup> and 4<sup>th</sup> are uncoated).

Tablets with and without SiO<sub>x</sub> thin film coating in the size of 5 x 5 x 1 cm were placed on the roof of the Batalha Monastery facing south (Figure 6.3), from 2021 June 9th to October 10th for 3 months. Then the samples were collected and observed under optical microscope, and evaluated by the spectrophotometer (see *2.2.2 Colour evaluation*) to define the colour change after natural aging.

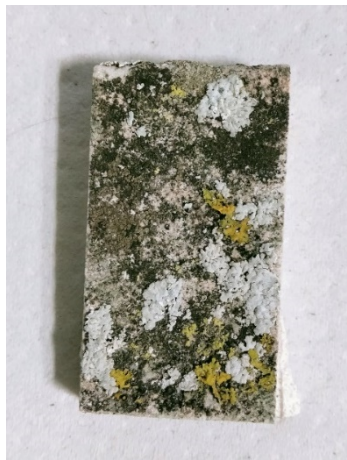
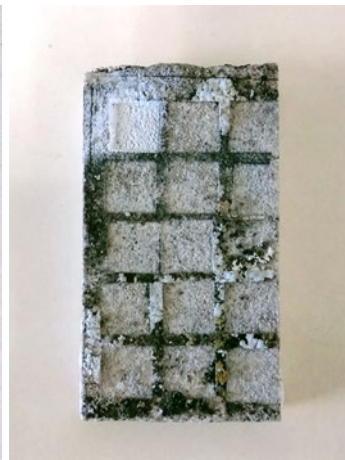
Treated area	Attenuation	Speed (mm/s)	PPD	Frequency (kHz)	Line spacing (mm)	Repetitions
1	45%	150	20	10	0.015	10
2	60%+45%	150	20	10	0.015	5+5
3	60%	150	20	10	0.015	10
4	60%	100	20	10	0.015	10
5	60%	3000	1	200	0.015	10
6	60%	1500	2	100	0.015	10
7	60%	750	4	50	0.015	10
8	30%	3000	1	200	0.015	20
9	45%	3000	1	200	0.015	20
10	45%	3000	1	200	0.015	21
11	45%	1500	2	100	0.015	10
12	45%	1500	2	100	0.015	15
13	45%	1000	2	100	0.010	15

(i) Tablet C, treated by fs-UV laser and the operation parameters of each cleaned area

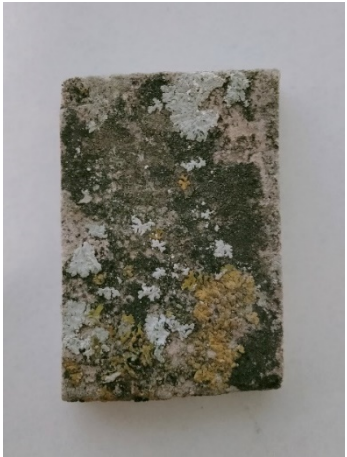
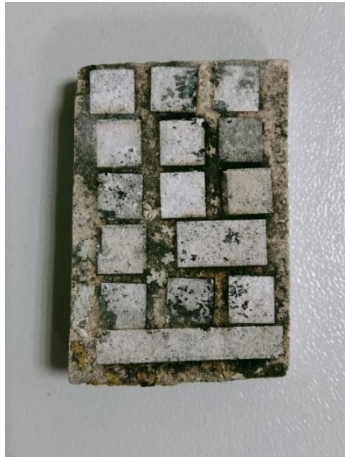
Treated area	Attenuation	Speed (mm/s)	PPD	Frequency (kHz)	Line spacing (mm)	Repetitions
1	100%	500	3	67	0.0075	2
2	30%	500	3	67	0.015	10
3	30%	500	3	67	0.0075	5
4	35%	500	3	67	0.0075	5
5	40%	500	3	67	0.0075	5
6	45%	500	3	67	0.0075	2
7	45%	666	3	67	0.010	2
8	45%	666	3	67	0.010	5
9	45%	1332	3	67	0.020	5
10	45%	1332	3	67	0.020	10
11	45%	1332	3	67	0.020	20
12	45%	1199	3	67	0.018	20
13	45%	500	2	100	0.005	5
14	45%	1000	3	67	0.015	15
15	45%	3000	1	200	0.015	100

(ii) Tablet E, treated by fs-UV laser operation parameters of each cleaned area

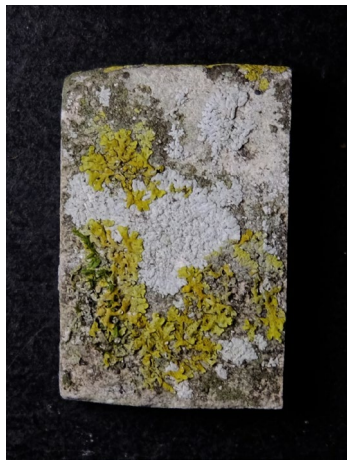
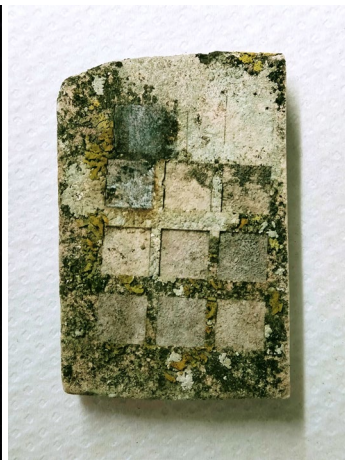
Treated area	Pump Power	Frequency (kHz)	Speed (mm/s)	Line width (mm)	Repetitions
1	9A	800	500	0.001	5
2	9A	800	1000	0.001	5
3	9A	800	250	0.001	3
4	9A	800	1000	0.001	3
5	9A	400	1000	0.001	5
6	4.5 A	400	1000	0.001	5
7	6A	400	1000	0.001	5
8	9A	800	500	0.002	3
9	9A	800	500	0.002	1
+	6A	800	500	0.001	1
10	9A	800	1000	0.002	3
+	6A	800	1000	0.001	2
11	9A	800	500	0.002	3
12	9A	800	2000	0.002	3
13	9A	800	3000	0.002	3
14	7.2A	800	500	0.002	3
15	7.2A	800	500	0.002	3

(iii) Tablet G, treated by ps-IR laser operation parameters of each cleaned area

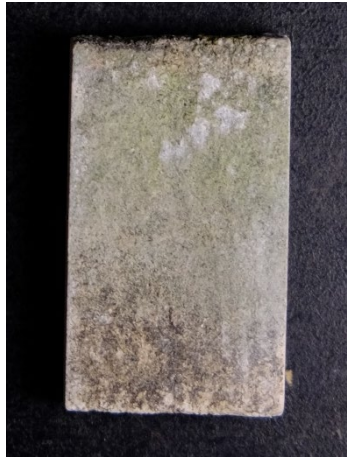
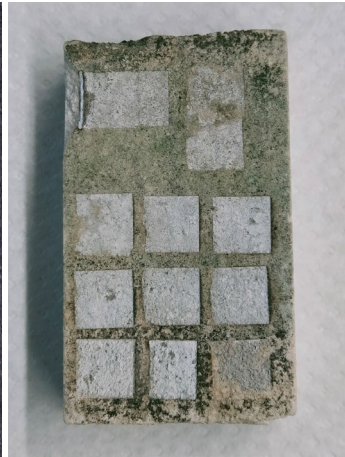
Treated area	Pump Power	Frequency (kHz)	Speed (mm/s)	Line width (mm)	Repetitions
1	9A	800	500	0.002	5
2	9A	250	5000	0.020	10
3	9A	250	500	0.016	10
4	9A	800	500	0.002	15
5	9A	250	2000	0.008	20
6	9A	250	2000	0.008	20
7	9A	250	3000	0.012	60
8	9A	250	2000	0.008	80
9	9A	250	1000	0.004	20
10	9A	250	2000	0.008	160
11	9A	250	2000	0.008	200
12	9A	250	2000	0.008	20
+	9A	800	500	0.002	5

(iv) Tablet H, treated by ps-UV operation parameters of each cleaned area

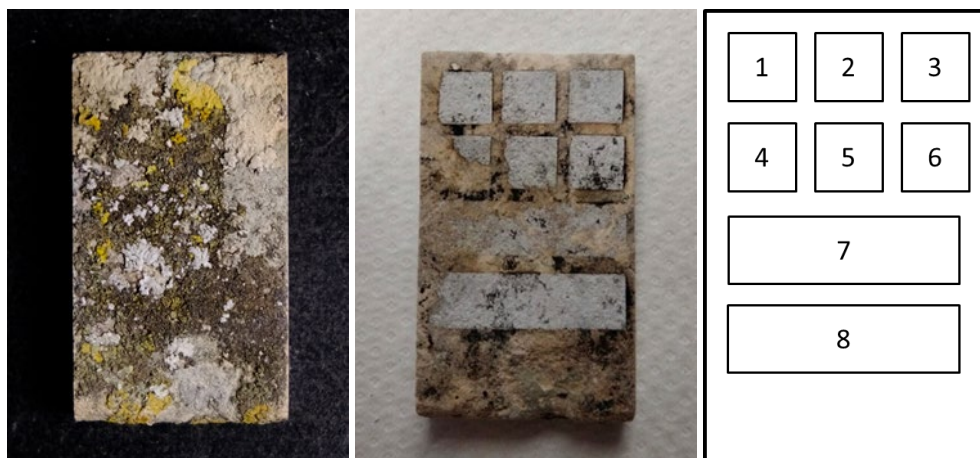
Treated area	Attenuation Power	Frequency (kHz)	Speed (mm/s)	Line width (mm)	Repetitions
1	100%				
2	100%	150	200	0.00285	1
3	100%	150	200	0.00285	2
4	100%	600	1000	0.0142	2
5	100%	600	1000	0.0071	1
6	100%	300	1000	0.0071	5
7	80%	300	500	0.0036	2
8	80%	300	500	0.0036	1
9	100%	300	500	0.0036	1
10	70%	300	500	0.0036	3
11	75%	300	500	0.0036	1
12	75%	300	500	0.0036	2

(v) Tablet I, treated by ns-IR operation parameters of each cleaned area
