Learning from tradition: a case study of the diagnosis, dendrochronological dating, and intervention on a 16th-century timber roof structure in the western Italian Alps

**Learning from tradition: a case study of the diagnosis, dendrochronological dating, and intervention on a 16th-century timber roof structure in the western Italian Alps**

*Tanja Marzi, Clara Bertolini-Cestari, Olivia Pignatelli*

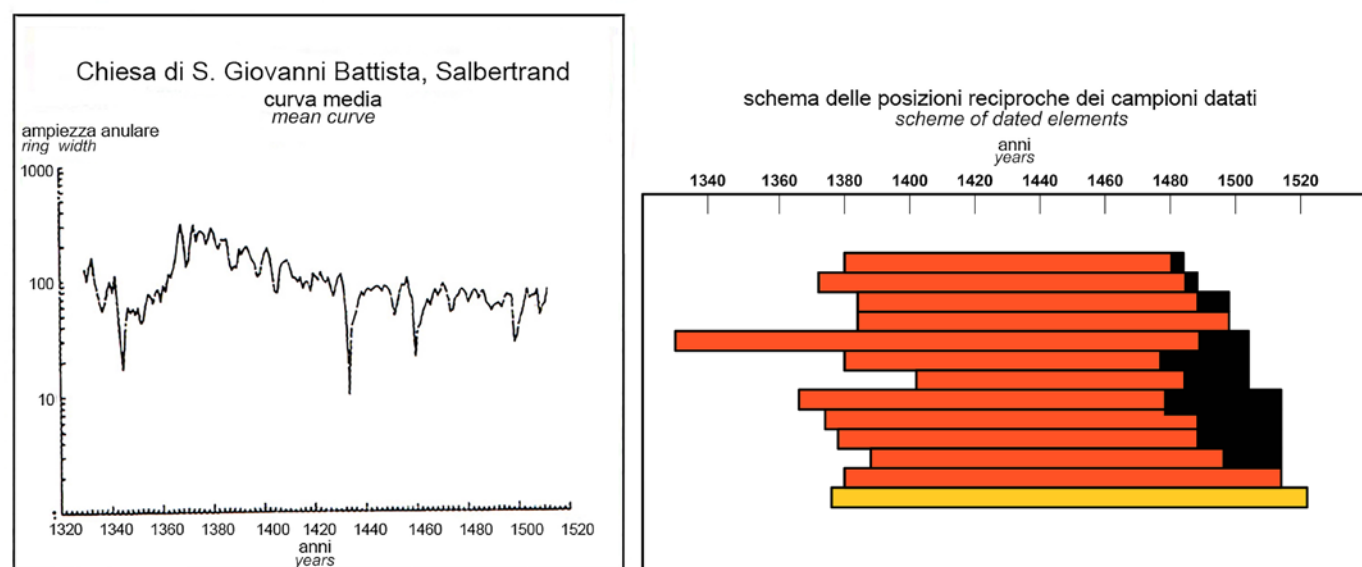
Fig. 8. Church of Salbertrand. Dendrochronological mean curve. Bar diagram of the dated elements: in black, the part of the existing sap; in red, different samples from the timber roof structure of the church; in yellow, the sample from the ridge beam of the porch roof.

In the church of San Giovanni Battista in Salbertrand, the dendrochronological investigation was carried out on 13 elements of the timber roof structure of the church (truss beams, struts, false rafters, and planks of the roof), including a single plank attributable to the 19th-century restoration carried out by Alfredo D'Andrade, and on the ridge beam of the roof of the porch. The beams, not so accurately squared, allowed the conservation of at least part of the sapwood in most of the elements sampled, and in some cases, even the last ring under the bark seems to be present, allowing a precise dating (Fig. 8).

The mean curve built for the roof covers the period between AD 1330 and AD 1512, overlapping only for a short time with that of the Valentino Castle (AD 1447-AD 1637).

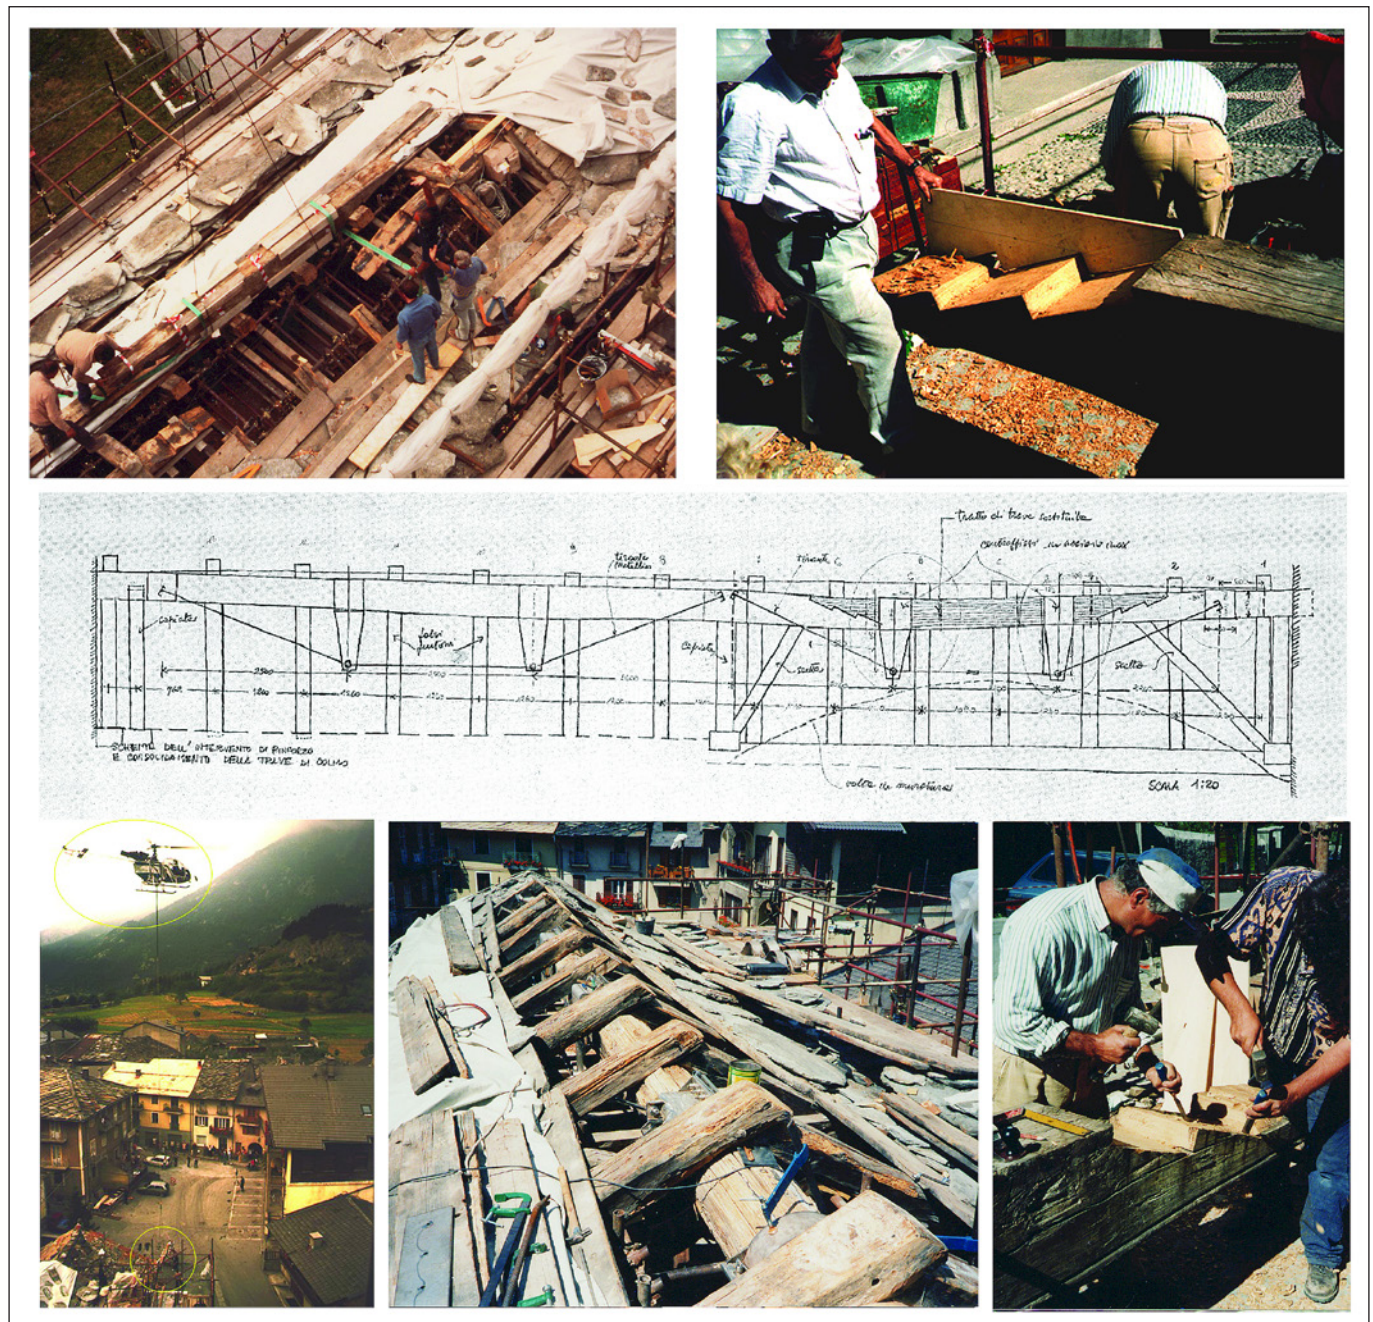
Fig. 10. Phases of the interventions carried out in 2000 with the integration of timber elements, the realization of the double "dart of Jupiter" joint, the transportation of the larch beam on the construction site, some details of the steel elements of the reinforced beam, and the scheme of the reinforcement intervention with Polonceau system. (Image source: drawings and photos courtesy of C. Bertolini-Cestari).

- removal of the damaged section (length 4 m) and positioning of a sound wooden element (an old beam from a demolition of a wooden floor was used for this). For this phase, provisional support of the two parts of the ridge beam with tubular trellis resting on the perimeter walls was necessary so as not to overload the underlying stone vaults. The connections between the ridge beam and the new element were made on-site with “head” connections, also known as the double “dart of Jupiter” joints, tightened by three bolted stainless-steel collars. In this regard, it should be noted that the use of external stirrups (or through screws), required during installation, presents little guarantee of duration over time. A synthetic structural adhesive was therefore used to provide further unity in the parts where the two surfaces of the connections line up (Figs. 9 and 10);

In addition to the interventions described above, the reinforcement of the ridge beam was completed with the realization of two reinforced beams, with double struts and double centering, with stainless steel rods – arranged in planes parallel to the lateral surfaces of the beam –, for the two spans of the continuous beam on three supports, respectively of 8 m of span. The intervention aims to stiffen the beam, which has an important deformation due to *fluage* (in the middle of the spans, the deflections are respectively 18 and 22 cm). The struts, placed at 1/3 of the span with a height of 0.80 m, are made of stainless steel with a thickness of 15 mm and are connected to the wooden beam with flanged and bolted collars. The ends of the tie rods are fixed to a steel collar whose anchoring is ensured by adjusting screws and stainless-steel pins. For all collars, deformable material (neoprene) has been interposed between wood and steel. In the middle of the beam, the tie rods are connected with a tensioner (threaded coupling) which ensures the initial tension setting, the control, or any eventual periodic adjustment (Figs. 9–11).
