The timber roof structure of Chapel XVI at Sacro Monte of Orta: an example of conservative strengthening work / Zerbinatti, Marco; Grazzini, Alessandro; Fasana, Sara; Vercelli, Giovanni. - In: TEMA. - ISSN 2421-4574. - ELETTRONICO. - 8:Special Issue(2022), pp. 42-52. [10.30682/tema08Slp]

# THE TIMBER ROOF STRUCTURE OF CHAPEL XVI AT SACRO MONTE OF ORTA: AN EXAMPLE OF CONSERVATIVE STRENGTHENING WORK

This paper describes the methodological approach, the design process, and the execution of the maintenance works for the timber structures and roof cover-

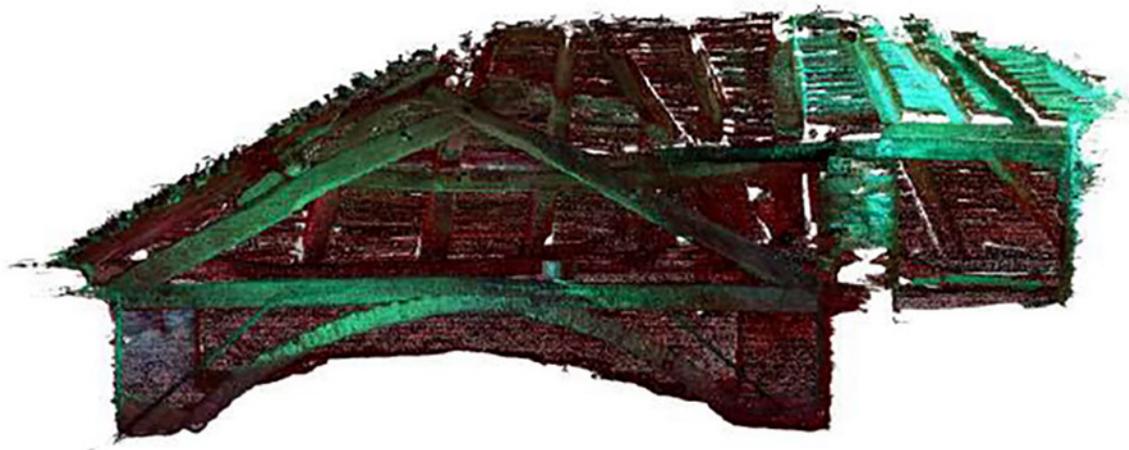
Fig. 2. Survey image by the laser scanner.

First of all, the correct design of the structural recovery of a historic construction must start from the reconstruction of the building phases, the geometric survey, and non-invasive or micro-invasive diagnostics for the characterization of the materials. The structure survey was carried out by Prof. Andrea Lingua and his team (Politecnico di Torino) by laser scanning with the return of a point cloud of the timber structures (after remove of noisy points, Fig. 2). The remarkable technology allowed determining with precision the geometry of the structure and the dimensions of all the elements, despite the structure itself being apparently disordered. This work enabled successive accurate structural modeling.

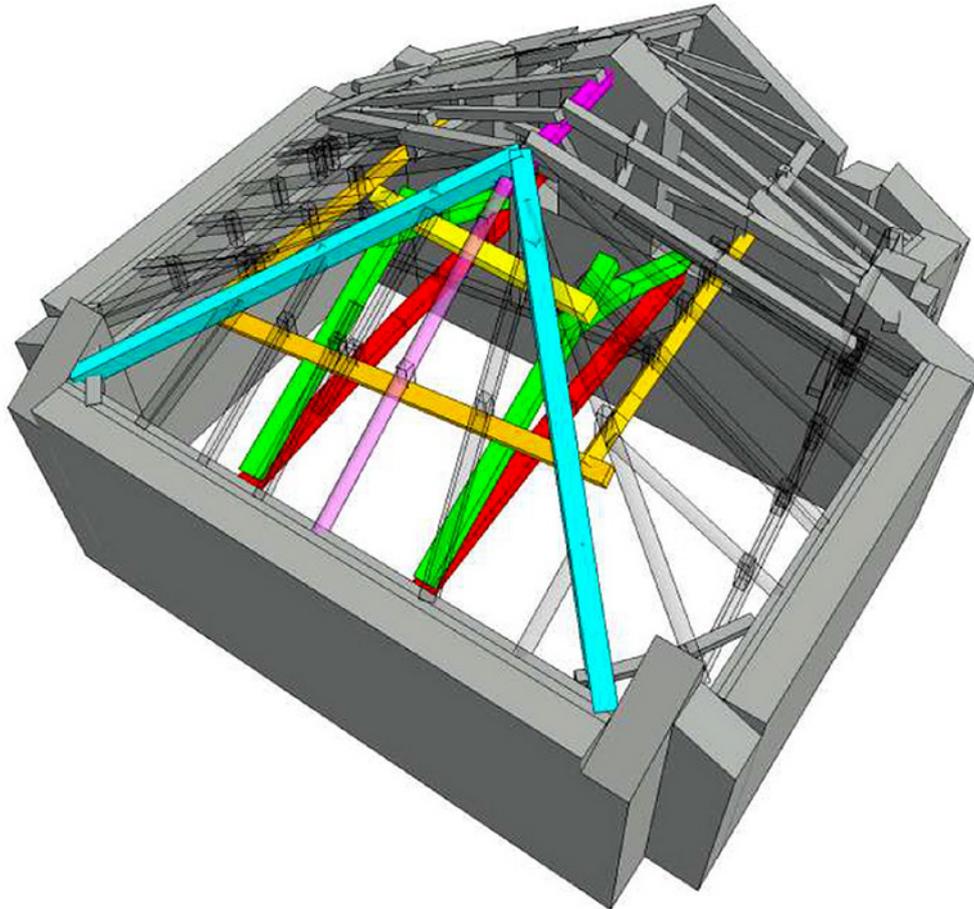
- two main trusses (North and South), resting on the perimeter walls and characterized by tie beam partially resting on the ribs of the vault (red in Fig. 3) and rafters (green in Fig. 3), worked with a *half-lap* joint at the ridge;
- quay beam on the crossing of the rafters (yellow in Fig. 3), characterized by two overlapping elements;
- two cantonal beams (blue in Fig. 3) resting on the perimeter walls through joists;
- ridge beam (purple in Fig. 3), resting on the West side on the masonry. On the East side, the ridge beam is supported by recent props and located below the intersection with the two cantonal beams, with partial support on one of the rafters (transparent violet in Fig. 3).

Fig. 3. The structural frame of existing timber elements.

The rafters of the trusses on the East side also support a cross beam on the East slope. This cross beam supports the rafters of the same roof, and at the cantilevered final part, also similar cross beams on the North and South slopes (all the cross beams are highlighted in dark yellow in Fig. 3). The structure is completed by minor rafters, with sections varying from 16 cm x 16 cm to 12 cm x 12 cm, including some strongly round sections. The arrangement of the minor rafters is laid out on all the slopes with orientation “hut” converging towards the ridge (Fig. 7). These minor rafters lie with fan-shaped planimetric distribution to support the thin stone slabs covering. In the Western part towards the chapel’s entrance, the fan-shaped distribution of the rafters is arranged to connect the different heights of the main ridge and the ridge of the frontal tympanum.

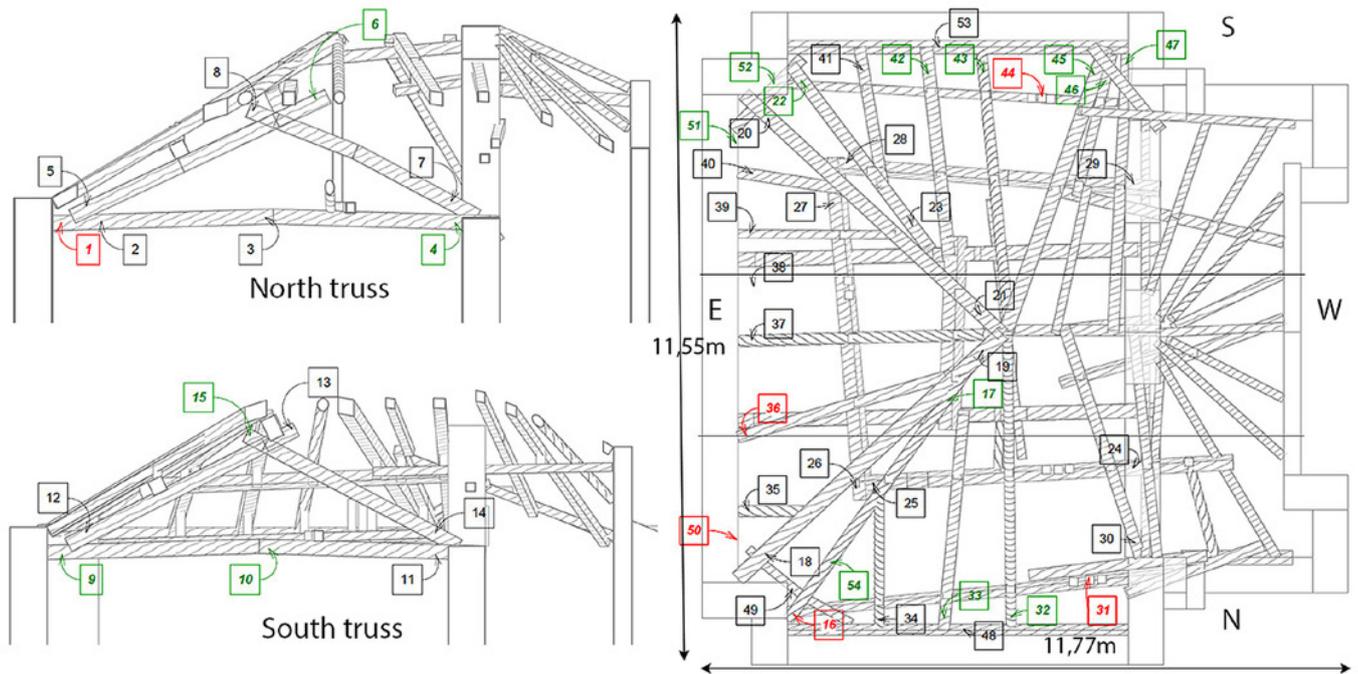
The timber structures were investigated using a resistographic test conducted at the final part of the elements, repeating the test at a short distance when a potential degradation has been identified. The most significant degradation was found near the support of the truss, (corresponding to point 1 in Fig. 4), strongly compromised by humidity and infiltrations of rain from the roof covering (stone slabs).

Fig. 4. Results of resistographic tests carried out on wood structures: in black, the points in good conservation, in green, those corresponding to slight or moderate degradation, in red, those corresponding to advanced degradation.

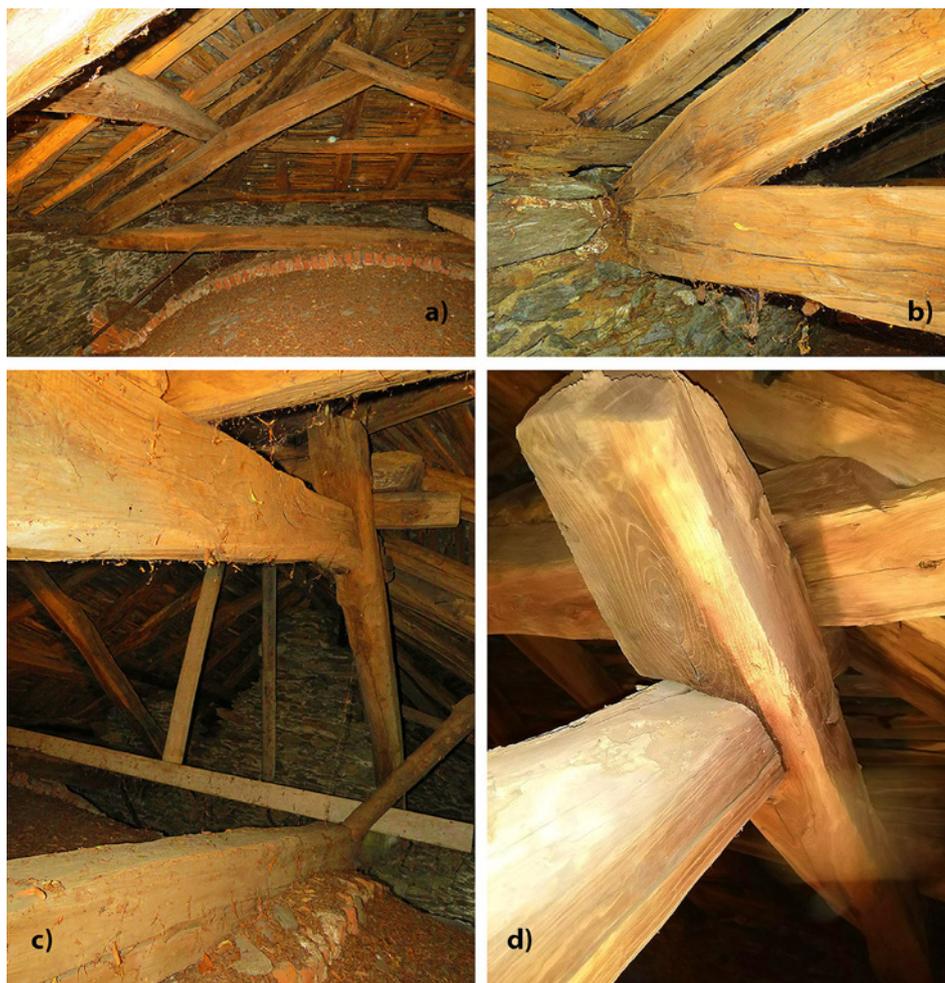
Both trusses are made up of timber tie beams, section 20 cm x 20 cm, resting on the East and West walls and timber rafters of a similar section (Fig. 5a). The connections of the rafters on the tie beams are arranged as common practice, with the support surface oriented according to the bisector of the angle of incidence (Fig. 5b). It should be noted that the tie beams of the trusses have metal elements inserted into the masonry walls and connected to anchoring brackets on the external sides, thus

forming a metallic tie of the ribs of the masonry vault (Fig. 5a). Both tie beams rest on the extrados of the vaults and are slightly curved (deformation just under 10 cm), with the supports at lower altitudes than the center lines (Fig. 5c). The top of the rafters has a *half-lap* coupling connection, therefore without the presence of the classic connection by the king post, with both rafters continuing in the complete section beyond the coupling area (Fig. 5d). The North truss has the supporting section of the tie beam totally degraded, corresponding on the East side (Fig. 5b), with a partial impairment of the coupling surface of the corresponding rafter. The South truss has conditions of partial degradation of the tie beam in the middle section and at the East final part. The East rafter presents conditions of partial deterioration in the top portion. The trusses support a quay beam on the fork generated by the crossing of the rafters (Fig. 5d). This beam is made up of the overlap of two beams in order to reach the correct support level for the cantonal beams and the

Fig. 5. (a) North truss; (b) detail of the tie beam-rafter connection, in evident degradation inside the masonry support; (c) tie beam rests on the extrados of the vaults; (d) detail of a half-lap coupling connection.

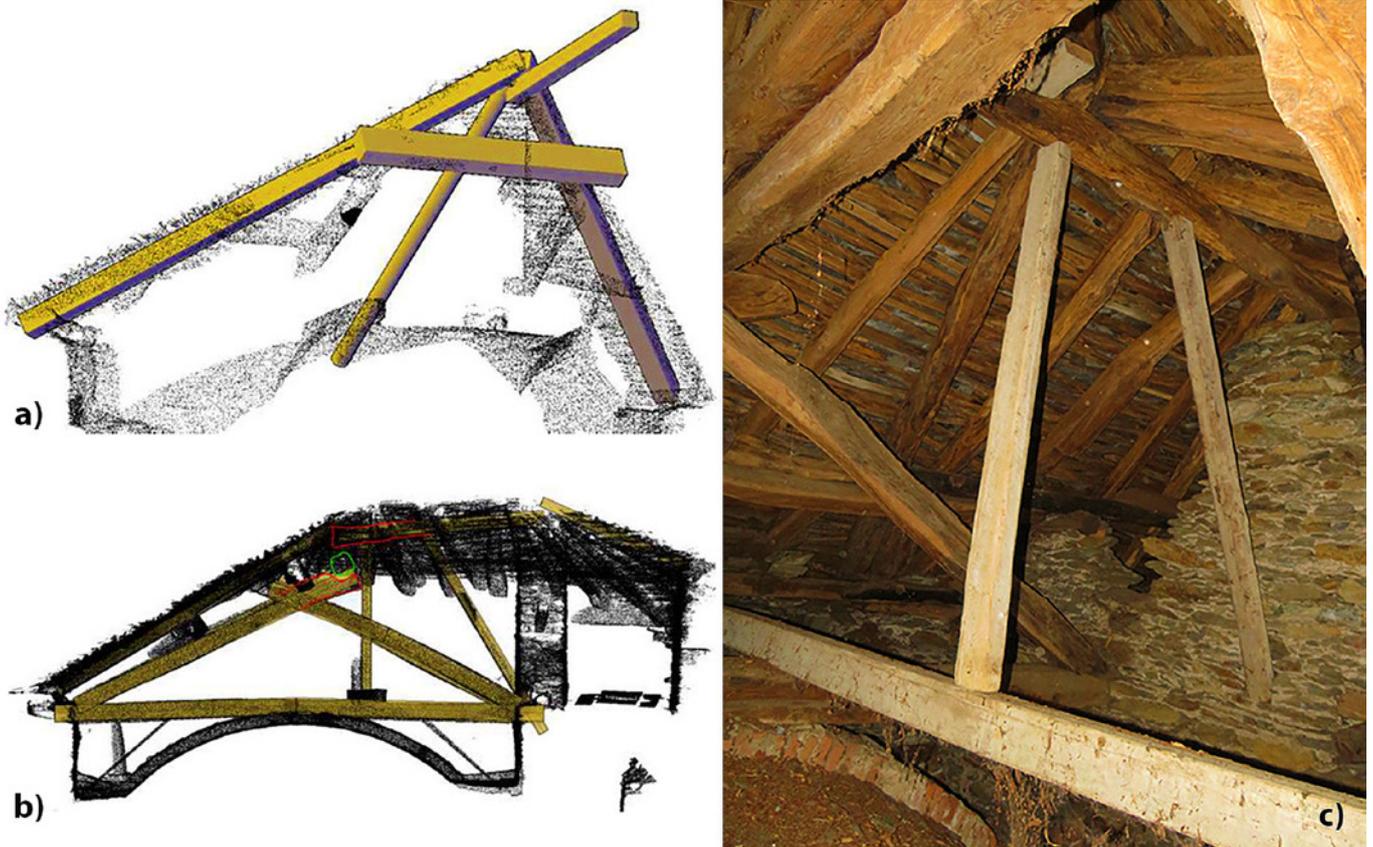
The two cantonal beams, with 20 cm x 20 cm sections, rest at the bottom on the East masonry near the North and South corners and high on the quay beam, continuing cantilevered until you reach the peak (Fig. 6a).

By observing the conformation of the trusses' rafters and the position of the ridge beam, it would have been possible to hypothesize the presence of a beam resting on the final part of the rafters, supporting the ridge beam (Fig. 6b). To a more careful analysis, it has been understood, instead, that such workmanship corresponds to an early construction phase of the building still without the forepart on the West side, resulting in the symmetrical roof pitches on the East and West side.

gence below the converging beams without finding any support. Currently, it is supported by two props of apparent recent insertion, one inclined and resting in the inner masonry on the western side. The other is vertical and rests on a crossbar resting on the tie beams of the trusses (Fig. 6c).

Fig. 6. (a) Laser scanner survey of the roof area, including the two cantonal beams; (b) hypothesis of the original configuration of the ridge beam; (c) props to support the ridge beam.

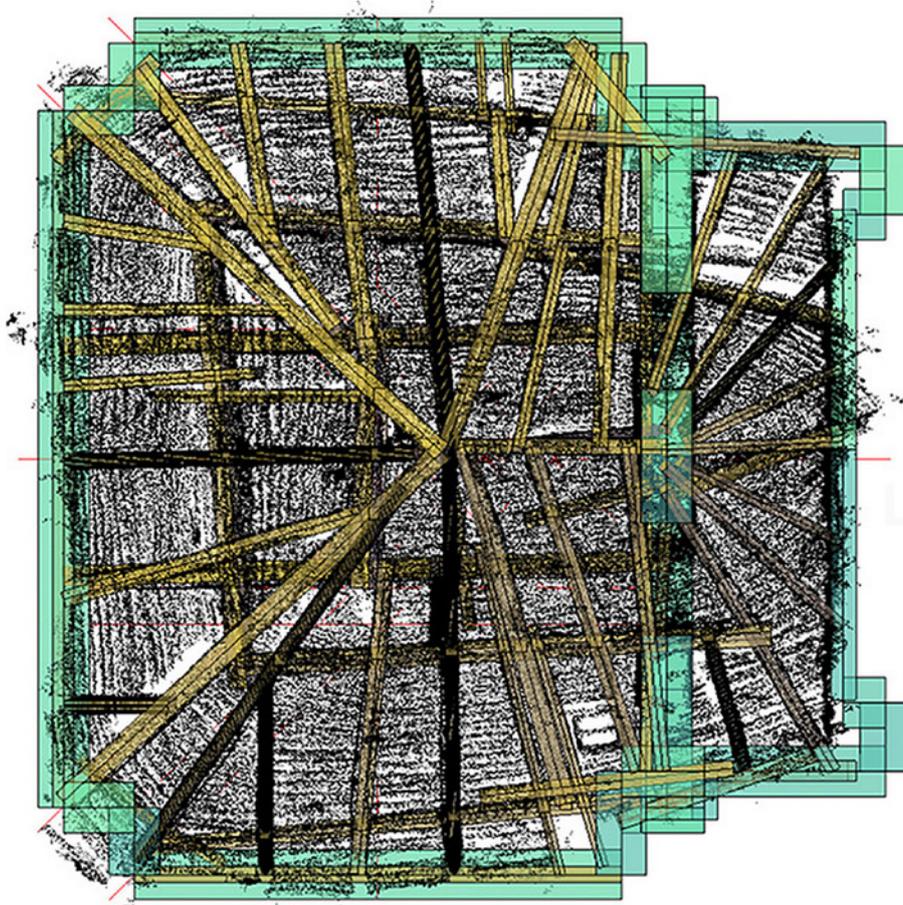
With regard to wooden frame supporting the stone roof covering, integrative elements are paired to some minor rafters degraded, especially in the terminal section. Along the entire perimeter of the roof, on the top of the walls, there are timber quay elements connected by means of wood processing or by partial overlapping, completed in the corners by diagonally arranged elements.

Fig. 7. Arrangement of the minor rafters in the "hut" roof schema.

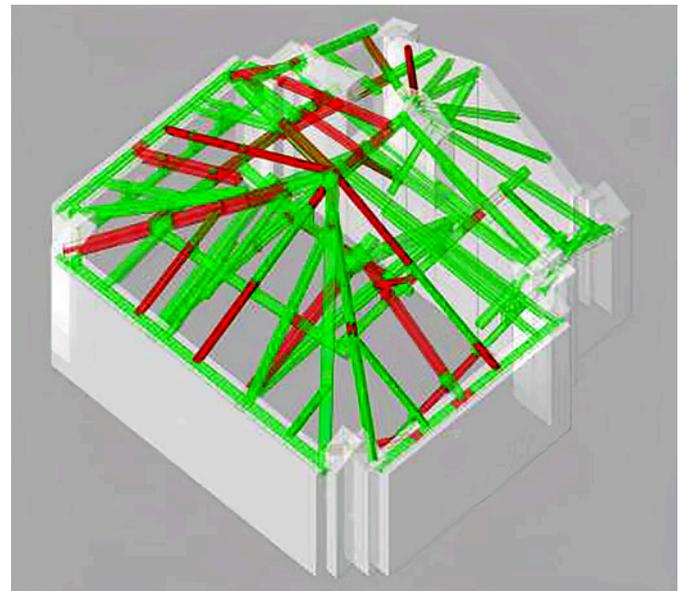
A three-dimensional structural model, carried out by finite element software, was made with the positioning of all the wooden elements in perfect match with what was detected by a cloud of points of the survey by the laser scanner. The bonds between the overlapping wooden elements were modeled by inserting vertical connection elements to simulate the reciprocal support connection. The structural modeling has taken into account all integrative elements, resulting in the transfer of a significant portion of the weight of the stone-roof covering on the supporting timber elements. This model allowed the evaluation of the thrusts of the two trusses on their chains and the horizontal forces transmitted by rafters to the quay elements. With separate modeling, the individual components were taken into account to compare the stresses with models that are much simpler and easy to control.

Fig. 8. Results of static verifications for the roof elements.

actual weight of the timber structure of the roof;  $2.8 \text{ kN/m}^2$  for the weight of the roof covering stone (3 layers of slabs, 3 cm thick each one);  $1.5 \text{ kN/m}^2$  for the snow overload, for a total of  $4.5 \text{ kN/m}^2$ . The checks were carried out considering chestnut wood, with the D24 to D18 resistance class [14]. The graphic representation of the verifications of the timber elements is shown in Figure 8, in which the elements with suitable dimensions are represented in green, while those with inadequate sizes are in red.

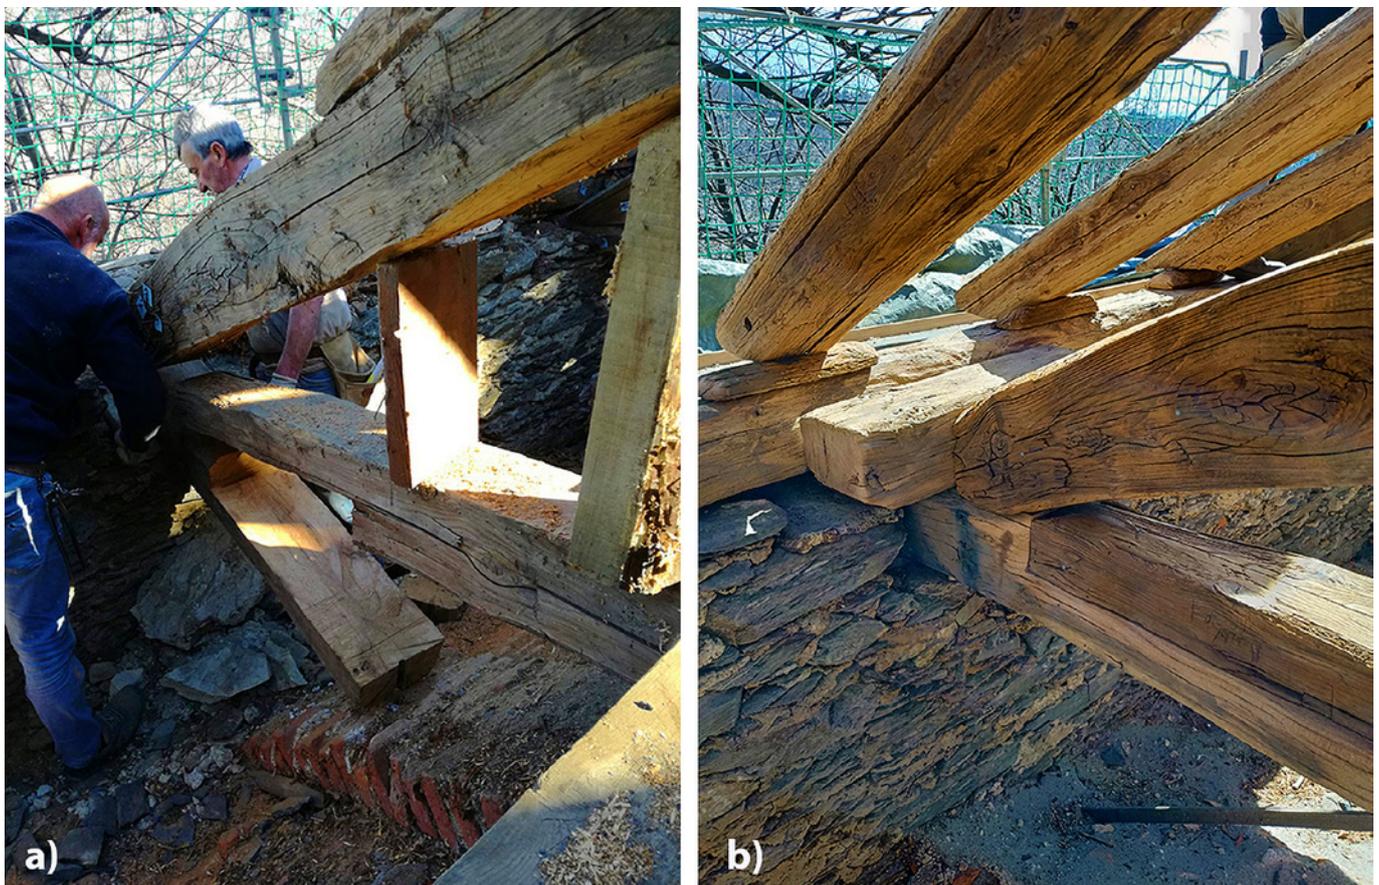
Fig. 9. (a) Positioning of the timber prosthesis; (b) the timber-timber prosthesis performed.

The restoration project has provided for the conservation and restoration of the elements most characterizing the roof, particularly the two trusses and one main cantonal beam. Through the preliminary surveys, it was possible to identify the undersized or degraded wooden elements, on which the subsequent structural analysis revealed excessive stresses, in particular in some elements spaced by an excessive distance. Therefore, it has been planned to preserve the less affected elements, replace newly or degraded substitute elements, and provide a repositioning for some of them (providing a closer distance where it was necessary) in order to ensure a better distribution of the weight roof covering over them. The adjustments were very modest and only due to the search for the best mutual positioning.

Also, it has been planned to replace all quay beams on the North, East, and South slopes and the angular elements, preserving the quay beam incorporated in the West masonry while still ensuring the connection with the new elements of the other layers. The replacement of the quay beams took place by the slight lifting of the minor rafters acting in such a way as not to unbalance the entire structure, prop it up and fan it to ensure the stability of the whole. Moreover was planned to replace the ridge beam and add two cross beams parallel to the same beam, creating a frame/scheme with a more precise structural concept. The supporting knot of the South truss, compromised by the material degradation, was reinforced with a conservative solution by means of timber-wood prosthesis inserted in contrast with clamping screws, without resorting to epoxy resin prosthesis of undoubted/unproven compatibility (Fig.

9). The main connection was made with screws passing from the extrados rafter to the intrados of the tie beam and between the integrative transverse element and the tie beam.

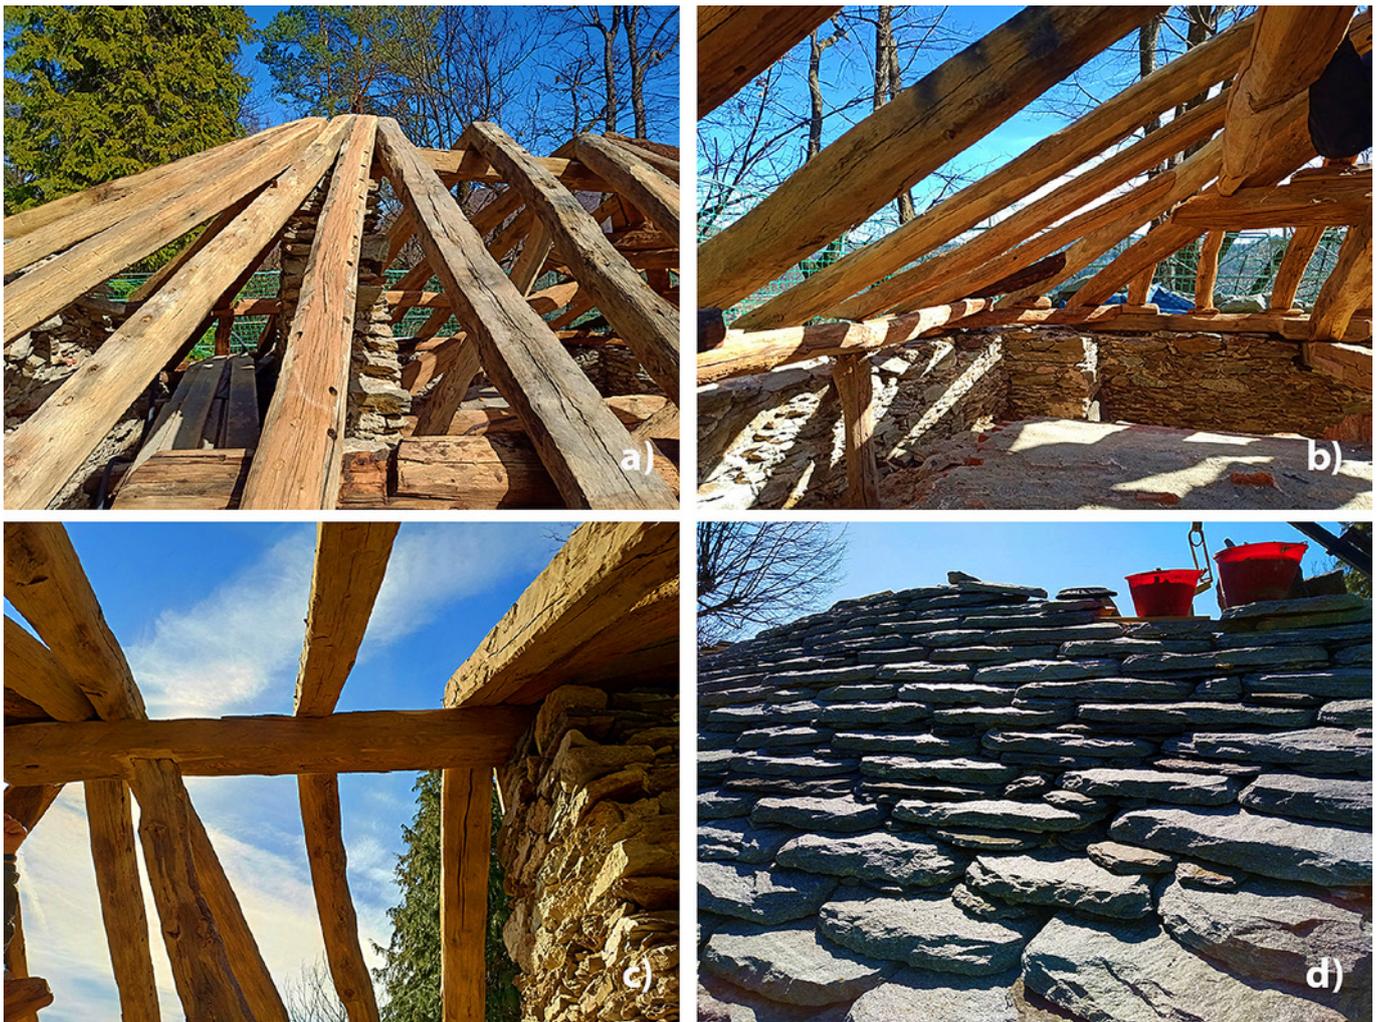
Fig. 10. (a) Placement of new timber elements alongside the original ones cleaned up; (b) integration of the new quay beams into the original structural scheme; (c) cleaning and static improvement of the area around the ridge beam; (d) reconstruction of the original stone roof covering.

During disassembly, the timber elements were separated by distinguishing elements in good conservation conditions from degraded elements to be eliminated (Fig. 10a). The separation of the elements was submitted to the Work Director for approval. The direction of the work was carried out by eng. Giovanni Vercelli, with the support of the technicians of the Ente di Gestione dei Sacri Monti. Recoverable elements have been cleaned and treated to improve their conservation (Fig. 10b, c). During the repositioning phase, the timber elements were remodeled in order to adapt to the geometry of the bearing structure, alternating the recovery elements with the replacement elements in chestnut wood (Fig. 10a, b).

The existing stone roof covering has been relocated following the traditional construction techniques (Fig. 10d), replacing the minor support degraded elements and adapting to the new stone slabs.
