The timber roof structure of Chapel XVI at Sacro Monte of Orta: an example of conservative strengthening work

The timber roof structure of Chapel XVI at Sacro Monte of Orta: an example of conservative strengthening work / Zerbinatti, M., Grazzini, A., Fasana, S., Vercelli, G.. - In: TEMA. - ISSN 2421-4574. - ELETTRONICO. - 8:Special Issue(2022), pp. 42-52. [10.30682/tema08Slp]

THE TIMBER ROOF STRUCTURE OF CHAPEL XVI AT SACRO MONTE OF ORTA: AN EXAMPLE OF CONSERVATIVE STRENGTHENING WORK

Marco Zerbinatti, Alessandro Grazzini, Sara Fasana, Giovanni Vercelli

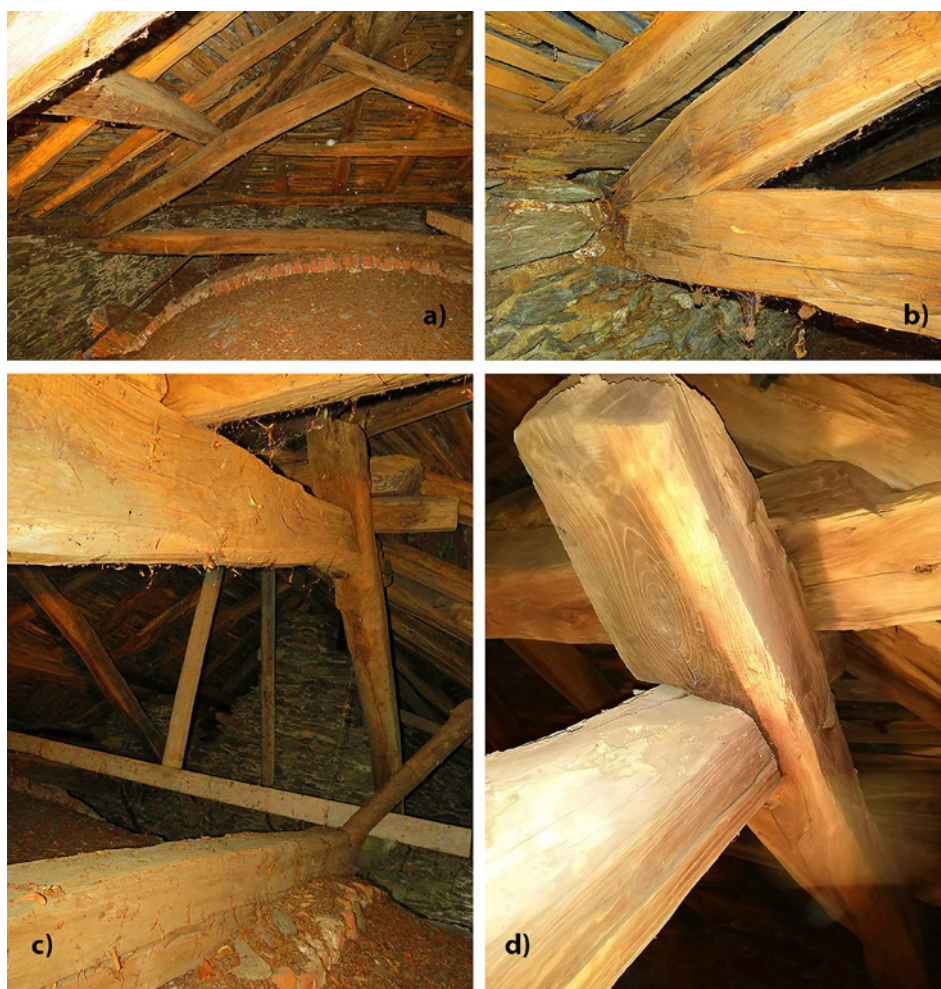
Both trusses are made up of timber tie beams, section 20 cm x 20 cm, resting on the East and West walls and timber rafters of a similar section (Fig. 5a). The connections of the rafters on the tie beams are arranged as common practice, with the support surface oriented according to the bisector of the angle of incidence (Fig. 5b). It should be noted that the tie beams of the trusses have metal elements inserted into the masonry walls and connected to anchoring brackets on the external sides, thus

forming a metallic tie of the ribs of the masonry vault (Fig. 5a). Both tie beams rest on the extrados of the vaults and are slightly curved (deformation just under 10 cm), with the supports at lower altitudes than the center lines (Fig. 5c). The top of the rafters has a *half-lap* coupling connection, therefore without the presence of the classic connection by the king post, with both rafters continuing in the complete section beyond the coupling area (Fig. 5d). The North truss has the supporting section of the tie beam totally degraded, corresponding on the East side (Fig. 5b), with a partial impairment of the coupling surface of the corresponding rafter. The South truss has conditions of partial degradation of the tie beam in the middle section and at the East final part. The East rafter presents conditions of partial deterioration in the top portion. The trusses support a quay beam on the fork generated by the crossing of the rafters (Fig. 5d). This beam is made up of the overlap of two beams in order to reach the correct support level for the cantonal beams and the

Fig. 5. (a) North truss; (b) detail of the tie beam-rafters connection, in evident degradation inside the masonry support; (c) tie beam rests on the extrados of the vaults; (d) detail of a half-lap coupling connection.

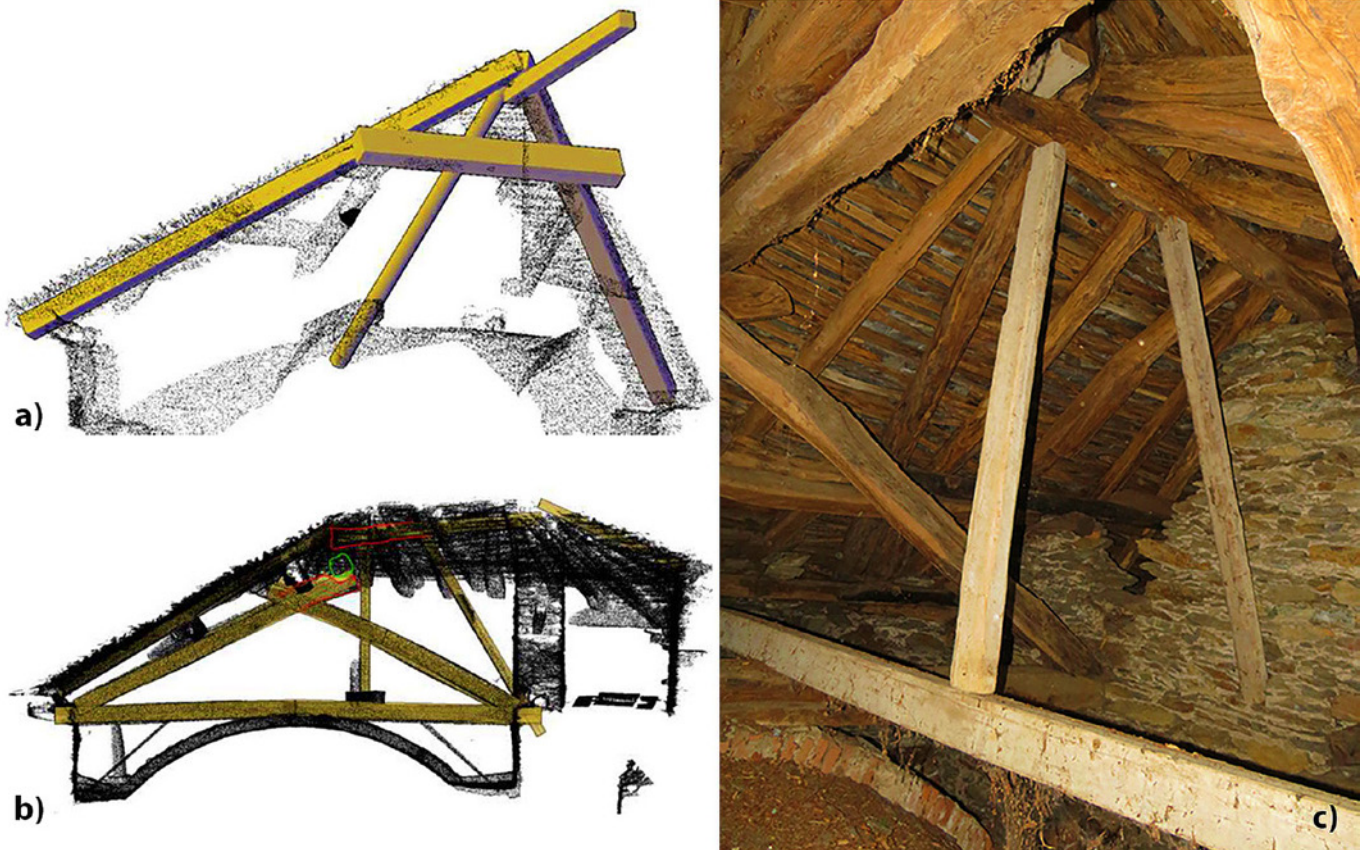
The two cantonal beams, with 20 cm x 20 cm sections, rest at the bottom on the East masonry near the North and South corners and high on the quay beam, continuing cantilevered until you reach the peak (Fig. 6a).

By observing the conformation of the trusses' rafters and the position of the ridge beam, it would have been possible to hypothesize the presence of a beam resting on the final part of the rafters, supporting the ridge beam (Fig. 6b). To a more careful analysis, it has been understood, instead, that such workmanship corresponds to an early construction phase of the building still without the forepart on the West side, resulting in the symmetrical roof pitches on the East and West side.

gence below the converging beams without finding any support. Currently, it is supported by two props of apparent recent insertion, one inclined and resting in the inner masonry on the western side. The other is vertical and rests on a crossbar resting on the tie beams of the trusses (Fig. 6c).

Fig. 6. (a) Laser scanner survey of the roof area, including the two cantonal beams; (b) hypothesis of the original configuration of the ridge beam; (c) props to support the ridge beam.
