Understanding the structures of Pier Luigi Nervi: a multidisciplinary approach

# Understanding the structures of Pier Luigi Nervi: a multidisciplinary approach

**Abstract:** The paper describes the strategies adopted to carry out the knowledge campaign on Hall C built by Pier Luigi Nervi at Torino Esposizioni, between 1949 and 1950, and belonging to the architectural heritage of the 20th century. The structure was built by combining reinforced concrete and ferrocement elements, thus implementing what for Nervi would later become the distinctive construction system of his artwork, which combined the use of precast in situ and cast-in-place elements.

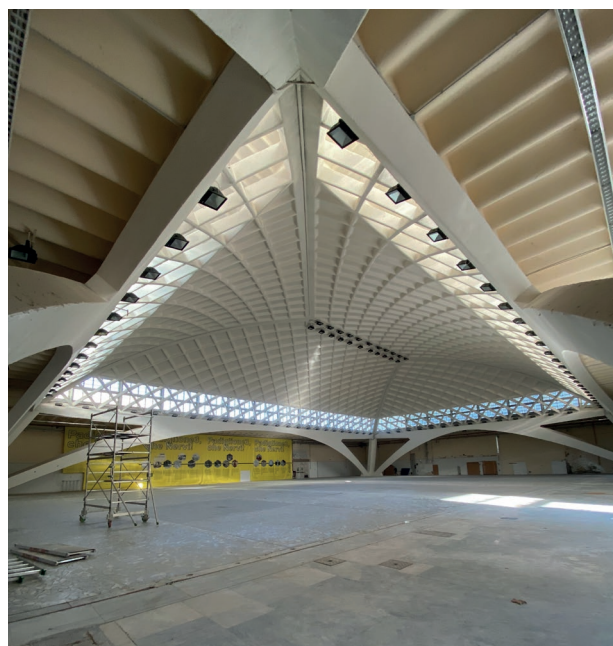
Figure 2 | View of the interior of Hall C, where it is also possible to appreciate the detail of the inclination of the arches supporting the vault and perimeter slabs.

ferrocement corrugated beams (Fig. 2), the insertion of which is useful in correcting the horizontal thrust of the vault. Finally, the inclination of the arches is determined by the resultant of the loads of the various supported elements, corresponding to the sum of the thrust of the arch and the perimeter floors.

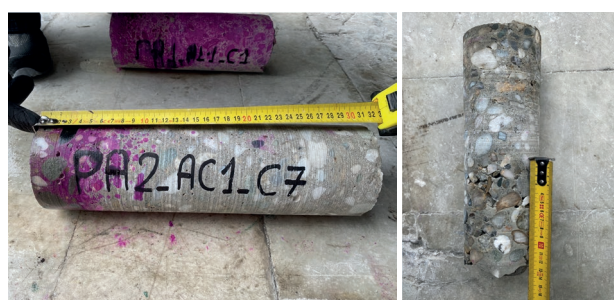
Figure 10 | Sample in the portion of the arch presumably made with Type 680 concrete (on the left), and a sample in the portion of the arch presumably made with Type 500 concrete.

and elastic modulus of concrete and to measure carbonation phenomena. In this case, the sampling was limited mainly to the arch since they are the most monolithic and massive elements in the entire hall, while two other samples were extracted to characterize a beam and a lateral pillar. One of the main objectives in the choice of sample extraction was to identify the presence of the two types of conglomerates hypothesized by Nervi, so core sampling was carried out at the points where this dissimilarity could be appreciated (Fig. 9). On the basis of the extracted samples, it was possible to state, even from visual inspection alone, the presence of different types of concrete, recognizable by the different size and quality of the aggregates found: samples taken from the struts, such as sample PC1\_C5 shown in Fig. 10, generally have a lower quality of aggregates than samples taken from the portions of the arches where Nervi had identified a Type 680 mix, such as sample PA2\_AC1\_C7, shown in Fig. 10.
