Integrated 3D Mapping and Diagnosis for the Structural Assessment of Architectural Heritage: Morano's Parabolic Arch

This paper illustrates an integrated approach to 3D mapping and structural diagnosis by means of non-destructive testing for the preservation of a historical industrial monument: the parabolic arch of Morano sul Po. This paper reports the results of the non-destructive test campaign carried out on the structure and focuses on the procedures for structuring an integrated approach, which served as the basis to provide guidelines for its conservation.

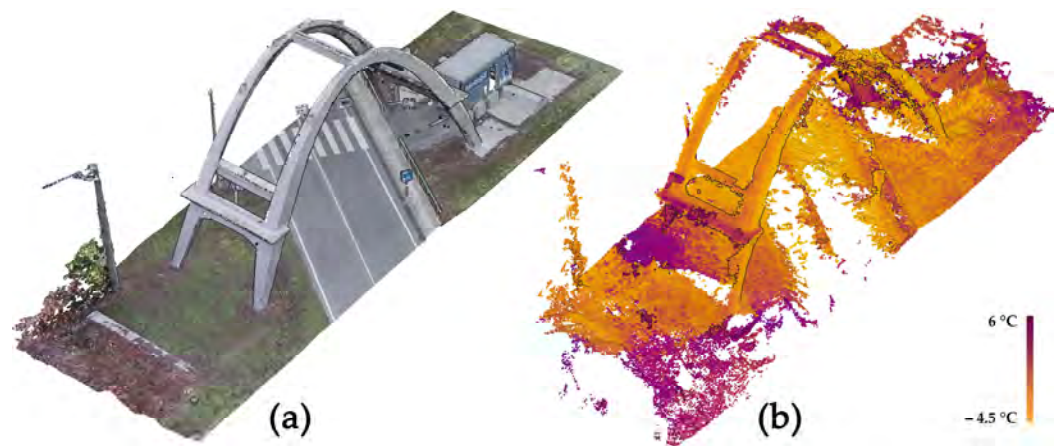
Figure 14. (a) Photogrammetric dense point cloud derived from the images acquired from the DJI Zenmuse XT2 visible sensor; (b) photogrammetric dense point cloud derived from the TIR images acquired from the DJI Zenmuse XT2 thermal sensor.

For these reasons, in many cases, the 3D reconstruction derived from the photogrammetric use of TIR images was characterized by a high level of noise and by the presence of numerous topological errors, gaps, or lack of information (Figure 14b). Often it is necessary to follow tailored strategies in order to optimize the results derived from the photogrammetric processing of the acquired thermal images. In most cases, a data fusion strategy is highly recommendable since it exploits the high spatial resolution of visible data (Figure 14a) in order to provide spatial referencing for the thermal information.
