Integrated 3D Mapping and Diagnosis for the Structural Assessment of Architectural Heritage: Morano's Parabolic Arch

# Integrated 3D Mapping and Diagnosis for the Structural Assessment of Architectural Heritage: Morano's Parabolic Arch

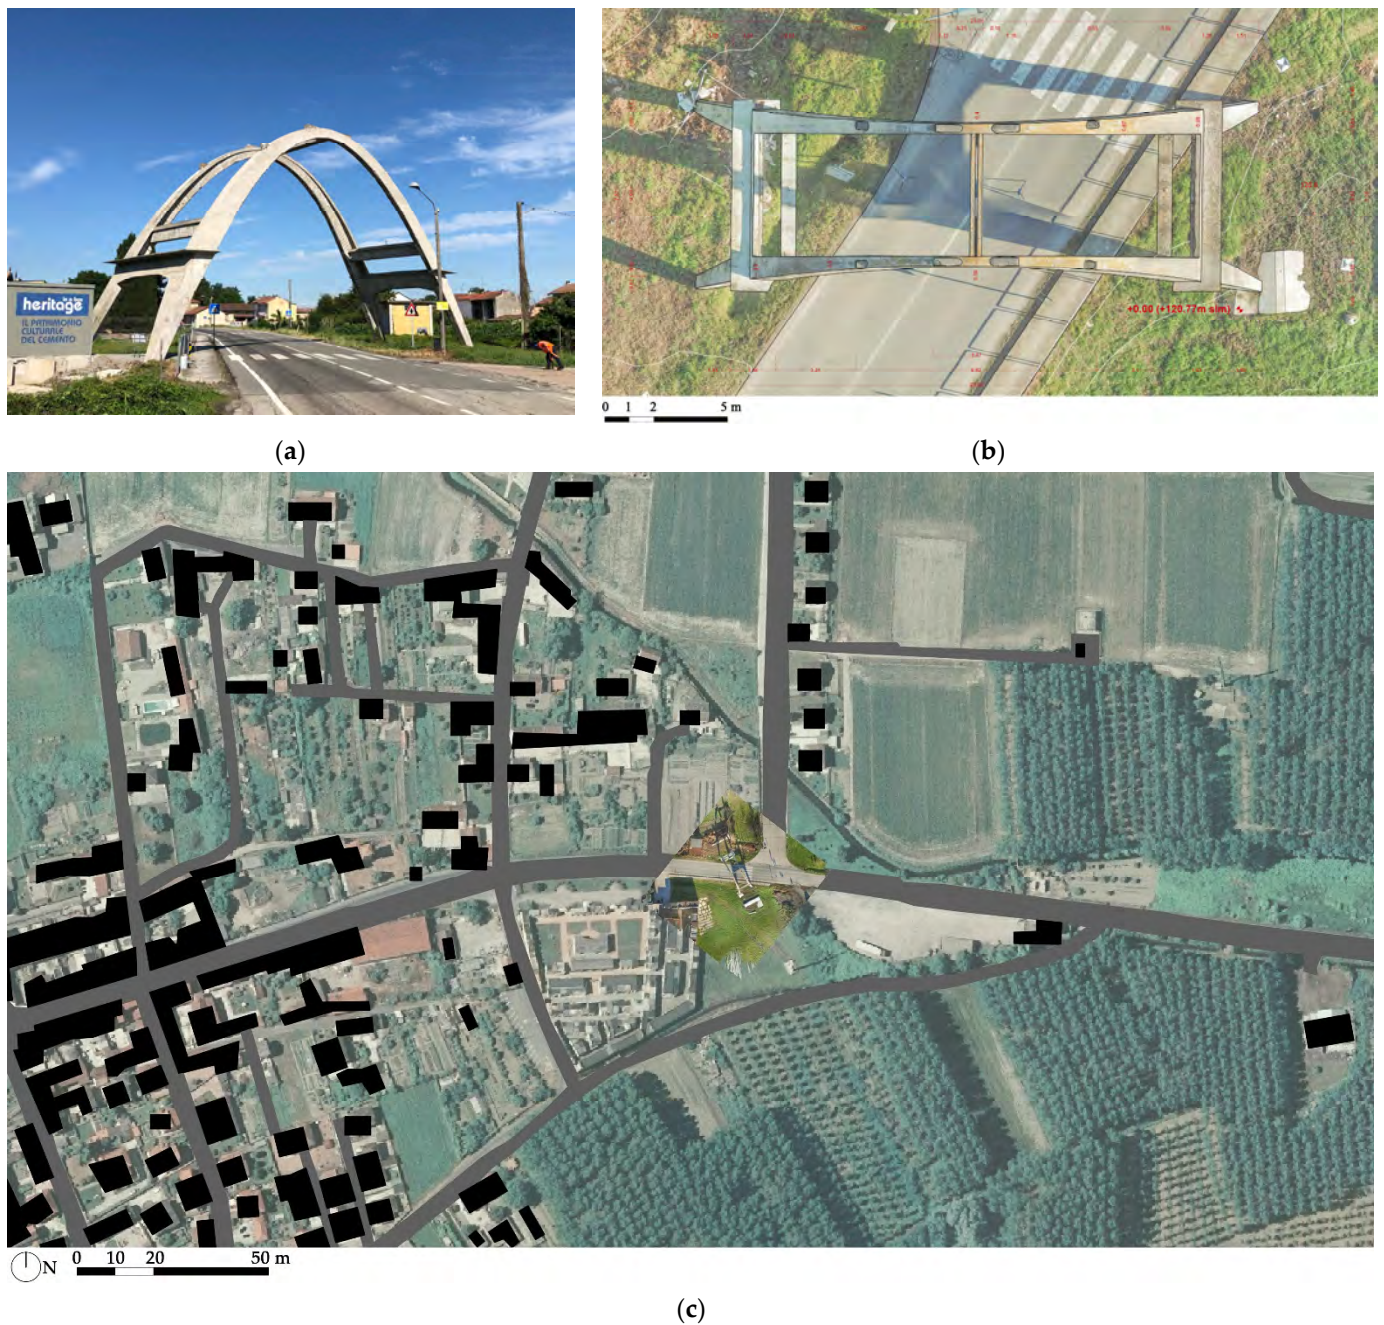
**Figure 1.** (a) Current view of Morano's Arch; (b) plan view from a UAV-photogrammetry-based orthophoto; (c) UAV orthophoto (0.005 m) overlaid on a regional orthophoto (GSD: 0.5 m), with buildings (black) and roads (grey) from a regional CTRN.

The arch of Morano sul Po (Italy) is located in the suburbs of the city of Casale Monferrato, along the state road no. 31bis (Figure 1). The parabolic concrete arch, together with the protection structure that was dismantled at the end of the last century, was conceived and realized to protect the road from the potential falling of the trolleys, or the carried raw material, of the cableway that is used to connect the mine sites in Coniolo Vecchio and Borino with the factory sites of Morano sul Po [6]. Figure 2a, which was taken from a historical postcard, shows the original configuration of the arch. The design of the concrete arch was appointed to Ing. Guido Sarti, who also provided the structural design of other parts of the cement factory, such as the clinker storage hall and silos, together with the design of the new cableway, which was realized in the period between 1951 and 1952, adopted the same path of the existing one, and was designed by Ing. Gualino in 1908. The structure is similar to one of the first parabolic clinker warehouses, built in the 1920s in the close town of Casale Monferrato, and that had recently undergone an extensive experimental campaign for its condition assessment [7,8].

In 2018, following a donation, the structure returned to the ownership of the Municipality of Morano after about forty years. In the summer of 2020, to avert the risk of falling fragments on the roadway, the removal of unstable surface layers was conducted on the arch using a pressure washer. In addition, the exposed reinforcing bars were treated with passivating paint. Recently, thanks to a grant from the Luoghi della Cultura 2018 call of the Compagnia di San Paolo, the structure became part of the Concrete Heritage Box initiative (Figure 1a) [9].

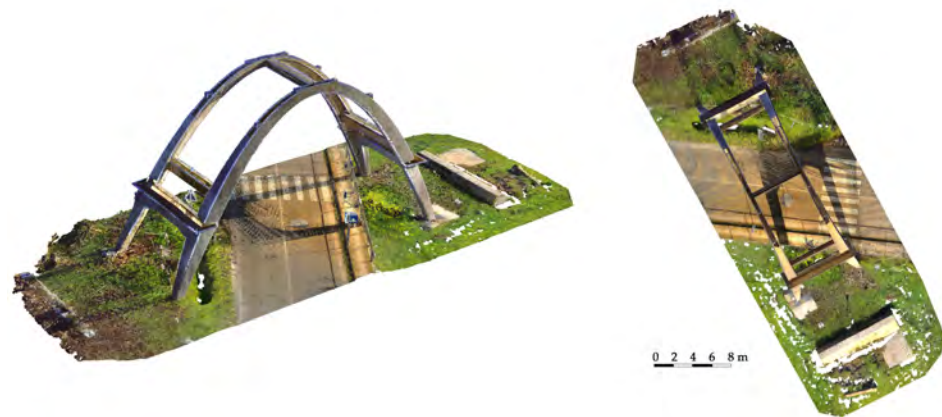
**Figure 3.** Two views of the LiDAR point cloud derived from the registration of the 19 acquired scans.

2. The LiDAR scans were merged (Figure 3) by exploiting the consolidated registration strategy, which consists of a preliminary alignment of the point clouds using an ICP algorithm, and then a rigid roto-translation of the block composed by the registered scans using the coordinates of the measured markers. The results were close to the usual residuals for similar surveys: the observed accuracy of the control points was  $\approx 6$  mm.

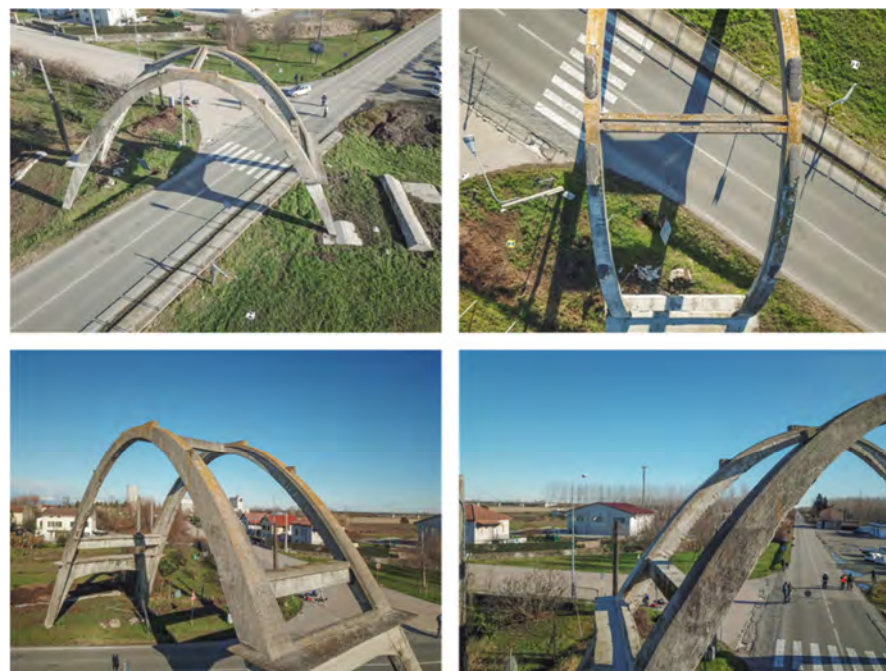
**Figure 4.** Digital images acquired from an aerial perspective using the micro UAV system, which enabled the acquisition of the extrados and the higher surfaces of the concrete arch.

3. The photogrammetric survey was carried out by integrating the acquisitions from both a micro UAV (Figure 4) and a DSLR (digital single lens reflex) camera using all of the images (more than 600). Regarding the image-based approach, an SfM solution was adopted. This type of 3D reconstruction is widely used in the field of image-based documentation of heritage buildings since it allows for the generation of dense and accurate point clouds that are characterized by high-resolution radiometry. This feature represents a very useful tool for restorers and conservators since it enables them to consider elements related to the material consistency of a building, thus facilitating its study and diagnostic investigations. The Agisoft Metashape platform (Version 1.8.1) was employed for this operation since it is one of the most commonly adopted and user-oriented software solutions in the field of image-based documentation of heritage buildings. The subsequent pipeline was managed without criticalities (Table 1): image masking, interior orientation of the camera, relative orientation of the images and tie-points extraction, georeferencing and bundle adjustment using the acquired ground control points, accuracy evaluation using both control and check points, and dense point cloud generation (Figure 5).

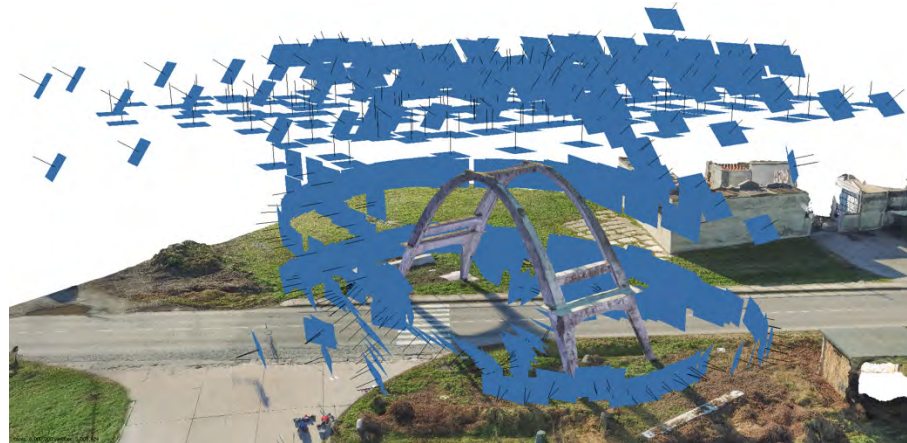
**Figure 5.** Oriented images (after the relative and absolute orientation) and photogrammetric dense point cloud.

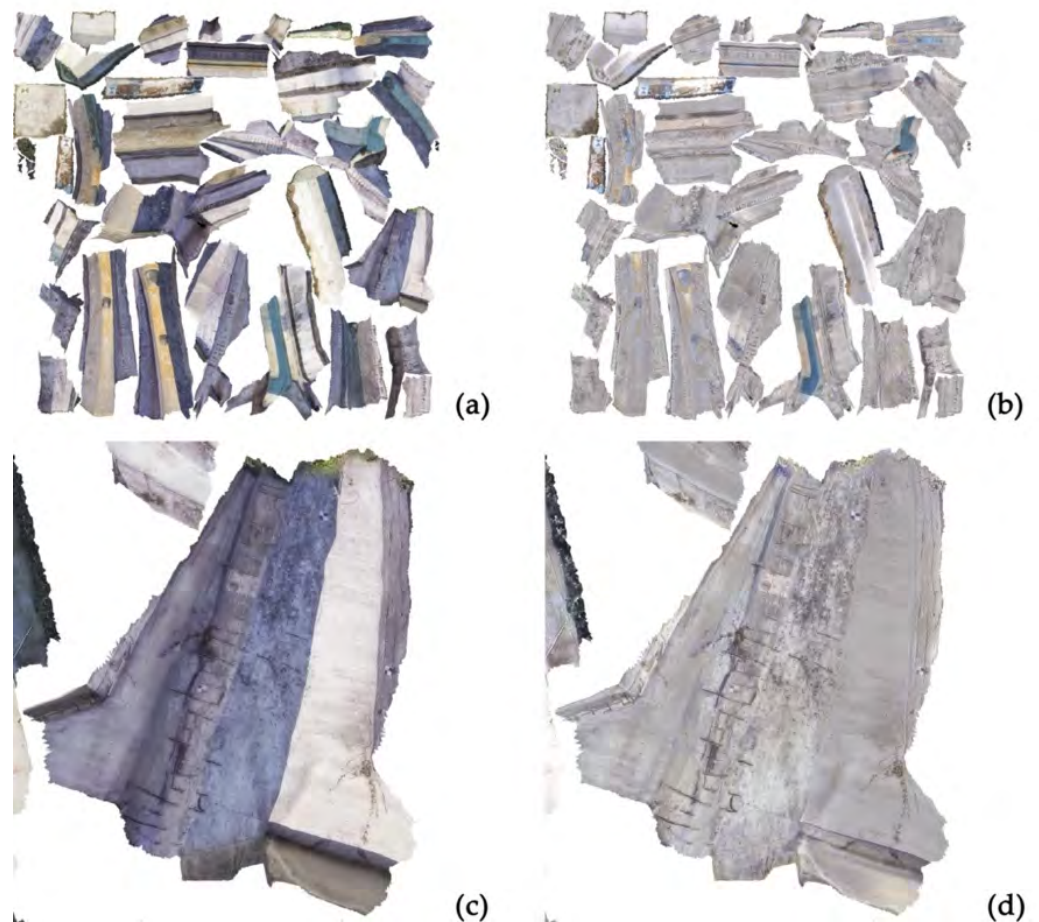
**Figure 6.** (a) Original UV map; (b) UV map after the editing process; (c) detail of the original UV map; (d) detail of the UV map after the editing process.

In order to facilitate the RGB reclassification for the semi-automatic decay detection procedure, the photogrammetric texture was edited with the aim of removing the shadows—due to the different sun exposures characterizing the different surveyed surfaces of the arch—and the radiometric discrepancies caused by the non-homogeneous illumination. As often happens when the data collection is performed in outdoor spaces, the impossibility of managing the lighting may cause the presence of areas characterized by significant differences in terms of radiometry. This can represent a problem for the reclassification task, where the RGB discrepancies are crucial for the proper detection of the analyzed degradation. For this reason, a 3D mesh was computed and a high-resolution UV map was generated (Figure 6). UV mapping is a texturing methodology that consists of projecting a 2D image—namely, the UV map—onto a 3D surface. The UV map is generated by processing oriented images of the photogrammetric block through orthorectifying and mosaicking procedures. Each point on the 2D textured surface corresponds to a vertex on the 3D mesh and is assigned a three-dimensional position, allowing for the texture to be projected onto the model. The UV space uses the Cartesian axes called U and V, while the 3D model is positioned in the XYZ reference system [28].

The generated UV map was processed with the aim of performing a radiometric equalization to homogenize the radiometry of composite elements of the same material but characterized by different solar exposures. This operation was carried out using the Agisoft Delightner platform, which allows for performing the equalization procedure by identifying different samples of underexposed and overexposed areas. The results of this operation can be observed in Figure 6d.

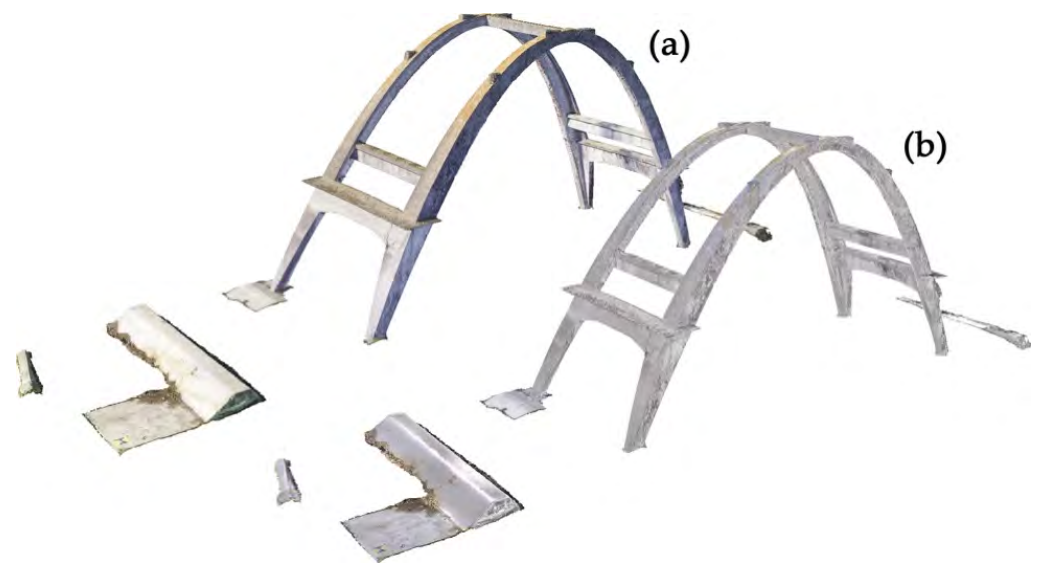
**Figure 7.** (a) Photogrammetric 3D mesh of the arch with the original texture; (b) reprojection of the edited texture on the original photogrammetric 3D mesh.

The edited texture was re-projected onto the computed 3D mesh (Figure 7) for the subsequent generation of the orthophotos that were used as primary data for the RGB-based reclassification for the identification of the analyzed types of decay. The reclassification of the exported raster images was carried out using the open-source software QGIS, which allowed—through the Raster Calculator tool—for grouping clusters of pixels with comparable digital number values and reclassifying them, exploiting the difference in terms of radiometry of the analyzed material (concrete) and decays (uncovered irons, efflorescence, and pollution blackening). After the reclassification processing, a degradation map was generated. In this case, the digital numbers embedded in each pixel of the classified orthophotos contained only four values: 0 for the concrete, 1 for the exposed irons, 2 for the areas affected by efflorescence, and 3 for the areas affected by the presence of pollution blackening (Figure 8).

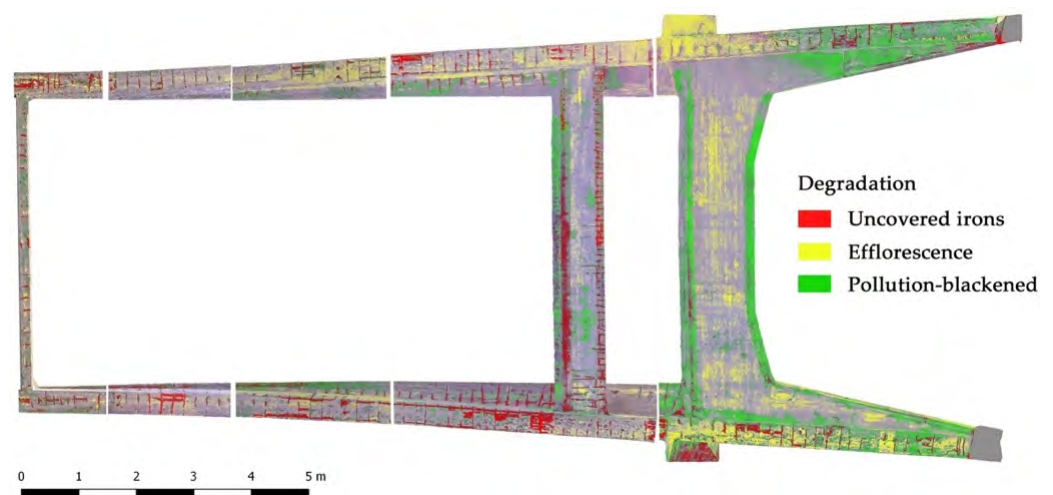
In this case, an RGB-based semi-automatic classification was performed with the aim to identify the areas characterized by the following degradations:

- Uncovered irons;
- Efflorescence;
- Pollution blackening.

**Figure 8.** Example of the RGB-based reclassification of a portion of the intrados for the semi-automatic identification of different kinds of degradation.

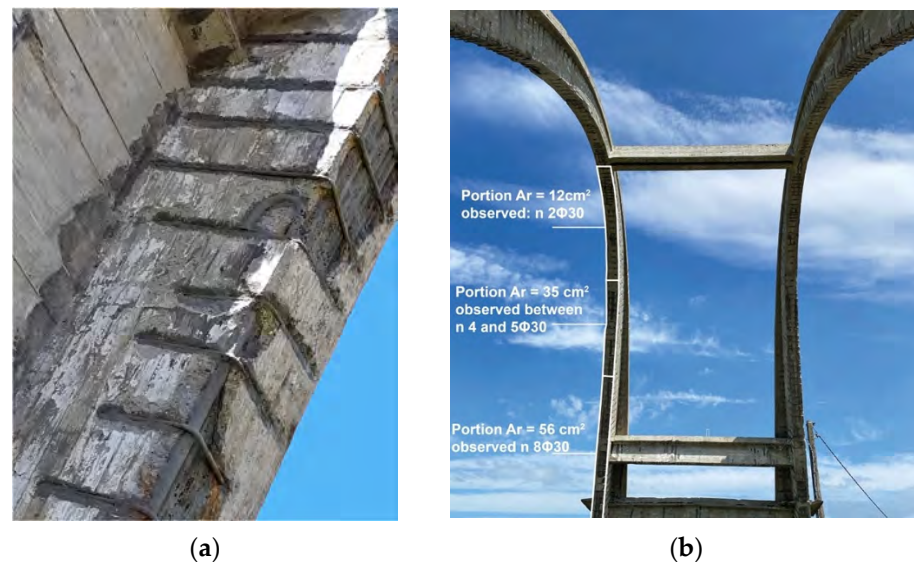
Pacometric tests allow for non-destructive verification of the presence and number of reinforcements in the structural elements of the work, as well as their orientation and arrangement, while also being able to estimate the thickness of the cover of the investigated elements. It was possible to directly measure the diameter of some of the outermost bars since the iron cover layer was absent in some places of the structure. Further comparison in terms of overall reinforcement area was possible from the design drawings (Figure 2b). The reinforcing bars were smooth with a diameter of 30 mm and had overlapping areas with hooked ends (Figure 9a). The stirrups, also smooth, had a pitch equal to 25 cm and a diameter of 12 mm. Pacometry made it possible to verify the presence of rebar even in areas where the cover was intact.

**Figure 9.** (a) Detail of the reinforcements of the arch; (b) measurements of surveyed reinforcements in the different portions of the arches.

Consistent with the design reported in the original drawings, it was observed that the percentage of longitudinal reinforcement decreased from the base toward the key of the arch (Figure 9b).

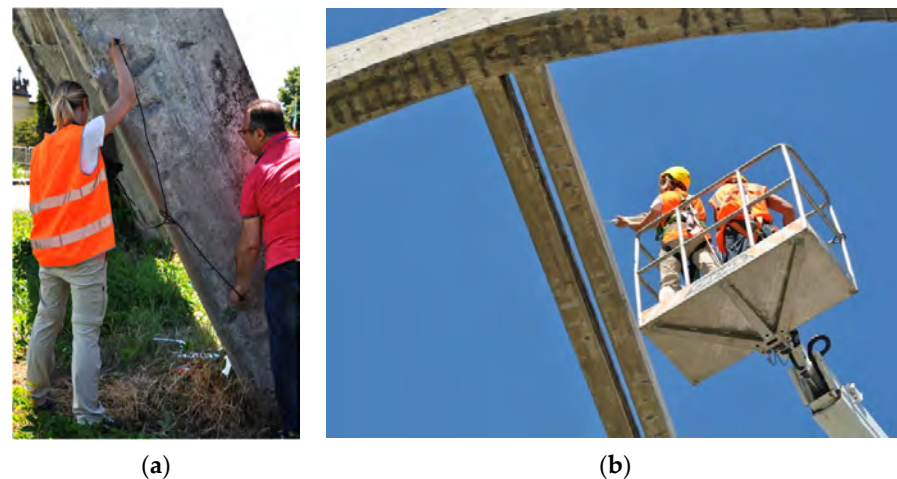
Ultrasonic pulse velocity tests are well-known non-destructive tests that are used to evaluate the quality and homogeneity of concrete. Measurements were conducted in accordance with the standards [7,10]. The measurement of the propagation time of the ultrasonic pulses was carried out using two probes, namely, a transmitter and a receiver, each with a frequency of 54 kHz, and applied to the surface of the element involved in the test. Indirect, i.e., homeosurface, tests were performed by placing the probes on the same face of the structural element at varying distances (Figure 10a), and once the distance between the points under test was provided, the instrument returned the time and speed of the wave propagation.

**Figure 10.** On-site testing of the various elements of the structure: (a) ultrasonic pulse velocity test; (b) rebound hammer test on one of the top beams connecting the arches.

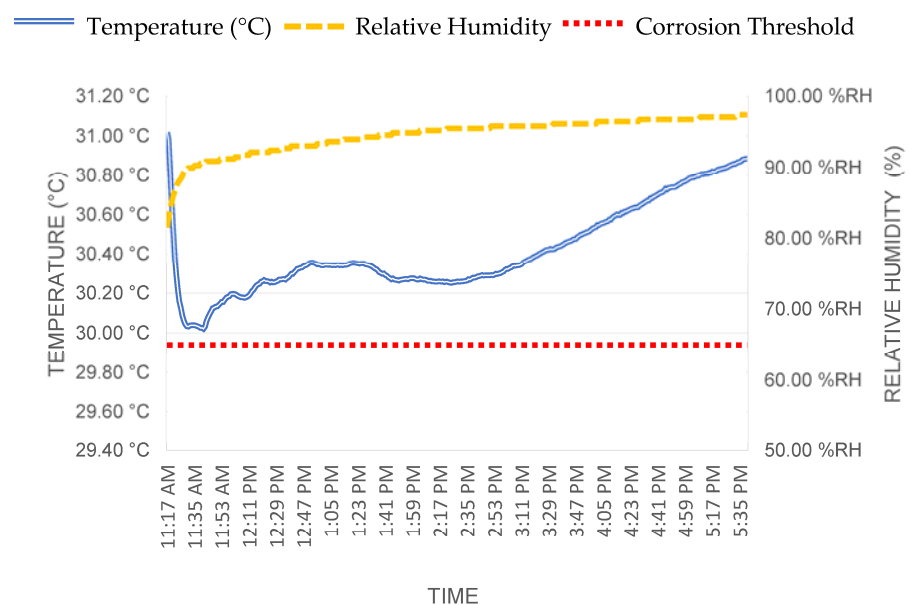
Environmental monitoring is an important factor to consider when assessing reinforced concrete structures. Several of the common deterioration mechanisms that affect reinforced concrete structures are initiated by a certain level of moisture present within the material. With corrosion, moisture is one of the two ingredients, together with oxygen, that needs to be present for the reaction to occur. Internal environmental monitoring was carried out at one location. A temporary sensor was installed inside the concrete to measure the internal temperature and humidity levels. Measurements were recorded every 20 min during the field workday (approximately 5 h). From the internal environmental monitoring, a high moisture content was detected from the data collected on site (Figure 13).

**Figure 13.** Graph illustrating the data collected of the internal temperature and humidity at the concrete column.

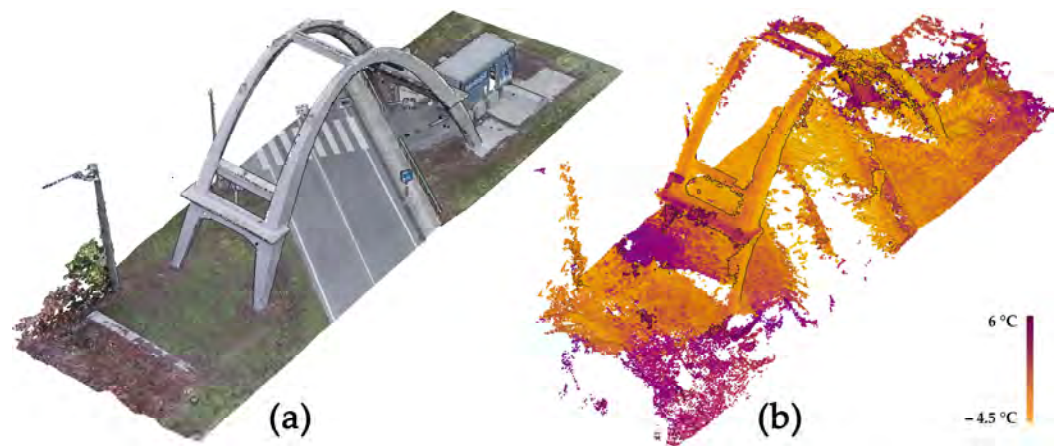
For these reasons, in many cases, the 3D reconstruction derived from the photogrammetric use of TIR images was characterized by a high level of noise and by the presence of numerous topological errors, gaps, or lack of information (Figure 14b). Often it is necessary to follow tailored strategies in order to optimize the results derived from the photogrammetric processing of the acquired thermal images. In most cases, a data fusion strategy is highly recommendable since it exploits the high spatial resolution of visible data (Figure 14a) in order to provide spatial referencing for the thermal information.

**Figure 14.** (a) Photogrammetric dense point cloud derived from the images acquired from the DJI Zenmuse XT2 visible sensor; (b) photogrammetric dense point cloud derived from the TIR images acquired from the DJI Zenmuse XT2 thermal sensor.

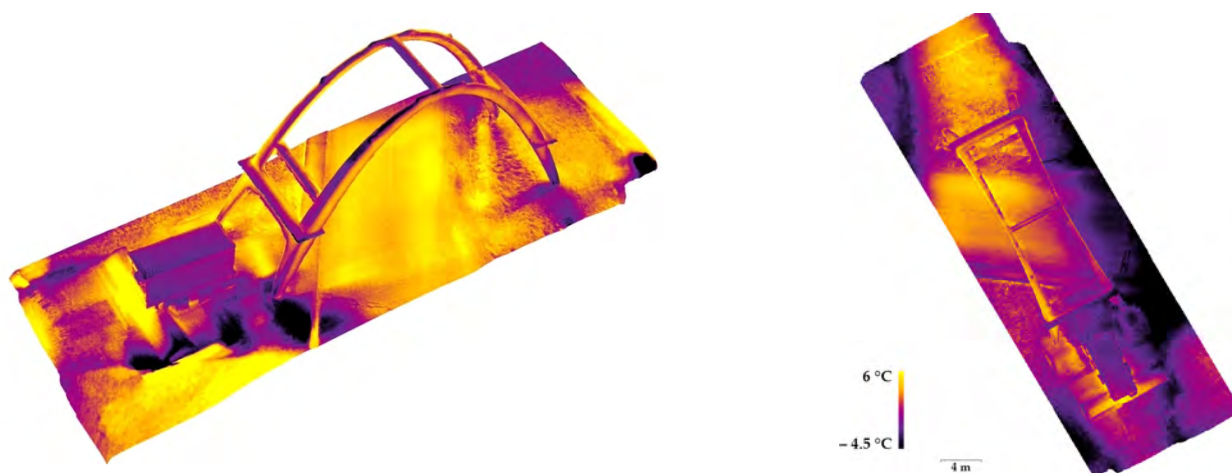
- A high-resolution thermal-textured 3D mesh (Figure 15);
- Thermal orthoimagery (Figure 15).

**Figure 15.** A 3D mesh derived from the integration between the visible data and the oriented TIR images.

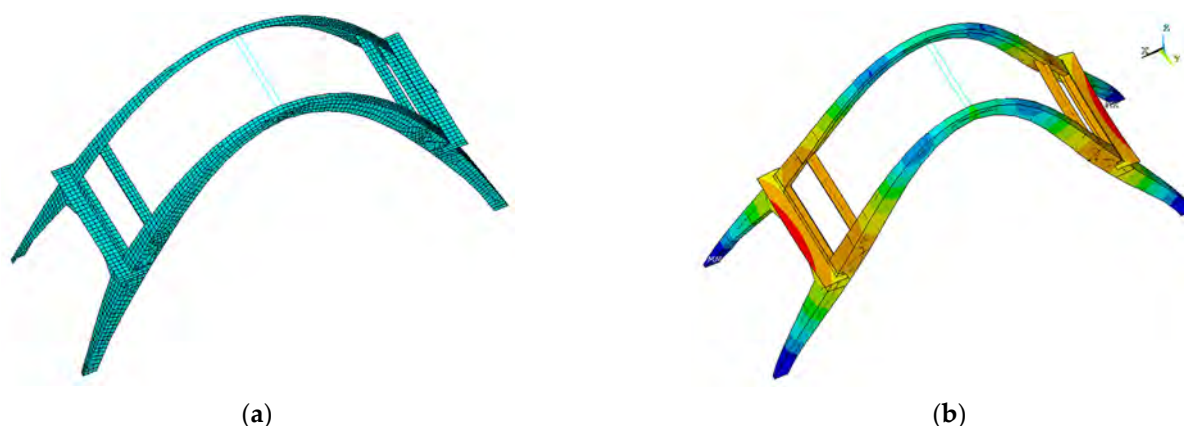
Figure 16a,b reports a view of the FE meshed model and the results of the static analysis, respectively. Overall, the distribution of deformations and stresses confirmed the substantial symmetry of the structure. The deformed shape of the structure indicated that the arch experienced its maximum deformation around the middle portion of the arches, in particular, at the joint with the beams.

**Figure 16.** (a) View of the 3D finite element modeling of the arch; (b) results of the static analysis that identified the static deformations of the structure (the scale goes to blue, deformations close to zero, to red, were the maximum deformations appear).

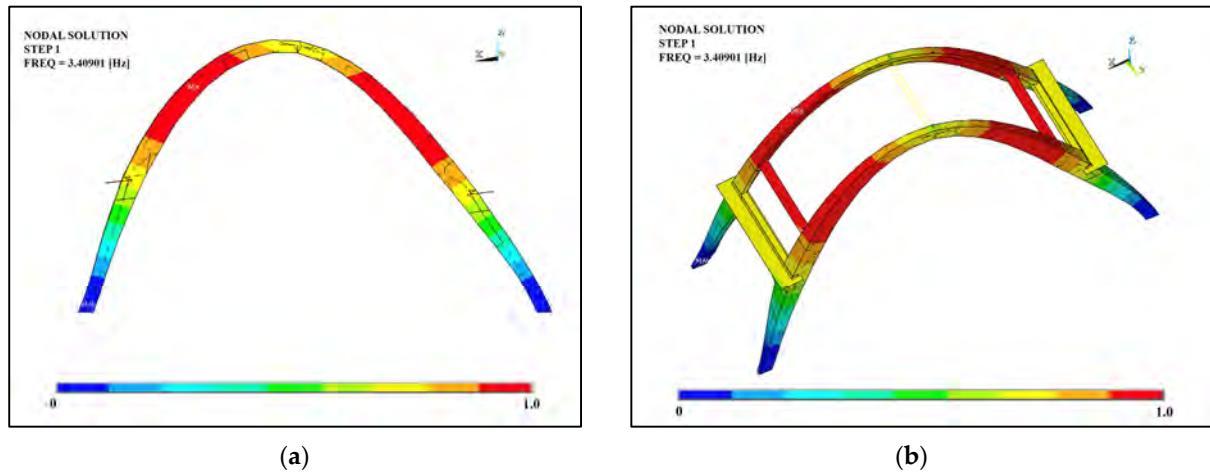
In order to spot possible criticalities to be better analyzed, structural and eigenvalues analyses were also carried out. Based on an average of all six degrees of freedom, modes 1, 2, 4, 5, and 6 were the modes that excited the most mass; the mode that affected the largest percentage of mass was the first mode, which corresponded with the translational modal form along the x and y directions, with model 2 in second place (Figures 17 and 18). Overall,

Figure 17. Mode 1: (a) lateral view; (b) perspective view.

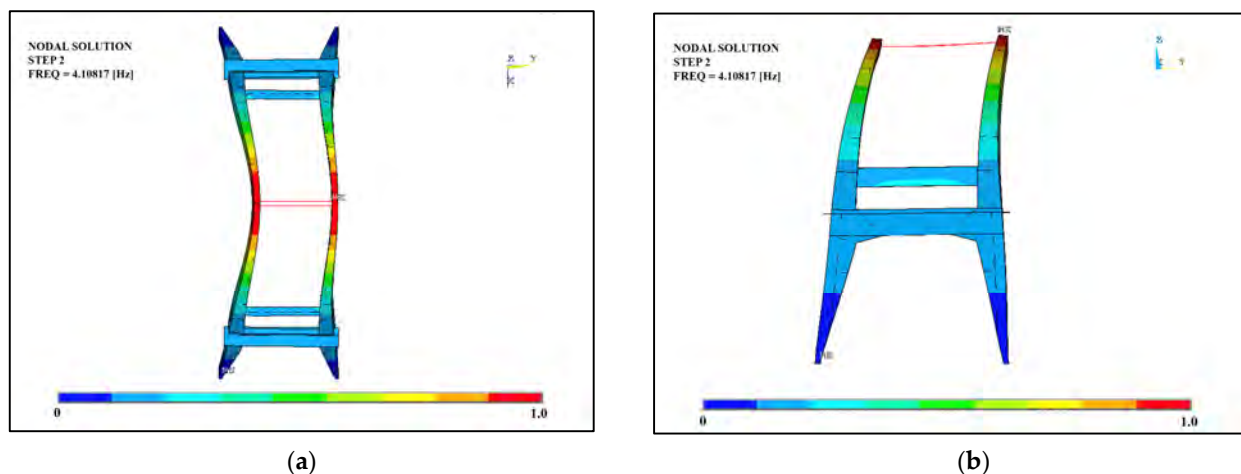
Figure 18. Mode 2: (a) top view; (b) lateral view.

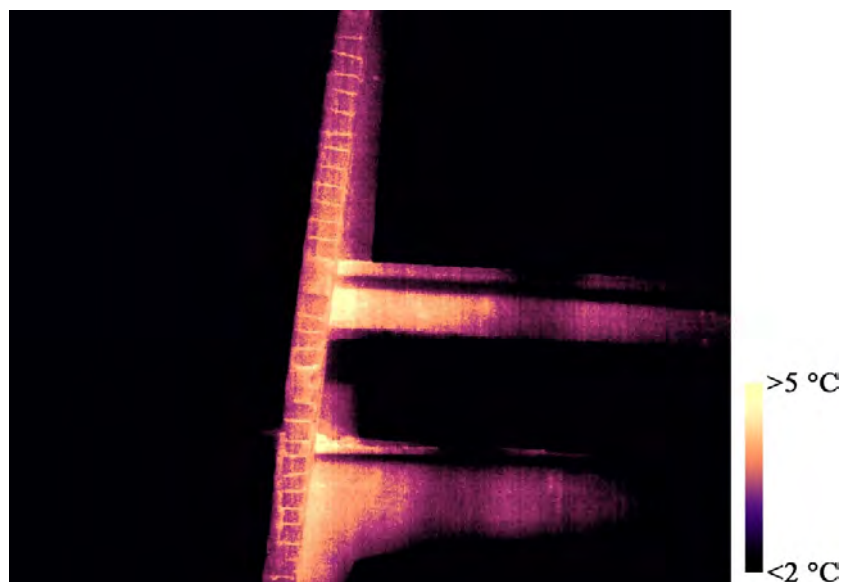
Moreover, the use of this type of imagery can represent a powerful alternative when the purpose is not only to identify but also to classify certain types of degradation. As an example, in Figure 19, it is possible to observe a portion of the intrados of the concrete arch of Morano. By exploiting the difference in terms of emissivity—leading to different temperature values—that characterizes the uncovered irons and the cement surface, it was possible to unambiguously identify, and consequently classify, the portion of the image occupied by the exposed steel bars by segmenting the pixels belonging to this class.

**Figure 19.** TIR image evidencing a thermal discrepancy between the uncovered irons and the concrete of the arch.
