The Frinco Castle: From an Integrated Survey to 3D Modelling and a Stratigraphic Analysis for Helping Knowledge and Reconstruction

Applications of Laser Scanning and Photogrammetry in Civil Engineering and Architecture: Beyond 3D Modeling II

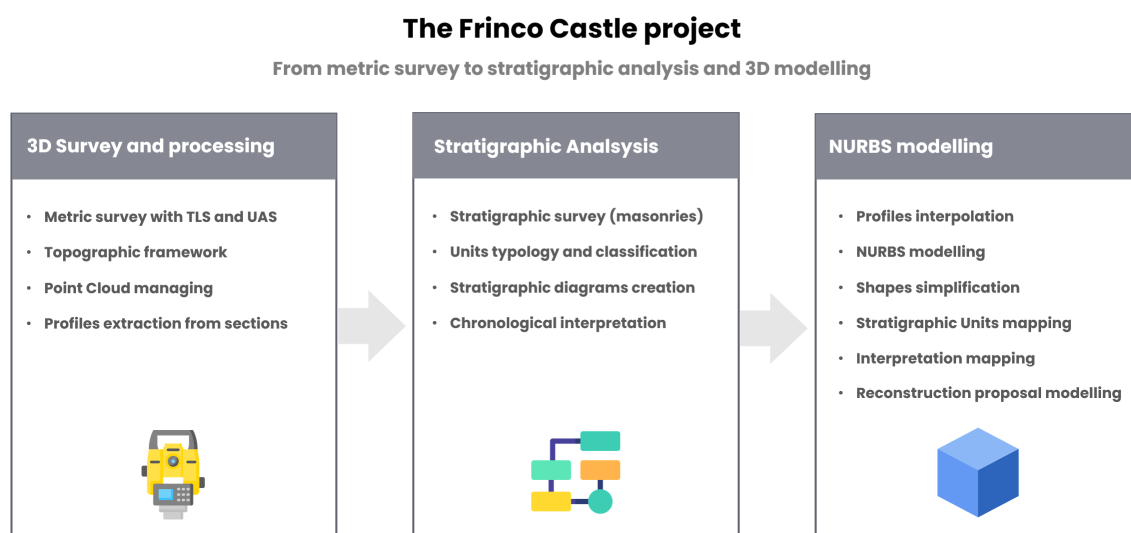
Figure 1. The main workflow of the project: from 3D survey to stratigraphic analysis and NURBS modelling of the Frinco Castle.

A geodetic survey was the backbone for the entire workflow of the project (Figure 1), as well as for a NURBS (Non-Uniform Rational Basis-Splines) representation. The building, around 70 per 40 m large and 30 m high, from the basement to the roof, consists of four main and various mezzanine floors. Due to the complexity and size of the building, by choosing to acquire the survey with the Trimble SX10 scanning station [1], we took advantage of the direct orientation of the point clouds through traverse adjustments, which can connect the indoor to the outdoor survey.

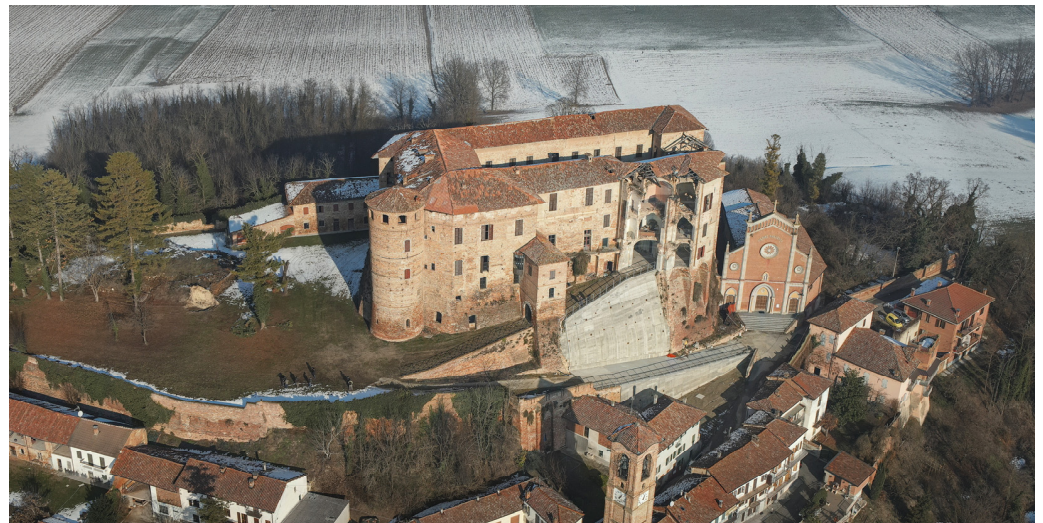
Figure 3. Aerial image of the Frinco Castle from the south side, from which the collapsed area is visible.

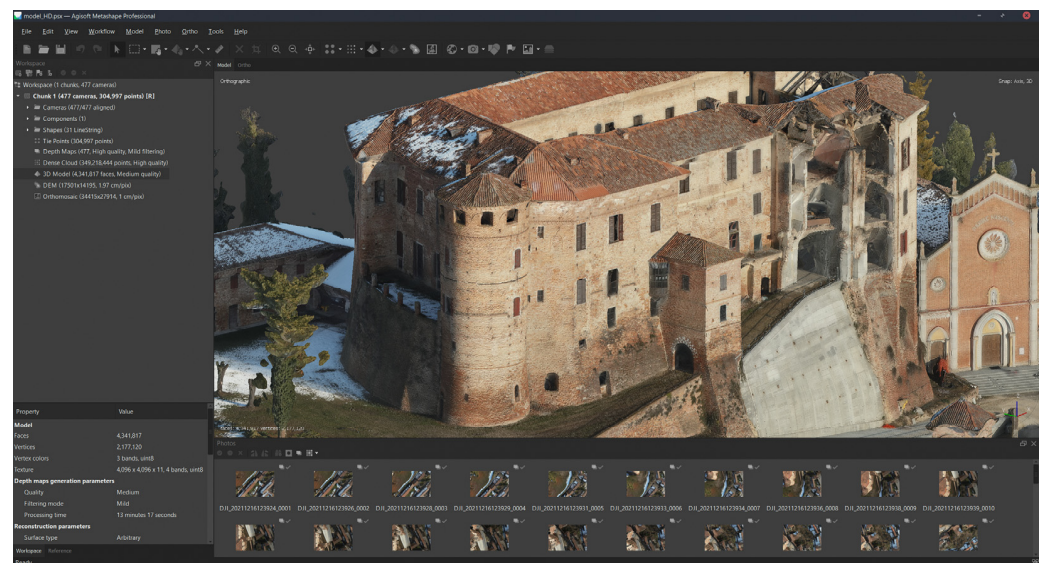
Figure 4. Photogrammetric process and 3D model inside the Agisoft Metashape software: aerial images acquired by DJI Zenmuse P1.

We aligned and integrated ground TLS and airborne UAS data in the Trimble Business Center suite. In the same software environment, we segmented and classified the point clouds to obtain a single integrated complete point cloud. Point cloud alignments were verified in CloudCompare as described in [14]. Polygonal meshes were generated to have complete reality-based 3D data (Figure 4) and for performing specific metric analyses [14].

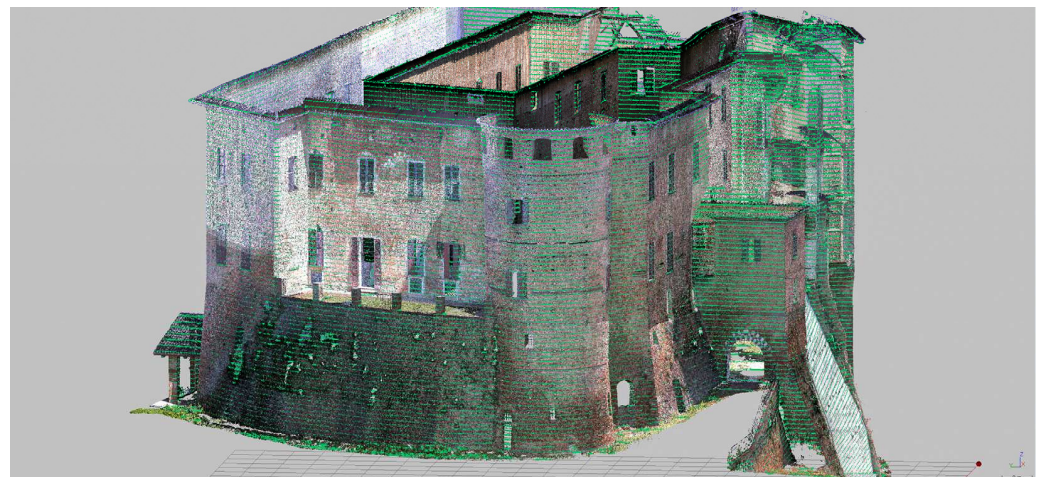
Figure 5. Profiles' extraction from the intersection between the point clouds and planar sections passing through X, Y, and Z planes.

At the end of the post-processing operations, photogrammetric and TLS data were the basis for the wired profiles' extrapolation. We generated planar sections by interpolating 3D point clouds with X, Y, and Z planes (Figure 5). This intersection creates orthogonal profiles that can be exported as CAD elements. These elements' ease of handling and metric accuracy favoured the NURBS modelling phase.

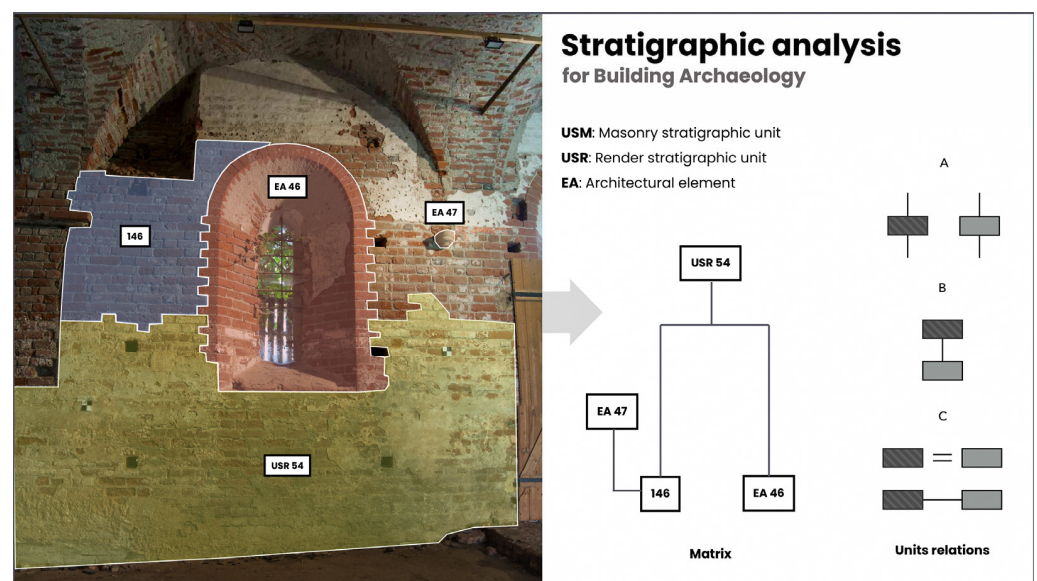
Figure 6. Stratigraphic analysis for historical architectures: from the unit's detection and classification (USM-USR-EA) to the unit's physical sequence by using the Harris Matrix. Units' relations are related to no connections (A), an overlap (B), and equality (C).

The documentation of stratigraphy is based on the collection of graphical and alphanumerical data related to stratigraphic units: layers on masonries have to be surveyed depending on their position, materials, and connections with other layers. These data can be collected using metric and photographic surveys to acquire masonry complexity. The drawing phase is essential, and it is executed mainly by using AutoCAD software (version 2020) for retracing the boundaries' delimitation of units on orthoimages (Figure 6).

According to the archaeological method, the detected units must be linked by establishing three types of physical relations: overlapping, equality, and no connection (Figure 5). These relations must be set and graphically represented using the stratigraphic diagram: the Harris' Matrix [25]. Through this schematic diagram, archaeological and architectural layers can be sequenced to establish a relative chronology (based on physical relations). A more accurate interpretation can be reached by validating the relative chronology with other external resources (historical archives) or precise analyses (archaeometry or chemical investigations of materials).

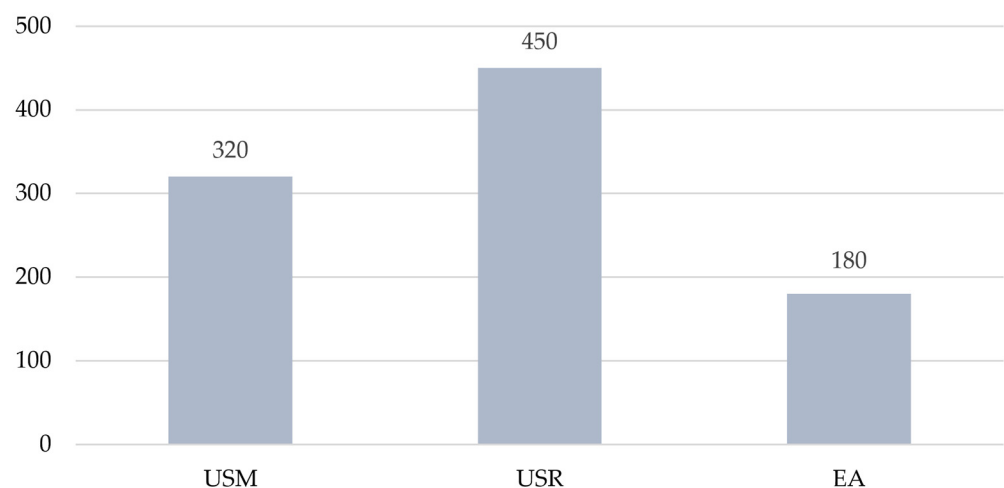
Figure 9. Part of the relational database for stratigraphic units' classification and description, and the physical relations among them.

Reference acronyms related to the building archaeology domain were used for classifying the masonry stratification [20,26,27]: architectural element (EA), masonry stratigraphic units (USM), and render stratigraphic units (USR). The analysis of external fronts led to identifying 950 units: 320 USM, 450 USR, and 180 EA (Figure 8). These elements were catalogued inside a database for documenting descriptions, typology, materials, and physical relations (Figure 9).

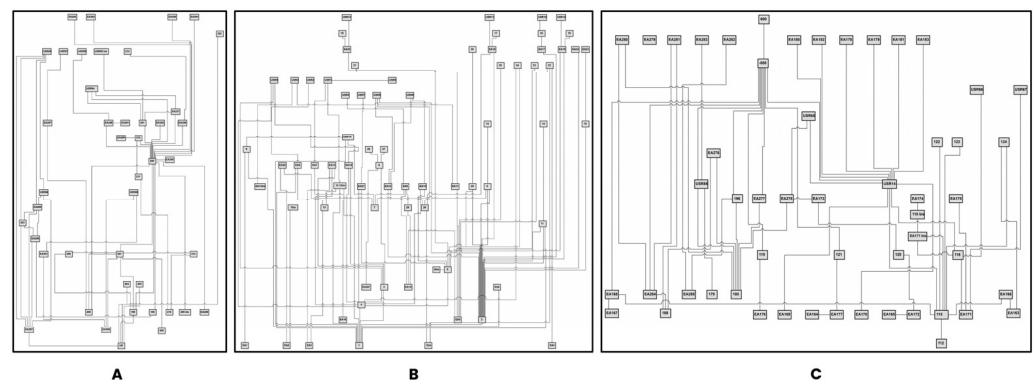
Figure 10. Three of the nineteen stratigraphic diagrams produced for the analysis of the Frinco Castle: square tower—forepart in the south front (A); the central part of the west front (B); the area of the collapse in the south front (C).

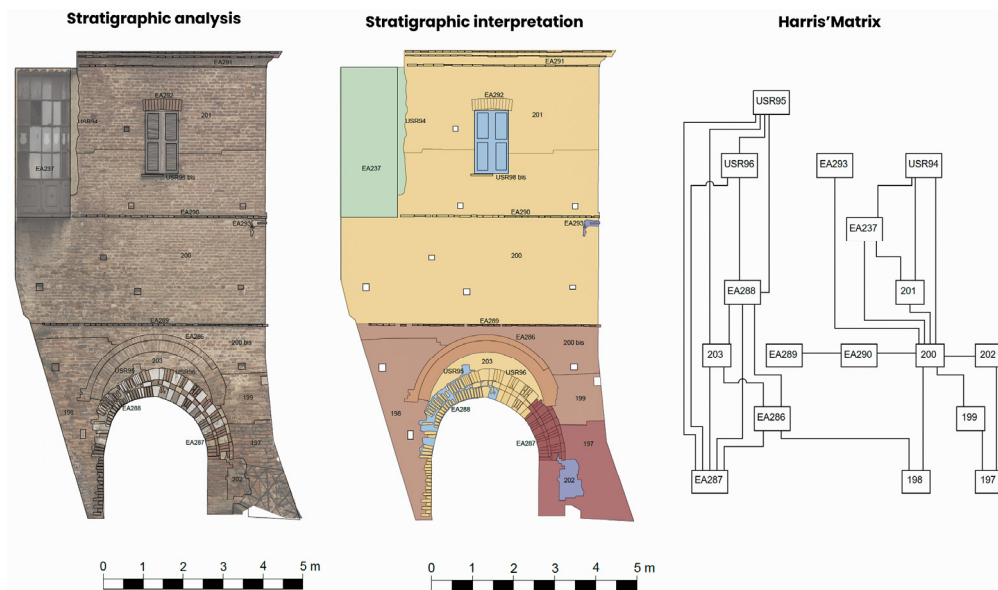
Figure 11. West side of the squared access tower: from the units' detection to the stratigraphic analysis and interpretation via Harris' Matrix for understanding the relative chronology of layers on masonries.

Once physical relations were established, stratigraphic units were collected into macro phases and periods to achieve a relative chronology for external masonries. The final analysis returned eight chronological periods, from the early construction site to the structural collapse period. The chronological sequence was graphically rendered on the orthophotos by setting false colours (Figure 11).

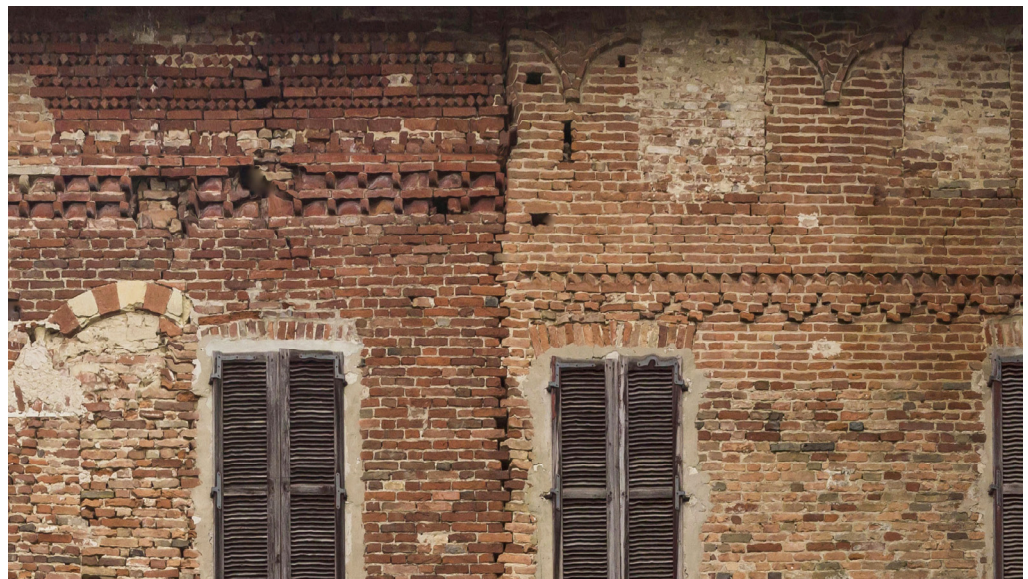
Figure 12. Section of the central part of the west front of the castle: on the left side, the earlier masonry and decorations (Period I), while on the right side, the connected masonry and Ghibelline decorations related to Period III.

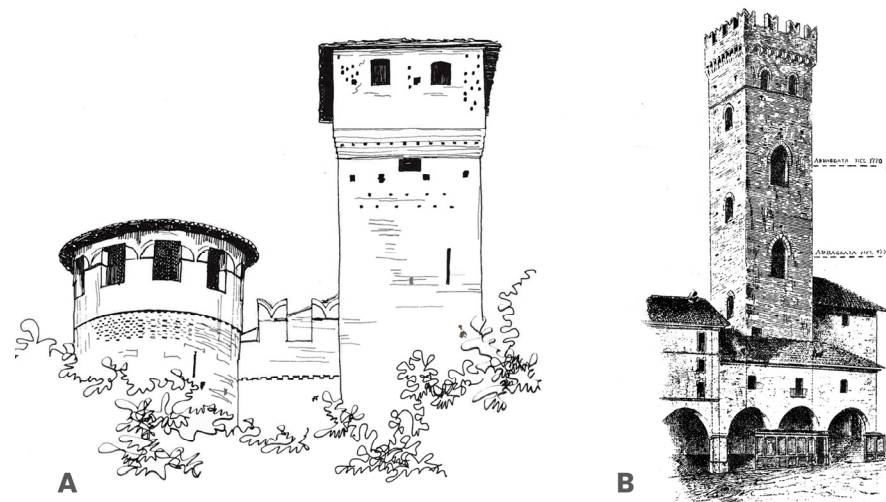
Figure 13. Ghibelline dovetail comparisons: (A) Castello Molare (AL); (B) Torre Scarampa-Bertamenga (AT). Drawings of Fonio M.R., from Conti F., 1980.

on the upper part of the fronts. These architectural components are related to Ghibelline decorations (EA207 related to dovetail battlements). In this regard, the castle became a Ghibelline defensive building by the Turco Family against the Solaro Guelf family [5,6]. For this reason, this period can be placed between the end of the XIII century and the first half of the XV century. This interpretation is validated by several chrono-typological elements located inside the city of Asti and the surrounding area: dovetail decorations dated to the second half of the XIII century can be found on the Comentina Tower (AT), Torre Troyana (AT) Torre Scarampa-Bertamenga (AT), and Castello Molare (AL) (Figure 13) [2,6].

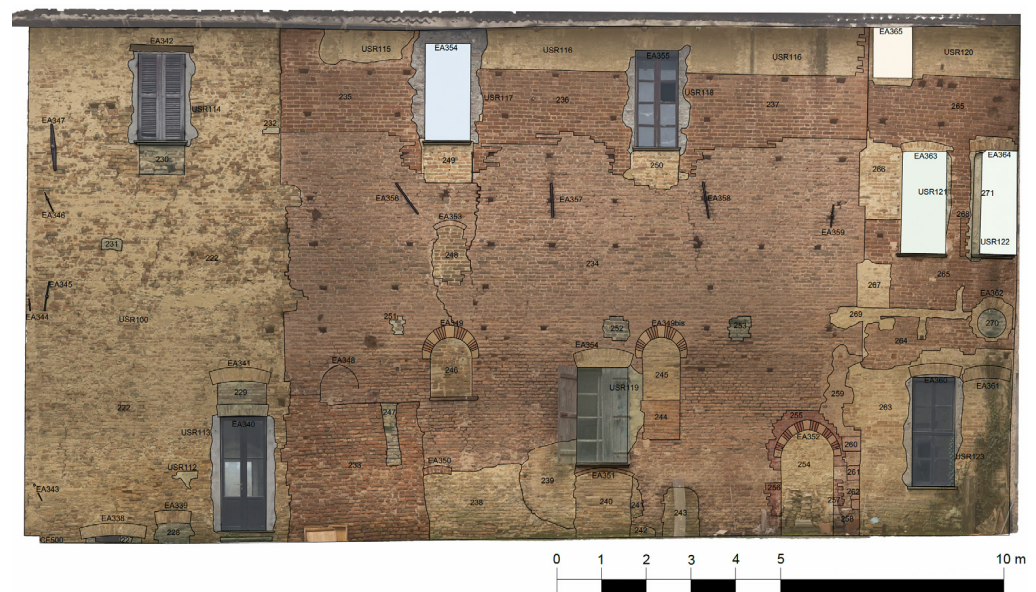
Figure 14. Part of the south front of the internal courtyard: stratigraphic units (USM, USR, and EA), analysis, and interpretation.

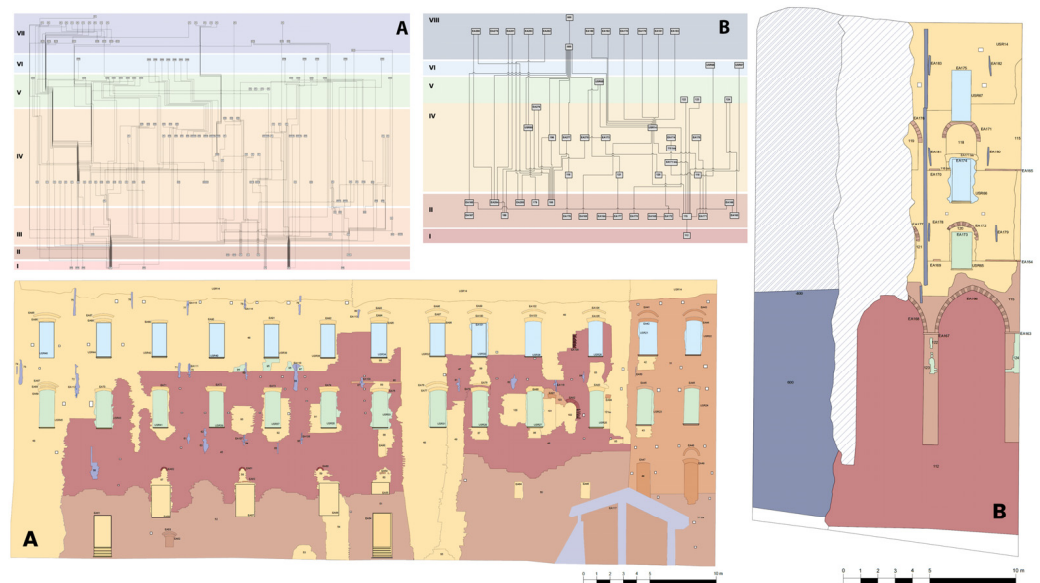
Figure 15. From the stratigraphic analysis and interpretation via Harris' Matrix to the digital representation on orthophotos: matrix and orthophoto of the north front (A); matrix and orthophoto of the collapsed area (B).

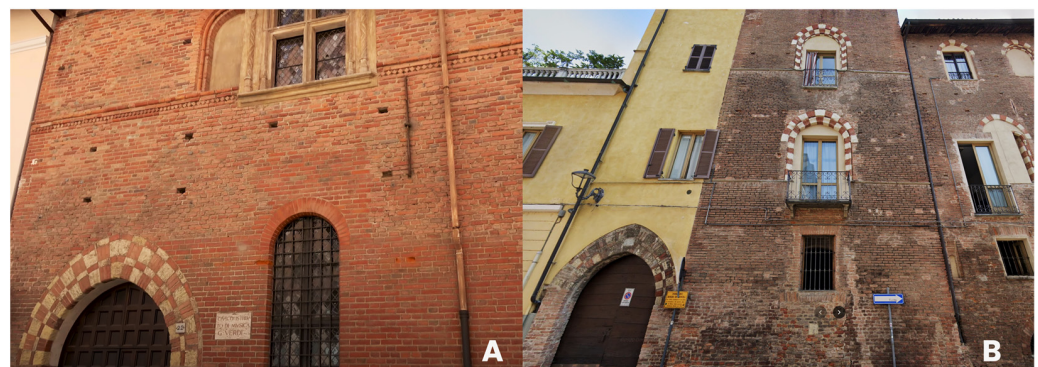
Figure 16. Comparisons on bichrome pointed arches related to doors and windows (ogival): (A) Verasis-Asinari Palace; (B) Roero Monteu Tower. From Google Street View.

This analysis confirmed that the most evident chronological phase is inscribed into the first half of the XVIII century and the end of the XIX century. Architectural interventions referred to this phase can be detected in the entire area of the castle, especially on the east side and in the internal courtyard. By contrast, the Ghibelline period (III period) is detectable especially on the west side and on the circular tower. Other important medieval evidence is related to bichrome pointed arches (I period) used on the south side of the castle, on the defensive entrance tower (squared plan), and on the single lancet windows. In this regard, the chronological interpretation was supported by several chrono-typological comparisons: bichrome (also double) pointed arches (doors and windows) belonging to the same type can be observed in the Solara Tower, the Verasis-Asinari Palace (which also has the same rhomboidal decorations as the western facade), and in the Roero Monteu Tower located in Asti (Figure 16).

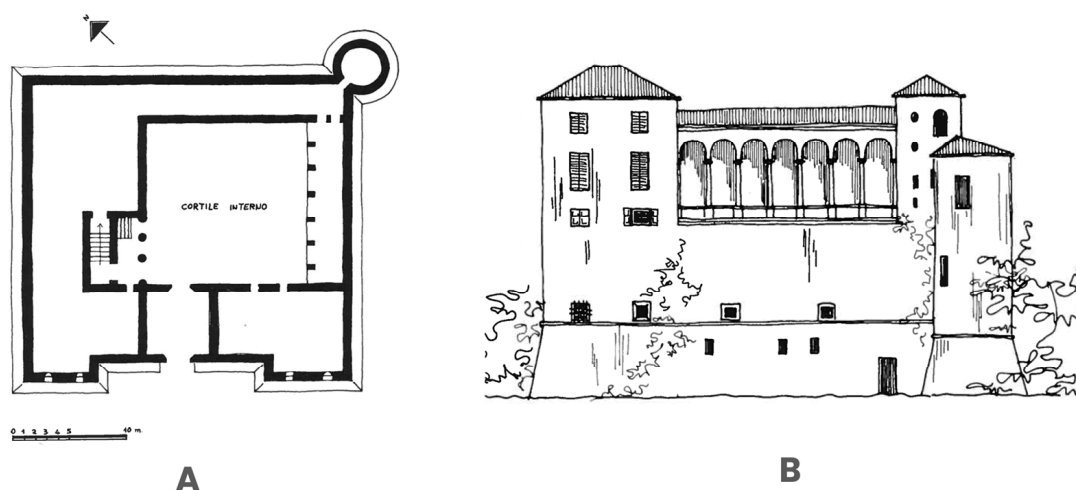
Figure 17. Tessarolo castle (AL). The architectural schema (circular tower, loggia, squared tower, and internal courtyard) is similar to the west side of the Frinco castle. From Conti F., 1980.

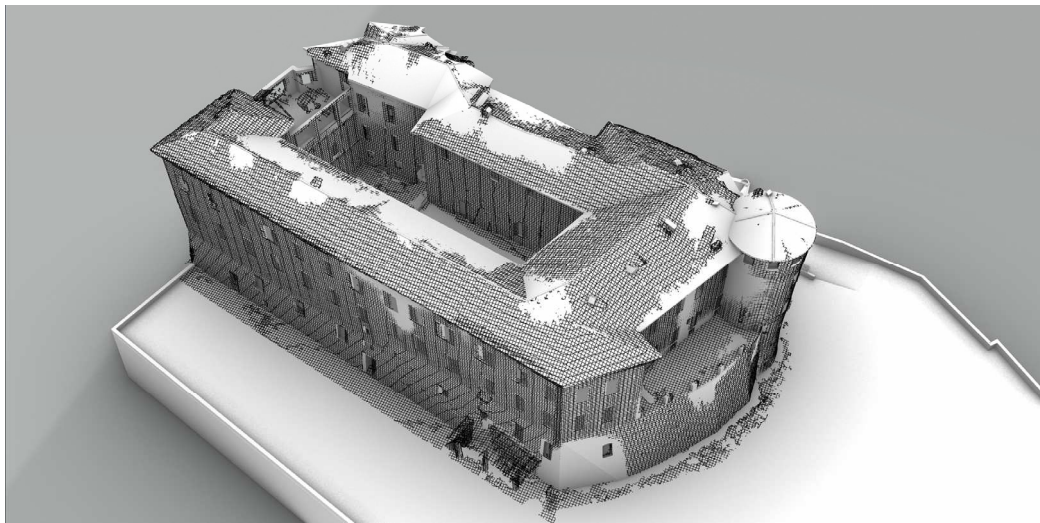
Figure 19. NURBS modelling of the castle: surfaces and geometries modelled on wired profiles generated from planar sections' extraction.

The first modelling phase started by importing wired profiles extracted from point clouds inside the Rhinoceros software (version 7.0), and then these geometries were the basis for NURBS curves and surface interpolations (Figure 19). Although this software allows for direct modelling on point clouds, wired profiles derived from planar sections were used primarily for having simple CAD profiles of the castle without the complexity and noisy elements related to point clouds.

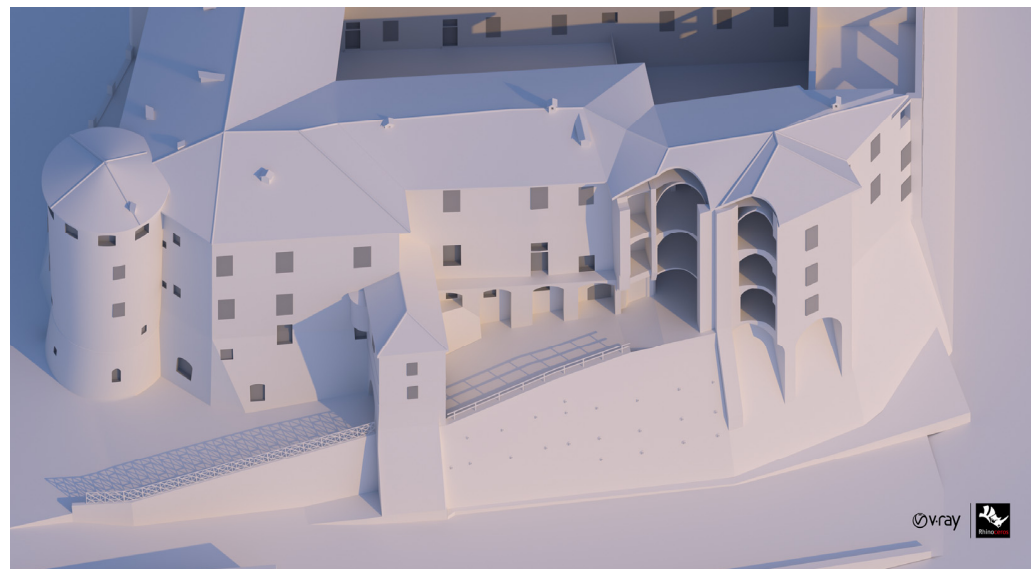
Figure 20. NURBS model of the castle related to the actual situation: the collapsed area on the south side.

Wired profiles were the backbone for the surface modelling. Using commands such as *extrusions*, *loft*, *sweep*, and *patch*, NURBS surfaces and solids were reconstructed. In particular, non-planar surfaces derived from the *patch* command were used for different architectural parts of the castle, especially for the concrete containment wall (collapsed side) and the stratigraphic units. The internal subdivisions and rooms were modelled only for the open area of the castle referred to the structural collapse of the south side (living area with bedrooms). However, the architectural components of the castle were modelled by simplifying their geometries and complexities (Figure 20).

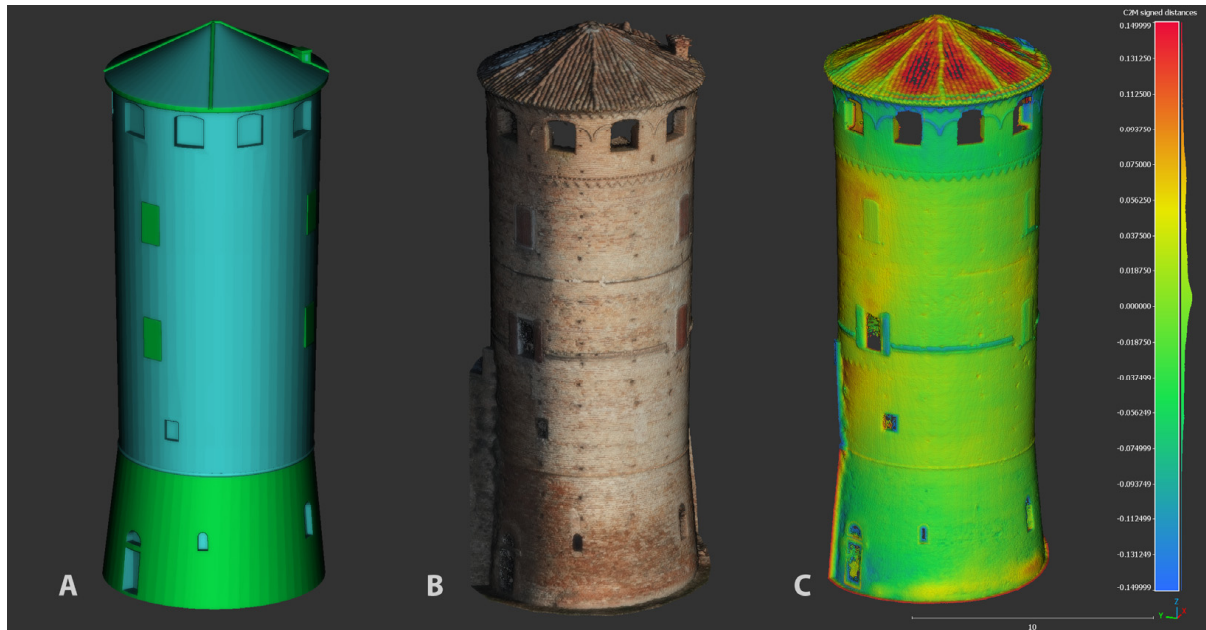
Figure 21. Standard deviation analysis between point clouds and NURBS concerning the circular tower of the castle: (A) NURBS simplified model; (B) point clouds; (C) scalar fields.

The second phase consisted of metric analyses of what had been modelled. The NURBS geometries and surfaces were compared with point cloud data. In particular, the circular tower was at the centre of this distance calculation. Using the CloudCompare software (version 2.4), the NURBS model of the tower was processed with the point clouds obtained from the DJI Zenmuse P1 photogrammetric acquisition (homogenous metric data). The *cloud-to-mesh* distance was computed using a measured range between 0.00 and 0.15 m.

The obtained standard deviation was 0.056 m, and the RMSe (root-mean-square error) was 0.059 m. The point coverage related to the initial metric range and scalar field was estimated here: between 0.00 m and 0.05 m, the coverage is 63%; between 0.05 m and 0.10 m, the coverage is 25%; and between 0.10 m and 0.15 m, the coverage is 12%. The most evident metric distances (read areas in the scalar fields) referred to the roof and wall bulging, primarily since these parts were modelled by simplifying geometries (Figure 21).

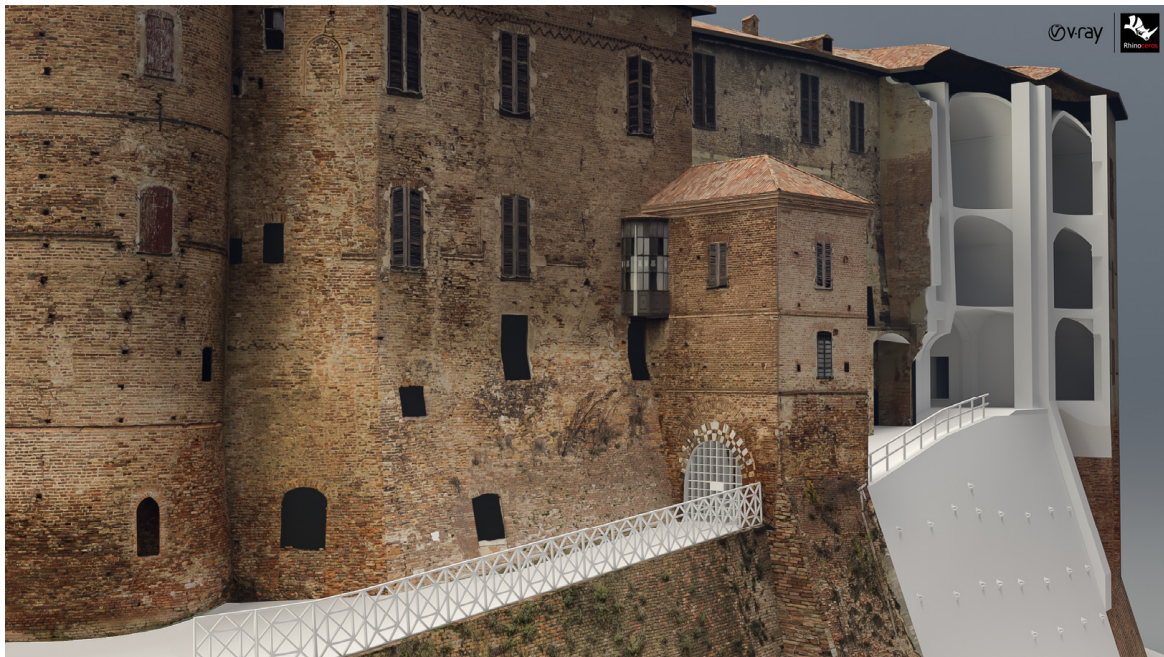
Figure 22. Textures and orthophotos mapped on the NURBS model of the castle related to the actual situation: the collapsed area on the south side.

The third phase started by mapping on the model highly detailed orthophotos and textures related to architectural fronts. Textures were applied on curved surfaces (the circular tower, angles, and angular windows on the south side) by using custom UV mapping. This operation involved, for each surface, the custom position and rotation on the X, Y, and Z axes of the photographic textures imported into Rhinoceros. Orthophotos, obtained from the photogrammetric process with 1 cm of GSD, were mapped as plane surfaces directly on the modelled walls, adjusting the X, Y, and Z placements of Gumball (real-time object editor via Cartesian axes). Finally, the stratigraphic layers were imported as CAD elements by using the same local coordinate system. In this way, lines and polylines referred to stratigraphic units were automatically mapped onto the walls. The planar surfaces were created from stratigraphic layers.

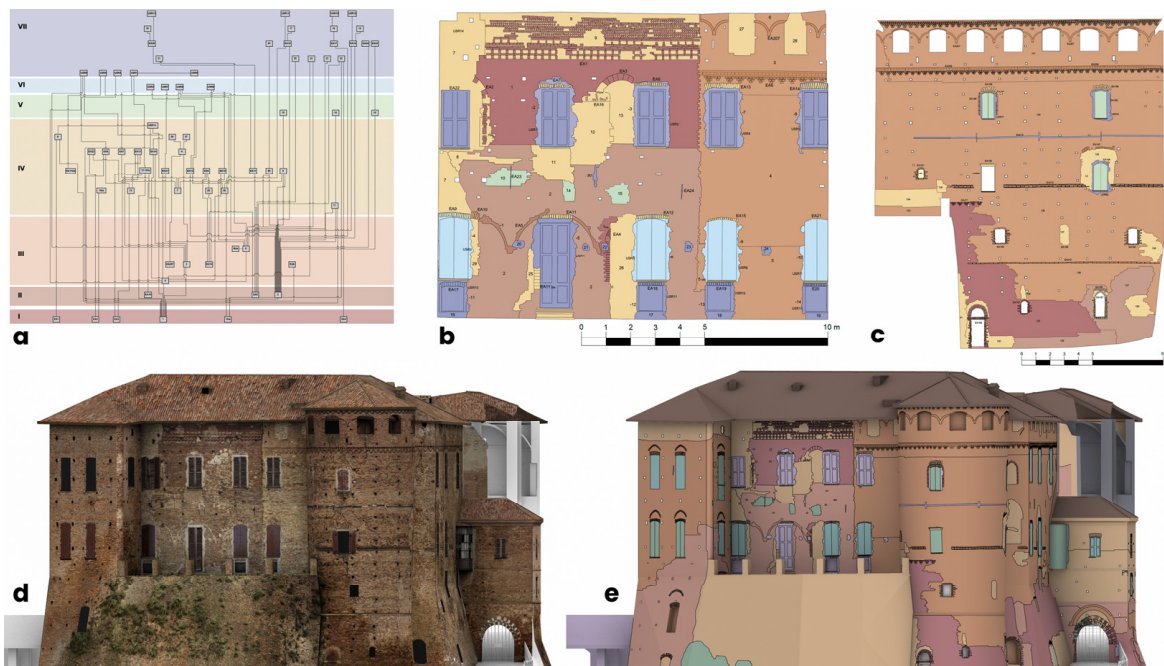
Figure 23. From the stratigraphic analysis to the immersive 3D model. Section of the west side: matrix and period of the central part of the west front (a,b); understanding of the cylindric tower (cylindric unwrap) (c); NURBS model with textures and understanding (d,e).

This phase was also crucial for orienting stratigraphic units (imported as CAD profiles). These elements were mapped on the walls' surfaces, and the non-planar surfaces (*patches*) of the stratigraphic layers were modelled on them using an offset of 1 millimetre. Surfaces referred to stratigraphic pieces of evidence were coloured using the same false-colour attributions used for the chronological interpretations. In this way, an immersive 3D classification of the chronological periods referred to the construction steps of the castle was obtained (Figures 23–25).

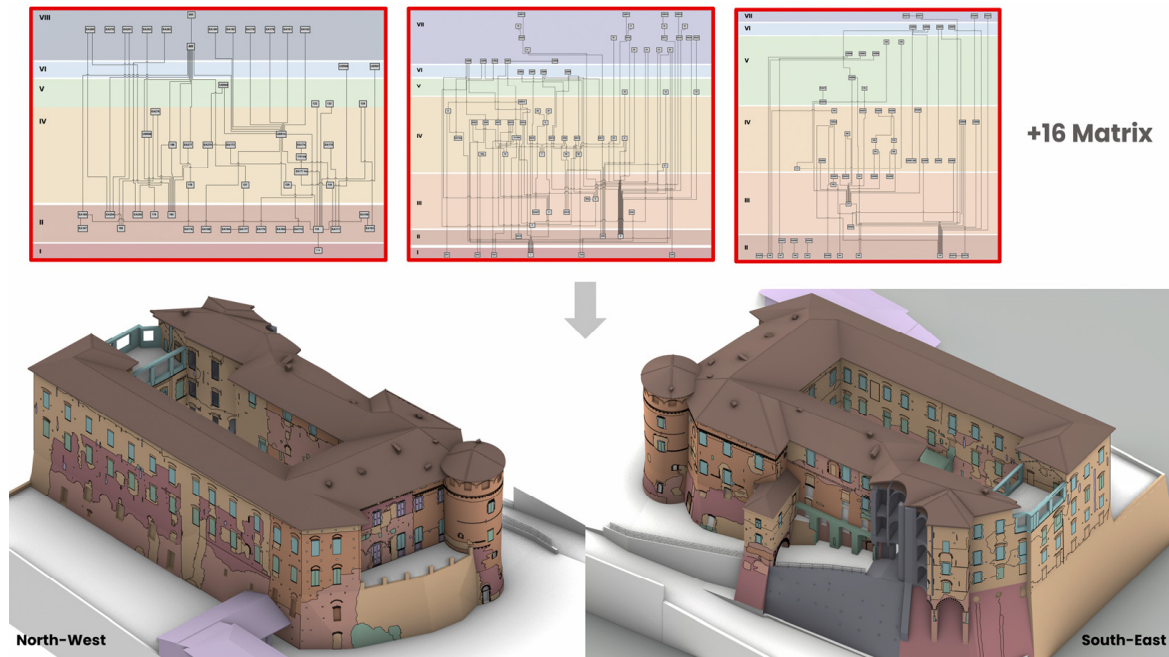
Figure 24. 3D NURBS model of the Frinco Castle coloured depending on historical interpretation carried out via stratigraphic diagrams. Details of the northwest and southeast of the castle.

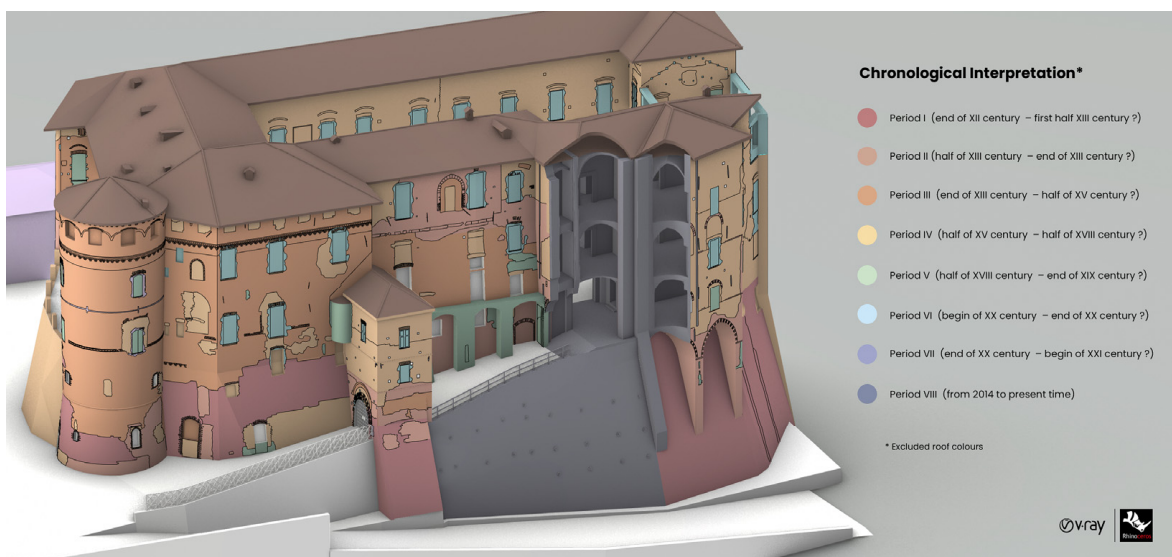
Figure 25. Three-dimensional NURBS model of the Frinco Castle with the stratigraphic analysis and interpretation: the legend shows the period sequences.

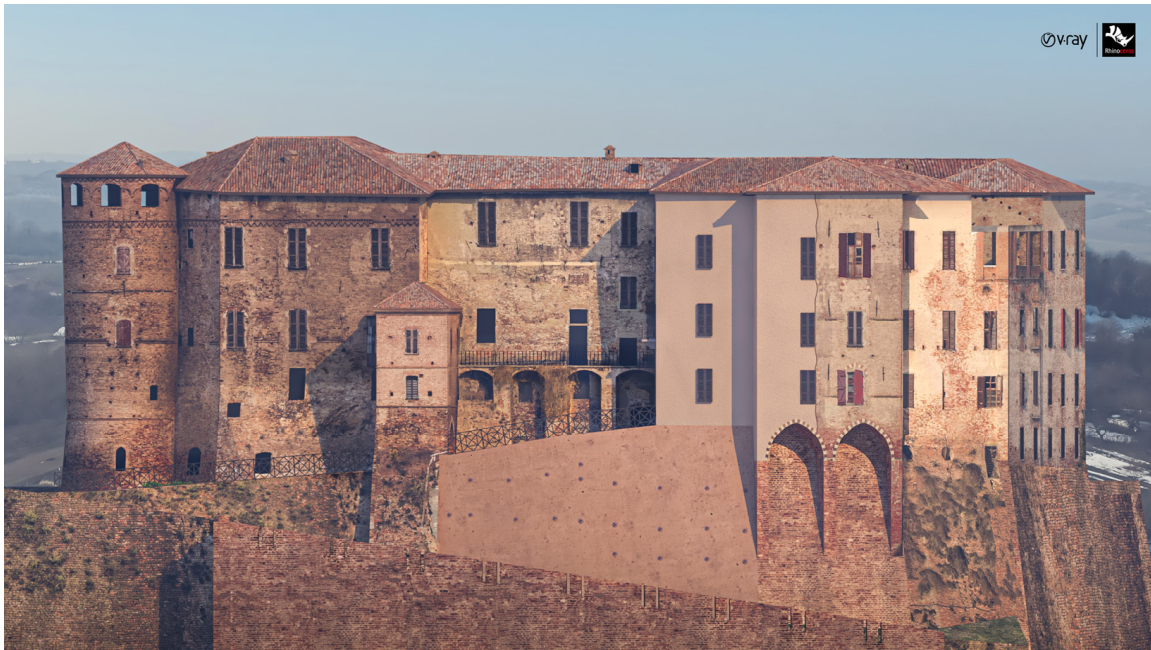
Figure 26. The 3D-rendered model proposed for reconstructing the collapsed area: modelled with Rhinoceros and V-Ray. South front of the castle.

The fourth and last phase of the NURBS modelling is the proposed hypothetical reconstruction of the collapsed area on the south side. The collapsed parts concern the main entrance, including the first and second floors and the pointed arches that support half of the forepart. These parts were remodelled starting from the previous model. The walls, the openings, the original balcony, and the forepart with the pointed arch were modelled using NURBS surfaces following photographic references related to the pre-2014

situation. Textural and material information were then applied to the model. The final result of the proposed reconstruction was rendered using the V-Ray engine [32] to support the restoration project carried out by the municipality of Frinco, local engineering studies, and cultural heritage authorities (Figures 26 and 27). The municipality jointly decided on the proposed solution for reconstructing the collapsed area and the Superintendence (local authority).

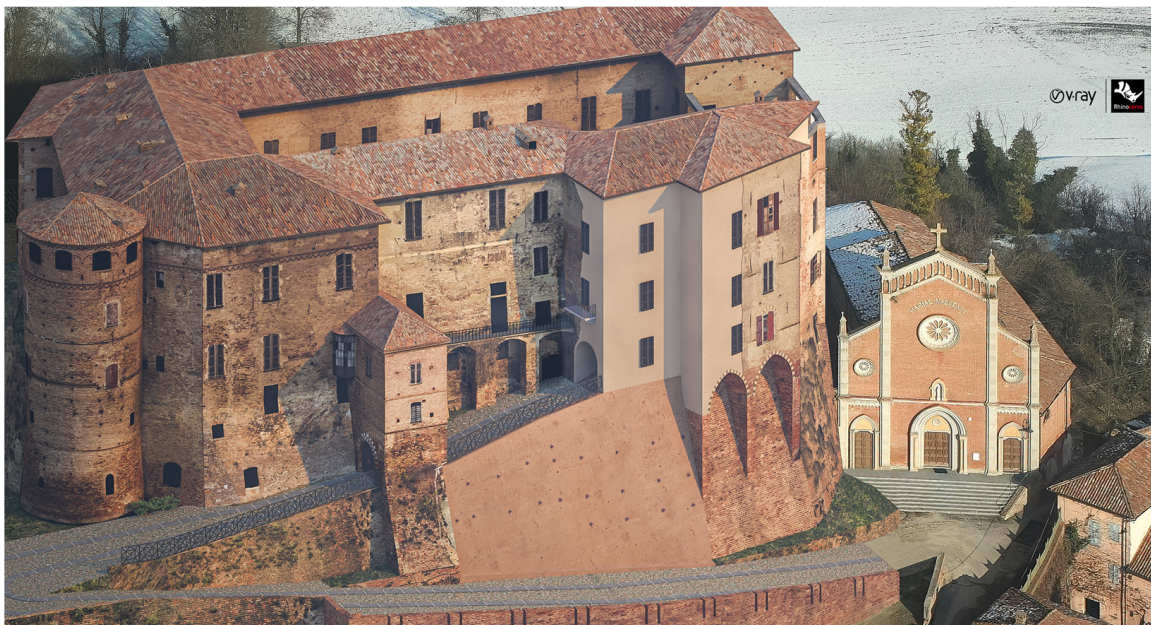
Figure 27. The 3D-rendered model proposed for reconstructing the collapsed area: modelled with Rhinoceros and V-Ray. Isometric view of the south front of the castle.

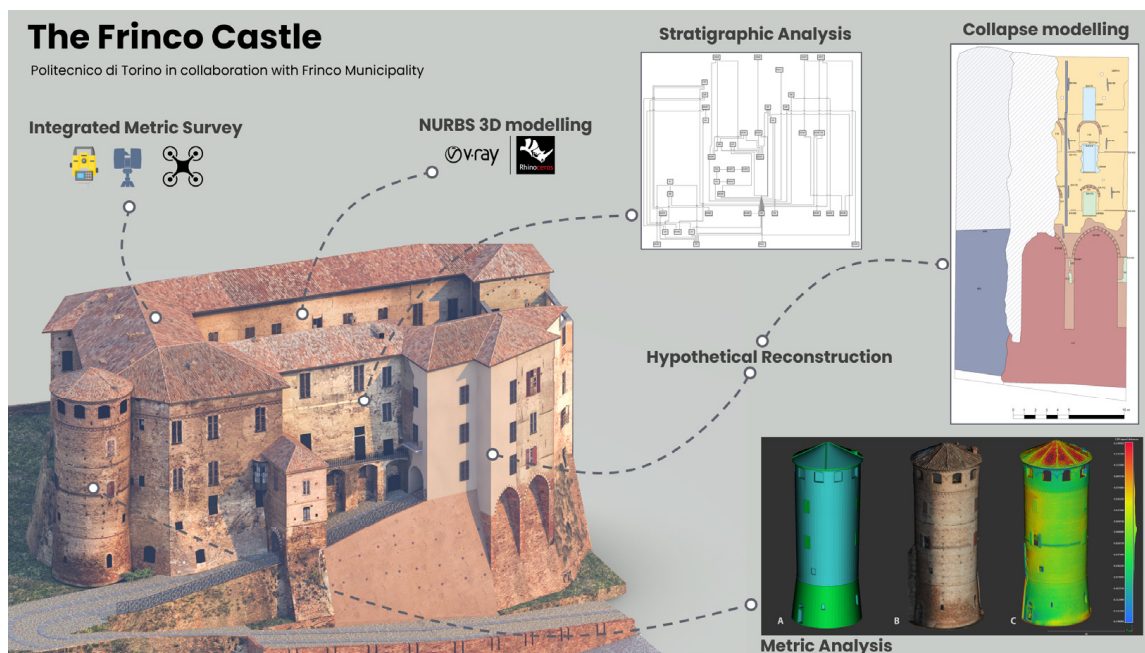
Figure 28. The Frinco Castle project: from the integrated survey to the NURBS modelling and metric analysis and from the stratigraphic analysis and the historical interpretation to the collapsed area reconstruction.

This project and the chosen workflow (Figure 28) were essential in different aspects. The geodetic survey returned a complete, highly accurate control network and 3D documentation. In this regard, integrating different instruments and techniques (from the Trimble Station to the aerial survey) permitted the acquisition of the castle's entire morphology (also hidden areas). For restoration purposes, the performed survey was essential for having metric support (and digital backup) to reconstruct the collapsed area.
