Garisenda Tower in Bologna (Italy): health monitoring by different non-destructive testing techniques

Garisenda Tower in Bologna (Italy): Health monitoring by different nondestructive testing techniques

Abstract. In the medieval Garisenda Tower in Bologna, several nondestructive testing (NDT) techniques are being used to examine structural damage and cracking evolution. The acoustic emission (AE) activity emerging from the monitored masonry structures of the tower is analyzed and related to surrounding temperature and strain measurements by distributed fiber optic sensors (FOSs). A seismometer was used to monitor low-frequency vibrations propagating across the ground-building foundation interface in order to examine the impact of local seismic activity or heavy vehicle traffic on tower vibration. The analysis of the monitoring results has led to the identification of several sources of AE activity, which apparently indicates the existence of an evolving cracking pattern. The correlation between AE activity and FOS strain measurements has revealed that the largest AE rate is observed during the wall contraction phases of tower cell, in a strain interval between -0.15 mm/m and -0.2

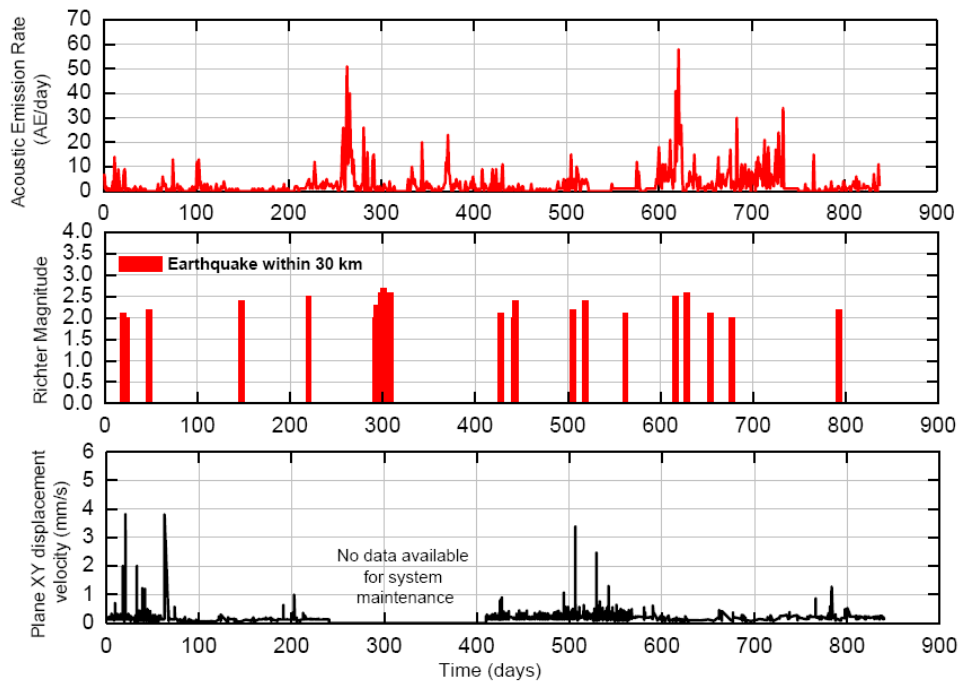
Figure 6: Rate trend of the AE signals during the entire monitoring period (up). Number of earthquakes, represented by their magnitude on the Richter scale, having their epicenters detected within a radius of 30 km from the city center of Bologna (middle). Speed of the transversal oscillations of the tower obtained by the seismometer (down).

As regards the other environmental actions on the tower, in the graphs of Figure 6 are compared the trend in the rate of the AE signals received by all the sensors during the entire monitoring period, the number of earthquakes, represented by their magnitude on the Richter scale, having their epicenters detected within a radius of 30 km from the city center of Bologna, as well as the speed of the transversal oscillations of the tower obtained by the seismometer. The earthquakes have been obtained from the web-site of the Italian National Institute of Geophysics and Volcanology (INGV)

The graph shows how there may be a correlation between the rate of the AE signals, which shows a significant increase in the initial days of monitoring, and the occurrence of two earthquakes with a magnitude close to 2.0 on the Richter scale. This correlation is also proven by the rather high values of the transverse displacement speed of the tower cell measured by the seismometer in the same period. On the other hand, around 250 days from the start of monitoring, although the rate of the AE signals presents a clear peak, no concomitant earthquakes appear. Unfortunately, in this case, the effects on the tower of the seismic action cannot be proven by the measurement of the displacement speed obtained by the seismometer, as the data in this period are not available due to system maintenance. The last peak of the AE signals occurs around 610 days from the monitoring start. Although in this case there are two concomitant earthquakes with a magnitude close to 2.5 on the Richter scale, but their effects on the tower are not proven by the increase in displacement speeds, which are almost null.
