Garisenda Tower in Bologna (Italy): Health monitoring by different nondestructive testing techniques

Abstract. In the medieval Garisenda Tower in Bologna, several nondestructive testing (NDT) techniques are being used to examine structural damage and cracking evolution. The acoustic emission (AE) activity emerging from the monitored masonry structures of the tower is analyzed and related to surrounding temperature and strain measurements by distributed fiber optic sensors (FOSs). A seismometer was used to monitor low-frequency vibrations propagating across the ground-building foundation interface in order to examine the impact of local seismic activity or heavy vehicle traffic on tower vibration. The analysis of the monitoring results has led to the identification of several sources of AE activity, which apparently indicates the existence of an evolving cracking pattern. The correlation between AE activity and FOS strain measurements has revealed that the largest AE rate is observed during the wall contraction phases of tower cell, in a strain interval between -0.15 mm/m and -0.20 mm/m, observed in a local temperature range from 5.0 to 12.0 °C. Finally, no apparent correlations of

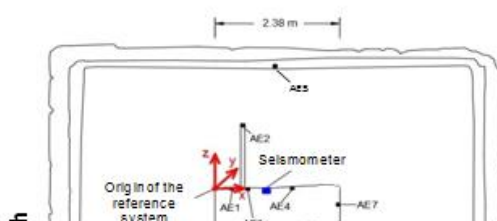
The experimental result analysis revealed several sources of AE activity, identified by a dedicated program of AE sources localization [11], implying the existence of an evolving cracking pattern. Figure 2 shows the plan of the tower cell at a height of two meters from the ground, with the AE sensors and the seismometer arrangement. In the same figure an axonometry with the representation of the AE sensors positions and the distribution of the AE sources localized along the walls in the South-East corner of cell are reported.

Figure 2: Plan of the tower with the origin of the Cartesian reference, for the arrangement of the AE sensors and the seismometer (up). Representation of the AE sensors positions in axonometry (down left). AE sources distribution along the South-East walls of the tower. The larger dots indicate overlapping acoustic sources. The points represented in blue were located from the 290th to the 450th day of monitoring in the masonry depth of the tower. The localization of other points from 450th day onwards is still in progress (down right).

The cell masonry of the tower has an overall thickness of about 275 cm (see Figure 2) and, starting from the inside of the cell, is composed of a depth of about 40 cm of selenite (a particular variety of crystalline gypsum) block masonry, a filling of heterogeneous "a sacco" masonry of about 150 cm, and about 80 cm of selenite blocks on the outside, including the ashlar coating. Therefore, the damage detected in the periods of contraction may be due to a phenomenon of differential deformation between the elements of selenite which are placed towards the cell compared to those of "a sacco" masonry. The latter, due to the thermal inertia of the materials, are subjected to less thermal oscillations and therefore undergo less marked deformations. This temperature gradient could induce shear stresses between the selenite blocks and the chaotic "a sacco" masonry capable of generating AE signals. As a result, a fatigue phenomenon caused by seasonal temperature changes would occur, slowly damaging the tower.

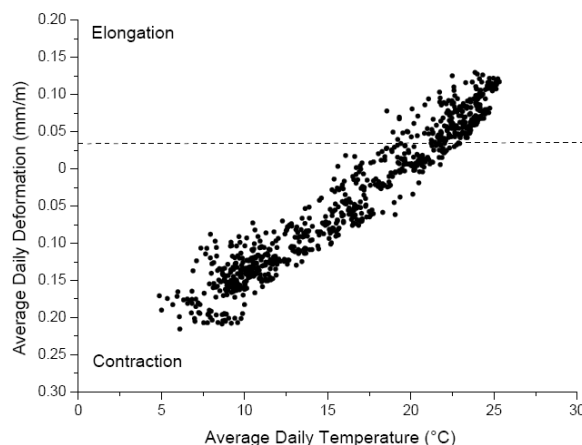
During the monitoring time FOS and temperature measurements revealed a fairly good correlation between wall deformations and tower internal temperature, with the largest contractions occurring at about 6.0 °C and the largest expansions occurring at 25.0 °C. See Figure 3 in which a graph showing the daily deformations, obtained by averaging the data recorded on the 6 optical strands, is reported as a function of the average daily temperature measured inside the tower cell.

Figure 3: Correlation between walls average vertical deformations measured by FOS and tower internal temperature.

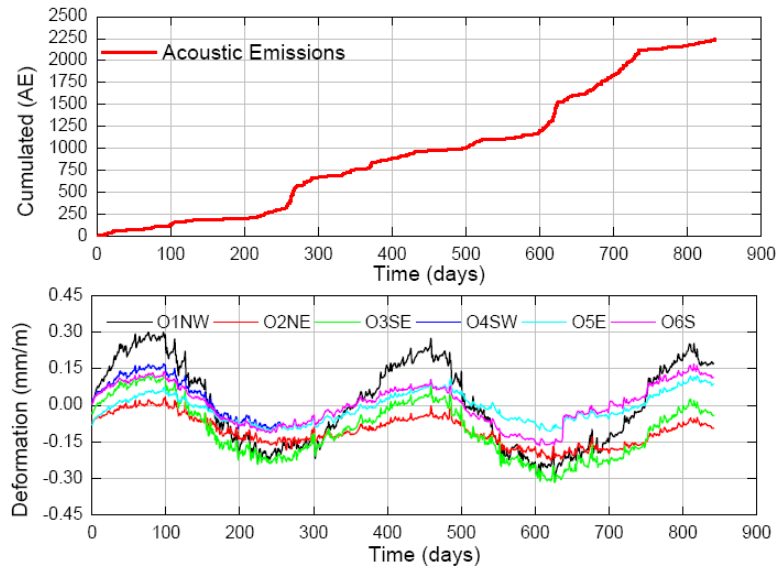
In addition, Figure 4 shows the growth of the AE signals cumulated function, obtained from all the transducers during the monitoring time, with the trend of the daily strains measured by means of the 6 optical strands. Observing the chart of the deformations trend, it can be seen that the minimum values of the contraction deformations are attributable to the optical strand O5E which is arranged in the South-East corner of the tower cell, while the maximum values of the expansion deformations are attributable to the optical strand O1NW arranged in the North-West corner. By relating the AE signals cumulative chart to that of the deformation trend, it can be seen that the maximum increases

of the AE signals are obtained in relation to the minimum values of the masonry walls contractions, i.e. around 240 days (January 25th, 2020) and 607 days (January 26th, 2021) from the start of monitoring.

Figure 4: Trend of the cumulate function of the AE signals recorded by the 8 sensors (up), and daily deformations measured by means of the 6 optical strands (down).

However, the continued growth of the cumulated function of AE signals during the monitoring period (Fig. 4), demonstrates that there are other effects besides those of thermal variations that produce damage to the tower. In many circumstances, the dead load, which could be very large in massive monumental buildings, is a major factor in the formation of the fracture patterns [12]. In this case, the inclination of the tower towards the side where the AE sensors have been applied can generate high stresses near the limit of the crack formation in the masonry. Therefore, the time-dependent creep behavior of the material under dead load and its interaction with fatigue due to thermal variations can be identified as the cause of damage.

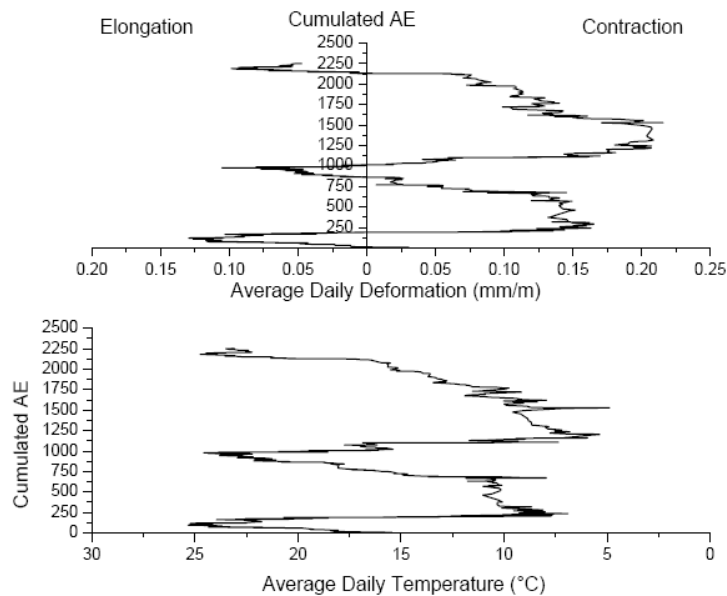
To better highlight this phenomenon, the correlation chart between the cumulated AE activity and FOS average daily deformations, as well as that between the cumulated AE activity and average daily temperature, are shown in Figure 5.

Figure 5: Correlation between cumulated AE activity vs FOS average daily deformations (up), and cumulated AE activity vs average daily temperature (down).

They reveal that the largest increases in AE signals is observed during wall contraction phases, in a strain interval near -0.15 mm/m or near -0.20 mm/m. This phenomenon is observed in a temperature range between 5.0 and 12.0 °C . This means that the tower at the cell level is damaged mainly in the winter season when the temperatures inside the cell are minimal and the masonry contracts after expanding in the hottest season, while in the other phases there is a trend characterized by a steady growth of AE signals but without apparent discontinuities or sudden jumps.

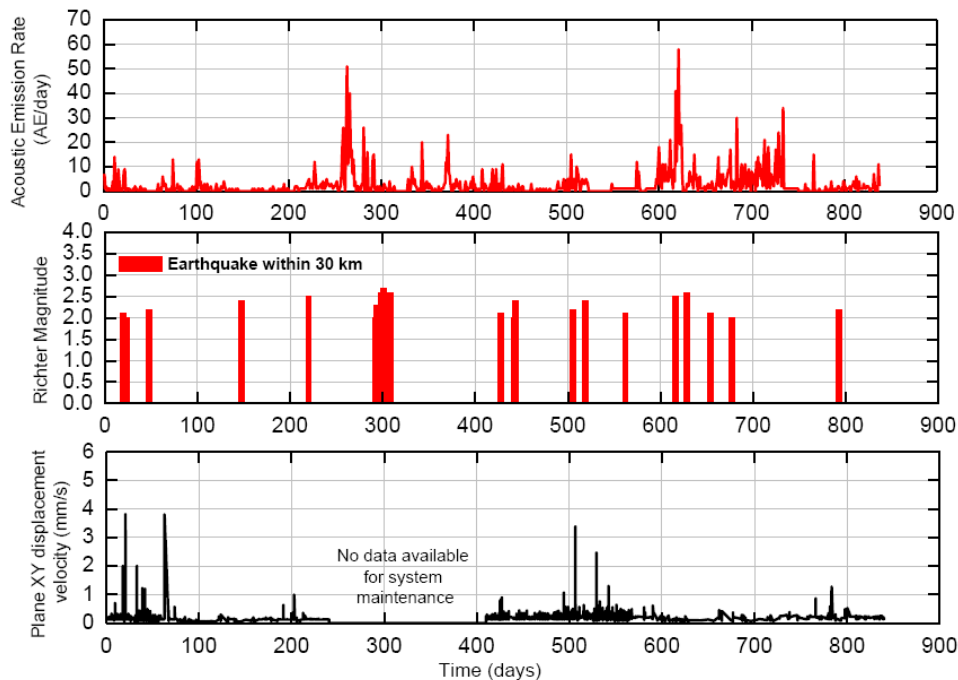
Figure 6: Rate trend of the AE signals during the entire monitoring period (up). Number of earthquakes, represented by their magnitude on the Richter scale, having their epicenters detected within a radius of 30 km from the city center of Bologna (middle). Speed of the transversal oscillations of the tower obtained by the seismometer (down).

As regards the other environmental actions on the tower, in the graphs of Figure 6 are compared the trend in the rate of the AE signals received by all the sensors during the entire monitoring period, the number of earthquakes, represented by their magnitude on the Richter scale, having their epicenters detected within a radius of 30 km from the city center of Bologna, as well as the speed of the transversal oscillations of the tower obtained by the seismometer. The earthquakes have been obtained from the web-site of the Italian National Institute of Geophysics and Volcanology (INGV)

The graph shows how there may be a correlation between the rate of the AE signals, which shows a significant increase in the initial days of monitoring, and the occurrence of two earthquakes with a magnitude close to 2.0 on the Richter scale. This correlation is also proven by the rather high values of the transverse displacement speed of the tower cell measured by the seismometer in the same period. On the other hand, around 250 days from the start of monitoring, although the rate of the AE signals presents a clear peak, no concomitant earthquakes appear. Unfortunately, in this case, the effects on the tower of the seismic action cannot be proven by the measurement of the displacement speed obtained by the seismometer, as the data in this period are not available due to system maintenance. The last peak of the AE signals occurs around 610 days from the monitoring start. Although in this case there are two concomitant earthquakes with a magnitude close to 2.5 on the Richter scale, but their effects on the tower are not proven by the increase in displacement speeds, which are almost null.

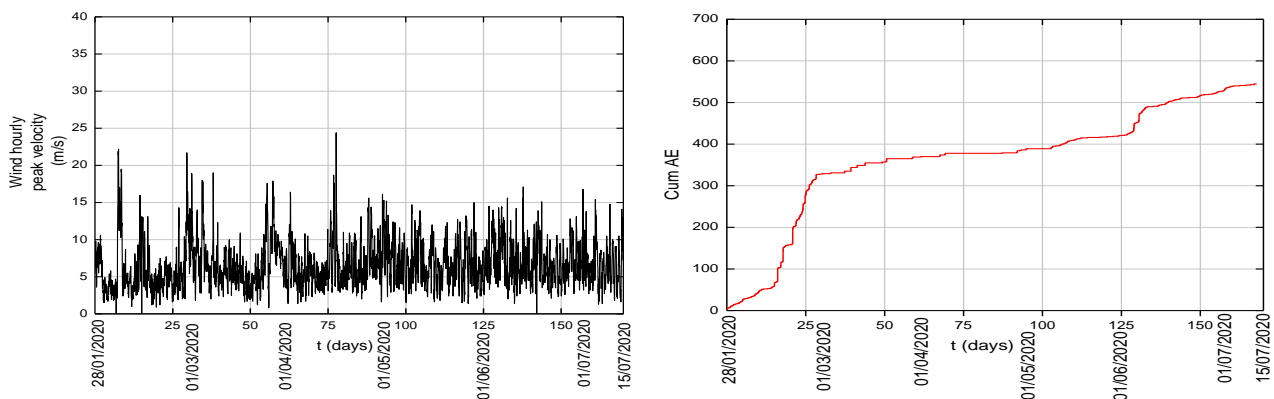
Concerning the actions of the wind on the tower, by way of example, in the graph of Figure 7 the hourly peak wind speed in m/s, recorded in the city of Bologna, is related to the cumulative function of the AE signals in the period from January 28th, 2020 to July,15th 2020, i.e., from 242 to 411 days from the start of monitoring. From the graph, it can be seen that wind and AE signals are not correlated, as the peaks in wind speeds do not correspond to simultaneous increases in the AE signals cumulated function.

Figure 7: Hourly peak wind speed in m/s, recorded in the city of Bologna (left), and cumulative function of the AE signals in the period of 242 to 411 days from the start of monitoring (right).
