Garisenda Tower in Bologna (Italy): health monitoring by different non-destructive testing techniques

Garisenda Tower in Bologna (Italy): Health monitoring by different nondestructive testing techniques

Keywords: Non-destructive techniques, Acoustic Emission, Fiber Optic Sensors, Seismicity, Medieval towers.

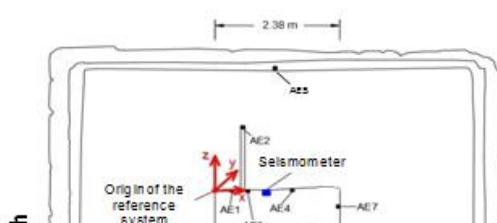
The experimental result analysis revealed several sources of AE activity, identified by a dedicated program of AE sources localization [11], implying the existence of an evolving cracking pattern. Figure 2 shows the plan of the tower cell at a height of two meters from the ground, with the AE sensors and the seismometer arrangement. In the same figure an axonometry with the representation of the AE sensors positions and the distribution of the AE sources localized along the walls in the South-East corner of cell are reported.

Figure 2: Plan of the tower with the origin of the Cartesian reference, for the arrangement of the AE sensors and the seismometer (up). Representation of the AE sensors positions in axonometry (down left). AE sources distribution along the South-East walls of the tower. The larger dots indicate overlapping acoustic sources. The points represented in blue were located from the 290th to the 450th day of monitoring in the masonry depth of the tower. The localization of other points from 450th day onwards is still in progress (down right).

The cell masonry of the tower has an overall thickness of about 275 cm (see Figure 2) and, starting from the inside of the cell, is composed of a depth of about 40 cm of selenite (a particular variety of crystalline gypsum) block masonry, a filling of heterogeneous "a sacco" masonry of about 150 cm, and about 80 cm of selenite blocks on the outside, including the ashlar coating. Therefore, the damage detected in the periods of contraction may be due to a phenomenon of differential deformation between the elements of selenite which are placed towards the cell compared to those of "a sacco" masonry. The latter, due to the thermal inertia of the materials, are subjected to less thermal oscillations and therefore undergo less marked deformations. This temperature gradient could induce shear stresses between the selenite blocks and the chaotic "a sacco" masonry capable of generating AE signals. As a result, a fatigue phenomenon caused by seasonal temperature changes would occur, slowly damaging the tower.

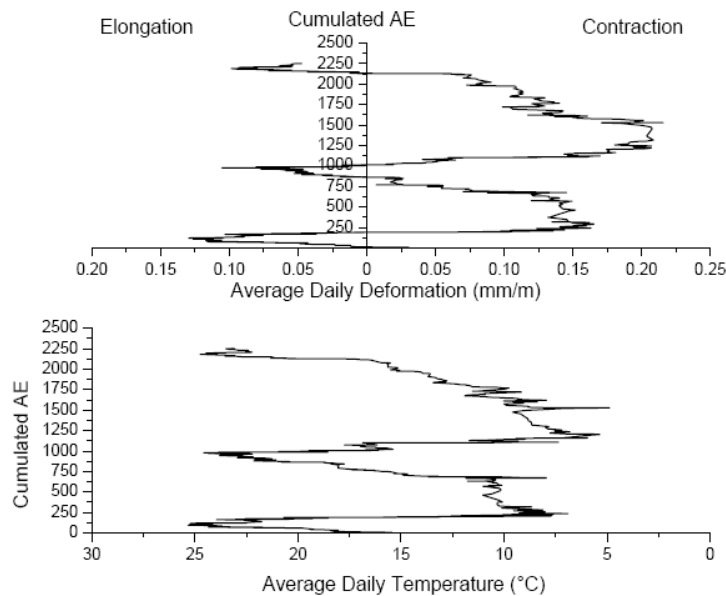
To better highlight this phenomenon, the correlation chart between the cumulated AE activity and FOS average daily deformations, as well as that between the cumulated AE activity and average daily temperature, are shown in Figure 5.

Figure 5: Correlation between cumulated AE activity vs FOS average daily deformations (up), and cumulated AE activity vs average daily temperature (down).

They reveal that the largest increases in AE signals is observed during wall contraction phases, in a strain interval near -0.15 mm/m or near -0.20 mm/m. This phenomenon is observed in a temperature range between 5.0 and 12.0 °C . This means that the tower at the cell level is damaged mainly in the winter season when the temperatures inside the cell are minimal and the masonry contracts after expanding in the hottest season, while in the other phases there is a trend characterized by a steady growth of AE signals but without apparent discontinuities or sudden jumps.
