RESTORATION OF A LANDMARK BALANCED CANTILEVER BRIDGE CONSIDERING DIFFERENT RESILIENCE AND SUSTAINABILITY STRATEGIES

Marco Domaneschi¹, Stergios A. Mitoulis², Raffaele Cucuzza¹, Valentina Villa¹ and Roberta Di Bari³, Gopika Siva²

Keywords: bridge, sustainability, resilience, cost-effectiveness.

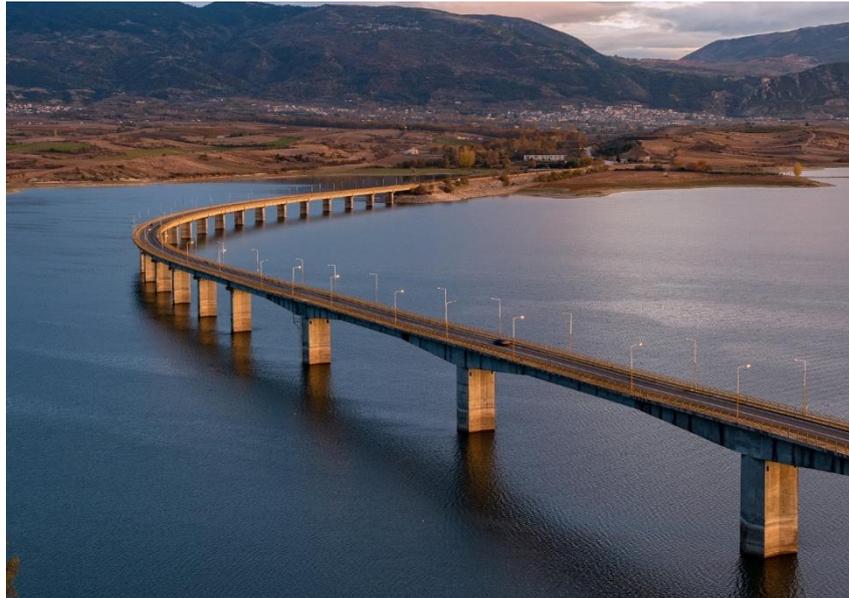
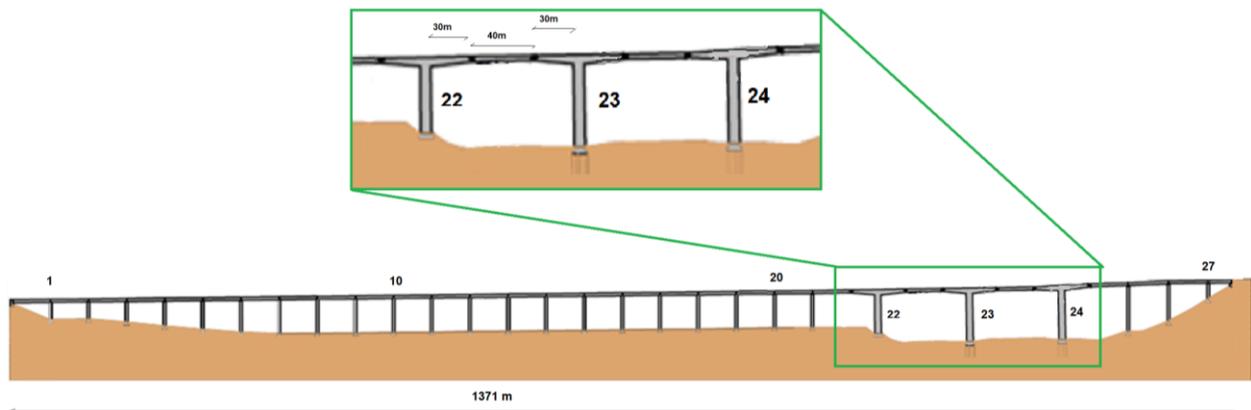
The Polyfytos bridge is an asset built in 1975 in the Municipality of Western Macedonia, Kozani, Greece and bridges the artificial homonymous lake of Polyfytos, with the local and the national road network relying entirely on its integrity. The balanced cantilever method was used to build a part of the bridge, specifically six cantilevers spanning from piers 22, 23 and 24 (Fig.1) accounting for a total of 260 meters (total length of the bridge is 1372 m).

Figure 1: Bridge layout.

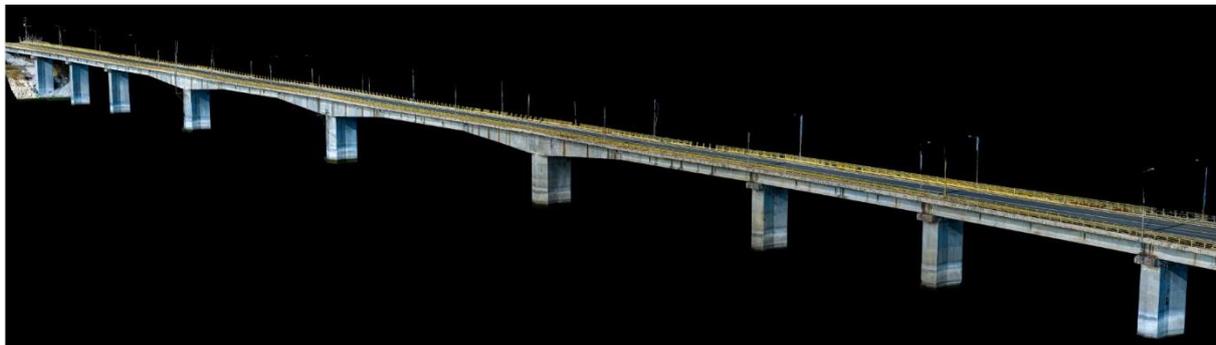
Located in the North-West part of the country, the Polyfytos bridge held the record for the largest overall length in Greece at the time of its construction, only surpassed by the Rio-An-tirrio bridge almost 35 years later. The part of the bridge under interrogation consists of 3 segmentally constructed balanced cantilever sets, extending 30 meters either side of the abutments. Neighbouring cantilevers are connected by 40m long precast members forming an overall span of 100m (Fig. 1). The geometry and individual sizes of the segments were measured in the original drawings and verified on a point cloud model (Fig. 2).

Figure 1: Point cloud model.

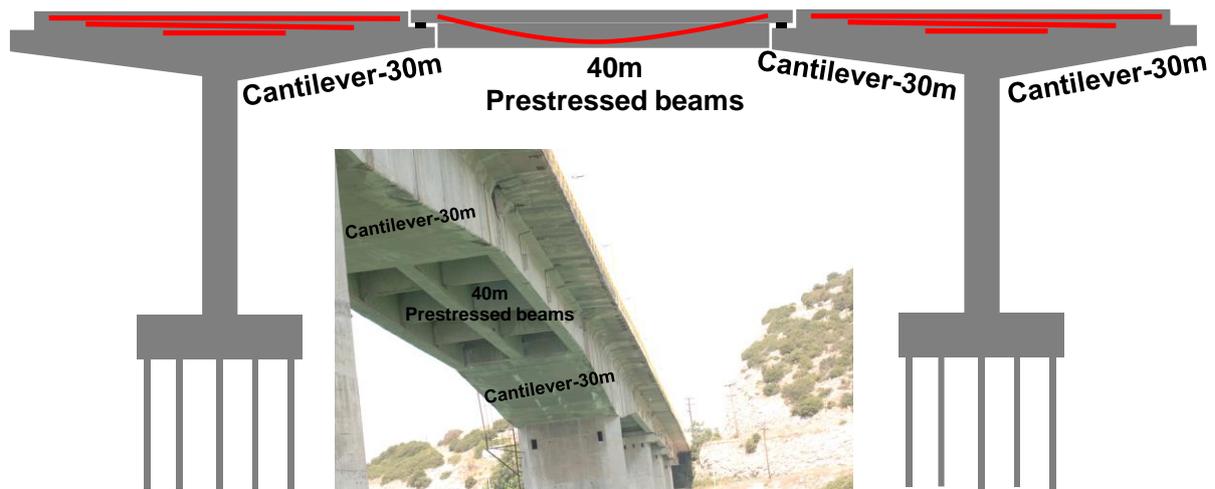
Prestressing concrete technique has been used in both the cantilever and precast beams (Fig. 3). The current view of the bridge deck with the original configuration of the prestressing cables in the cantilever beams and the precast beams between the half-joints is also depicted in Figure 3. Besides, Figure 4 reports the scheme of the current configuration of the bridge after about 50 years of in-service conditions. It can be seen that the failures of the brackets due to long-term material effects and the progression of prestressing cables in particular induced differential failures of the central beam between the half-joints. However, due to the property of the simply supported central beam, no additional coercive stresses developed.

Figure 3: Schematic (not true) configuration with prestressing cables (red lines) and the actual view of the deck between Piers 23-24.

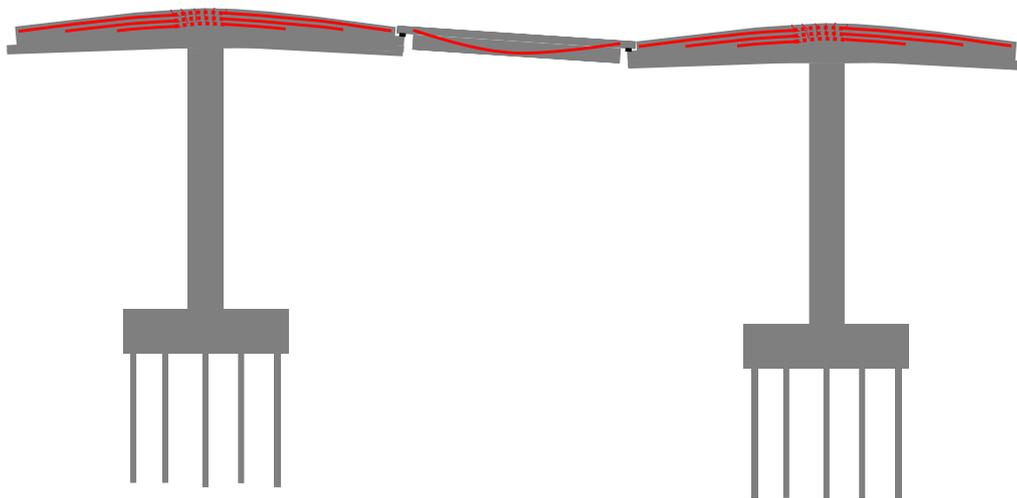
Figure 4: Current deteriorated condition of the cantilevers of the bridge after 48 years of service. The sketch shows the corrosion of the tendons above the piers (hypothesis based on extensive cracking observed on the locations) and the deflection of the deck (measured on a point cloud).

Herein, corrosion was assumed to be the main source of deterioration for the investigated bridge essentially disregarding additional failure mechanisms that might contribute (e.g. scouring, spalling of the reinforced concrete). In fact, when a strand is exposed to moisture its exposed interface becomes particularly prone to corrosion induced damages. Of particular concern is the so-called "localized corrosion" that could lead to substantial local reductions in the cross section of the strand and consequently to severe reductions of its tension capacity. Each strand could have (a) corroded and uncorroded wires within the same section and (b) corroded and uncorroded parts across its length.

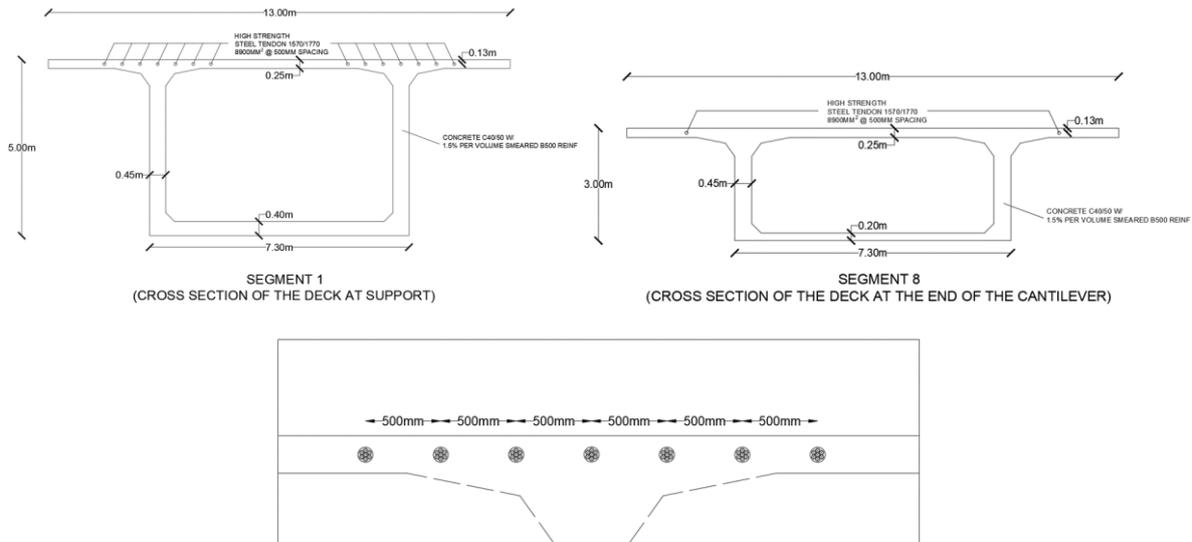
The part of the bridge under interrogation consists of 3 segmentally constructed balanced cantilever sets, extending 30 meters either side of the abutments. Neighboring cantilevers are connected by 40m long precast members forming an overall span of 100m. The geometry and individual sizes of the segments were measured in the original drawings and verified on a point cloud model. The position and trajectory of the prestressing tendons was not mentioned in the drawings so they were modelled according to standard practice of balance cantilever construction (all tendons on top flange of segment). Figure 5 depicts some critical cross sections of the cantilevers and details.

Figure 5: critical cross sections of the cantilevers and details.

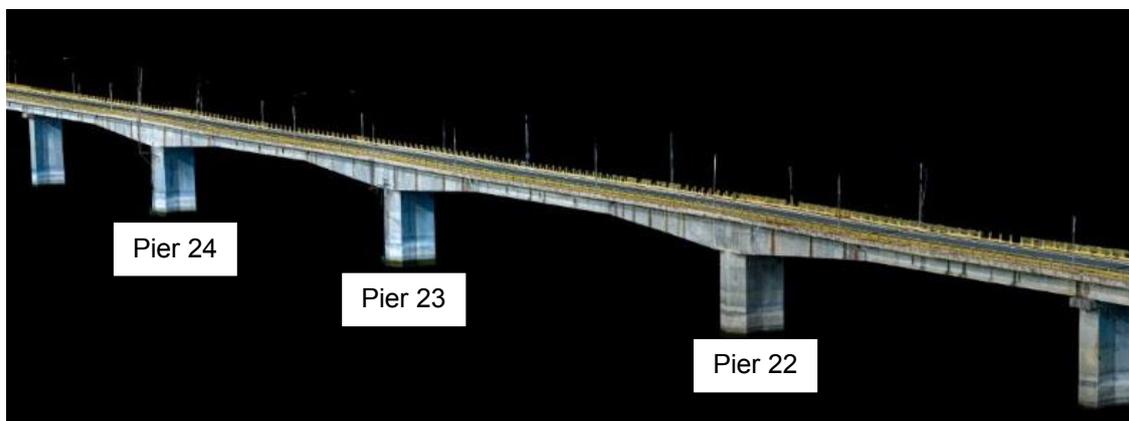
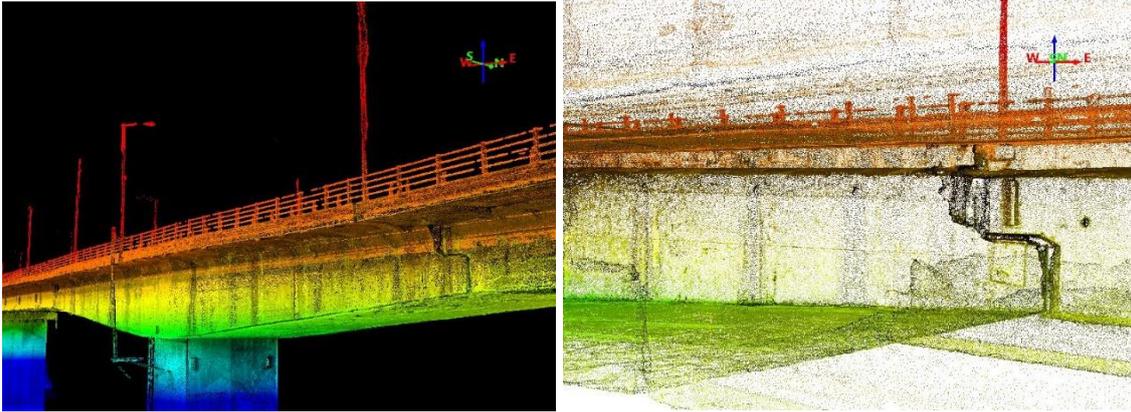
The point cloud of the bridge with some details of the cantilever and the half-joint is depicted in Figure 6. The deflection of the most critical cantilever of the bridge is reported in Figure 7, where the dashed line is the expected elevation, while the solid line is the measured position, i.e. 133mm and 207mm lower than the expected. Such deflections are the cantilever displacements downward at the tip (end) of the most critical cantilever.

Figure 6: point cloud.

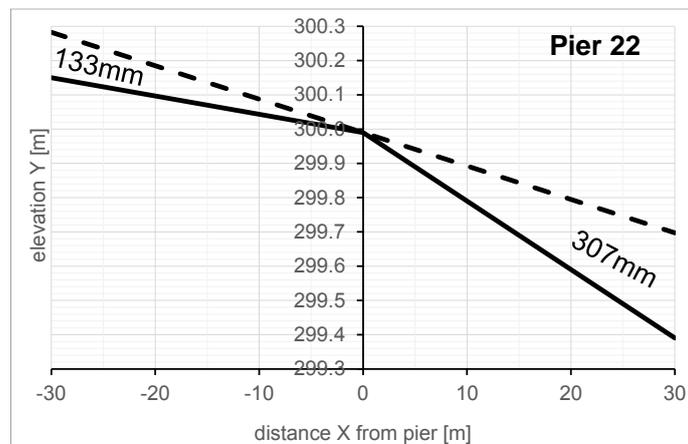
Figure 7: Measured deflection of the critical cantilever. Dashed line shows the hypothetical original elevation. Solid lines show the measured deflected cantilevers.

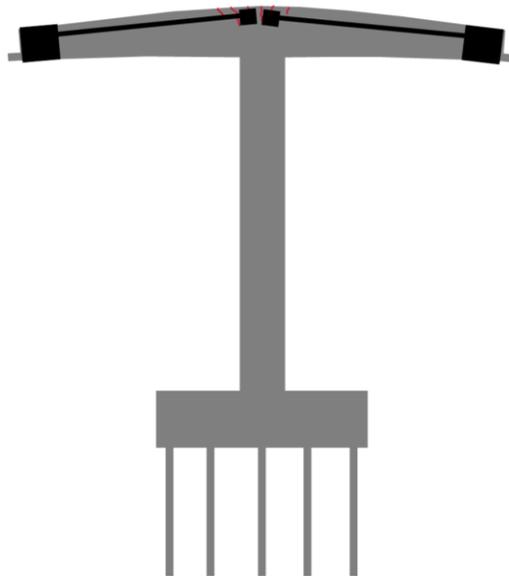
- g) Realization of all functional facilities like road signs, safety barriers, etc;
- h) External prestressing system realized by the addition of 4 cables along each cantilever in order to restore the original deflection. At this design stage, additional cables are supposed to be of the same section of that one recognized in the technical drawings. Moreover, the level of compression stress introduced into the system should be designed aiming to avoid cracking as depicted in Figure 8.

Figure 8: Scheme of prestressing system

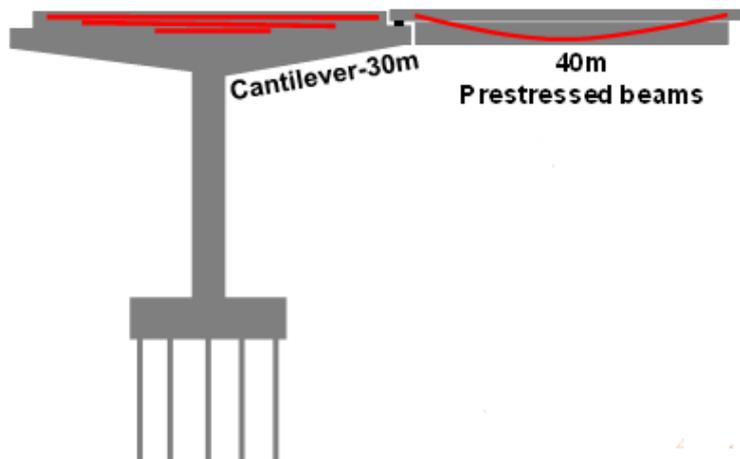
The costs associated to each scenario have been evaluated by using the Italian price lists provided by ANAS S.p.A [26], with the exception of the prestressing system assessment for which the authors adopted the parametric cost pointed out by [27]. Though price list may change from one country to another, although not drastically within the European community, authors focused mainly on the comparisons between different retrofitting scenarios. Aiming to realize a comparison between the 2 scenarios, the authors selected a module of the bridge for which all the operations have been evaluated from an economical point of view (see Figure 9). The final amount of the estimations for each scenario is referred to the adopted module, hence, the cost of the overall intervention can be easily derived.

Figure 9: Module of the bridge considered for the cost evaluation
