# Failure and Damage of Reciprocating Lip Seals for Pneumatic Cylinders in Dry Conditions

Luigi Mazza \* and Edoardo Goti

Department of Mechanical and Aerospace Engineering, Politecnico di Torino, Corso Duca degli Abruzzi 24, 10129 Torino, Italy; edoardo.goti@polito.it

**Abstract:** Lip seals are components subjected to high mechanical stress and they are responsible for many out-of-service in pneumatic cylinders. The aim of this work is the development of an experimental methodology to evaluate lifetime duration and analyse failures and damages of rod lip seals for pneumatic cylinders. A dedicated test bench was designed and manufactured which reproduces actual working conditions of the seals i.e., compressed air action (seal pressurisation) and relative linear reciprocating motion. Three types of seals made of two elastomers (NBR and polyurethane) were tested; dry condition was considered to speed up the tests. The influence of geometric parameters like seal seat dimension and seal axis misalignment with respect to the rod axis, was analysed by multiple experimental tests. Results in terms of seal life duration and failure modes are presented which allow comparison of seals pe

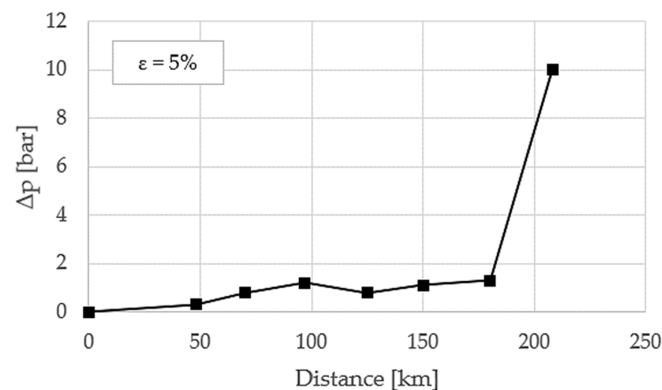
The reciprocating linear movement of the rod of the test bench is obtained by connecting the rod to a pneumatic cylinder with a stroke of 500 mm, controlled by a 5/2 two-stable positions electro valve. The distance travelled by the rod is recorded, and tests are carried out until the seals mounted in the test chamber are no longer able to guarantee their sealing function; this distance expresses the lifetime of the seals under the considered test conditions. To this aim, the movement of the rod was periodically interrupted, and leakages (through the seals) were assessed by measuring the pressure drop in the inner test chamber between the seals. The chamber is filled to the initial pressure of 10 bar (relative value), and after 1 h, the pressure decrease  $\Delta p$  is read. Leakage test is carried out even before starting the tests to check for leakages due to mounting eccentricity. Seals are considered out of service when the pressure drop  $\Delta p$  is equal to 10 bar, which corresponds to the complete emptying of the chamber down to the ambient pressure. Figure 5 shows an example of a leakage test. The pressure drop to failure is usually recorded as a peak after an extended period of run where pressure drop increases slowly; during this period, a variable behaviour is detected even with possible recovery of sealing capability. Then, close to failure, the sealing capability is usually lost abruptly.

**Figure 5.** A typical leakage test repeated across the duration of an endurance test.

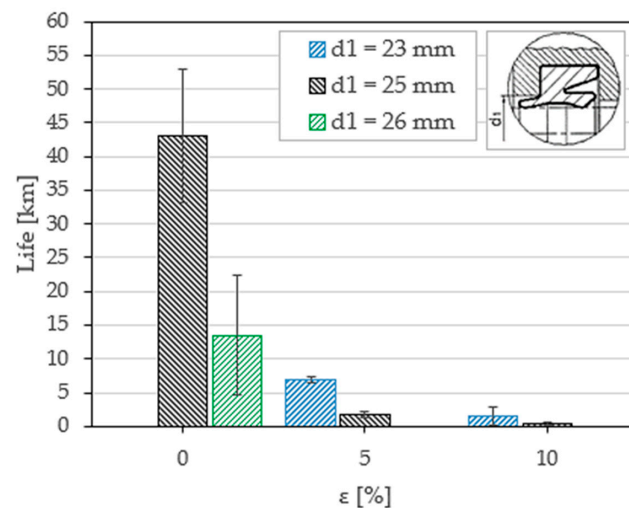
Figure 7 shows how the life of lip A1 seals is affected by the eccentricity  $e$  and the diameter  $d_1$  of the shoulder. The performance decreases significantly as the magnitude of both parameters increases. In general, this type of seal is not able to operate properly if its seat is machined differently with respect to the nominal dimension suggested by the seal manufacturer, and it poorly withstands lopsided radial forces. Failure mode I is the dominant mode when eccentricity is high and diameter  $d_1$  is close to its nominal value, whereas mode II dominates as the shoulder diameter is increased, whatever the eccentricity value.

**Figure 7.** Lifetime for seal type A1 due to increased eccentricity and increased diameter  $d_1$  of the seat shoulder.

The results of Figure 7 predicted that the lifetime duration with null eccentricity and a nominal value of diameter  $d_1$  could be very long (test time of several weeks). Being this an overly long time for a large set of experimental tests, as here considered in this study, the condition  $d_1 = 23$  mm and  $e = 0$  mm were not investigated.

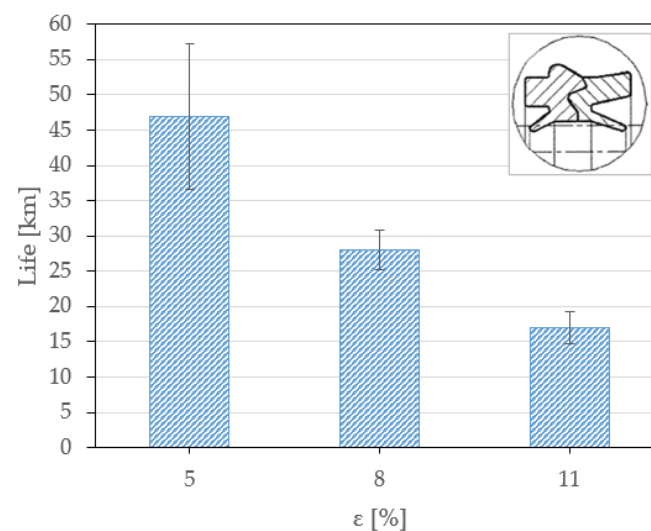
Figure 9 shows the estimated life of A3 seals. Compared with type A2, the life of these sealing elements is shorter when loaded through the same eccentricity value. Since A2 and A3 seals have the same geometry, the problem is related to materials. Polyurethane demonstrated its higher wear resistance with respect to NBR. Failure is typically from wear damages (failure mode III), where no case of seal extrusion was detected.

**Figure 9.** Lifetime for seal type A3 due to increased eccentricity.

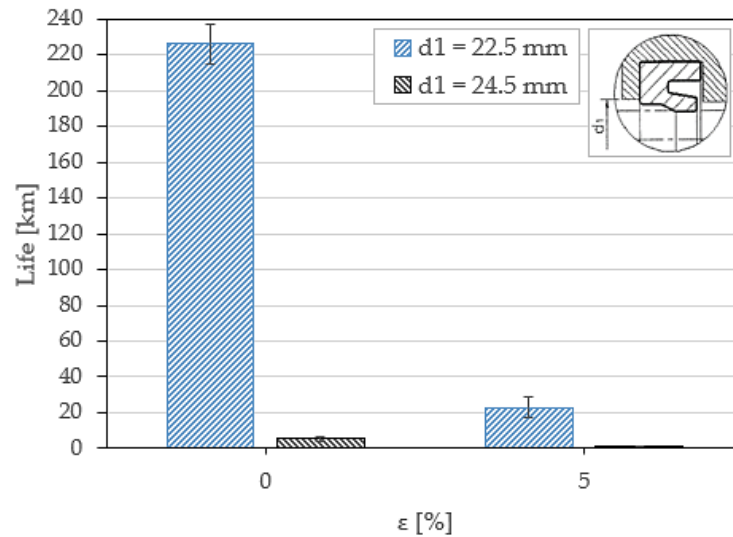
The estimated life of B1 seals is shown in Figure 10. Because B1 seals are the only ones without a rod scraper, a direct comparison with previous seal models is not possible. However, the service life of B1 seals is comparable to that of A1 seals, the latter having similar overall dimensions and the same material. As in the case of A1 seals, B1 showed an abrupt decrease in life with increased eccentricity.

**Figure 10.** Lifetime for seal type B1 due to increased eccentricity and increased diameter  $d_1$  of the seat shoulder.

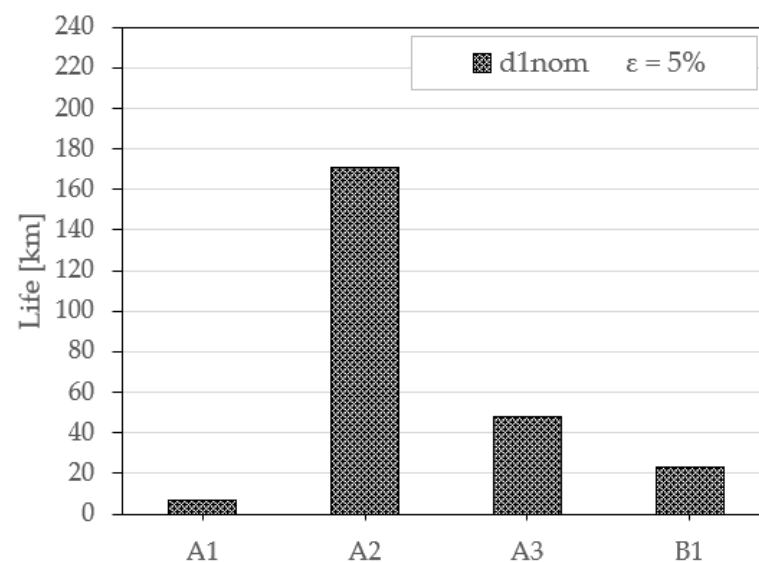
By way of comparison, Figure 11 shows the average experimental lifetime measured for seal types A1, A2, A3 and B1 when the shoulder diameter is the nominal value suggested by the seal manufacturer and the operational eccentricity during the tests is 5%.

**Figure 11.** Lifetime comparison with nominal value  $d_{1nom}$  of the shoulder and eccentricity of 5%.

A2 seals are the toughest, as they showed the highest wear resistance thanks to the high-performance material (EU) coupled with the increased mechanical strength against tearing and spirallisation provided by the stiffer cross-section. The key role of the material is highlighted in comparison with the A3 seals, whose average estimated life is three times lower than seal A2 while keeping the same cross-sectional geometry and overall dimensions.

The comparison between seals A3 and A1 indicates that the cross-sectional geometry plays a non-negligible role as well for the same material (NBR). The denser and squatter section of seal A3 positively affects the seal life, which is five times higher compared with A1 seals under a 5% eccentricity.

Among NBR seals, B1 seals also performed better than A1, and their life was, on average, 2.5 times higher under a 5% eccentricity and a nominal diameter of the shoulder. This effect is even larger if one compares the results obtained when the seal is retained by a nominal shoulder diameter  $d_{1,nom}$  and operated under null eccentricity, where the average life of seal B1 was approximately 5.5 times higher than seal A1 (see Figures 7 and 10). In other test conditions, e.g., null eccentricity and seat diameter larger than the nominal, the lifetimes are similar.
