Failure and Damage of Reciprocating Lip Seals for Pneumatic Cylinders in Dry Conditions

# Failure and Damage of Reciprocating Lip Seals for Pneumatic Cylinders in Dry Conditions

Luigi Mazza \* and Edoardo Goti

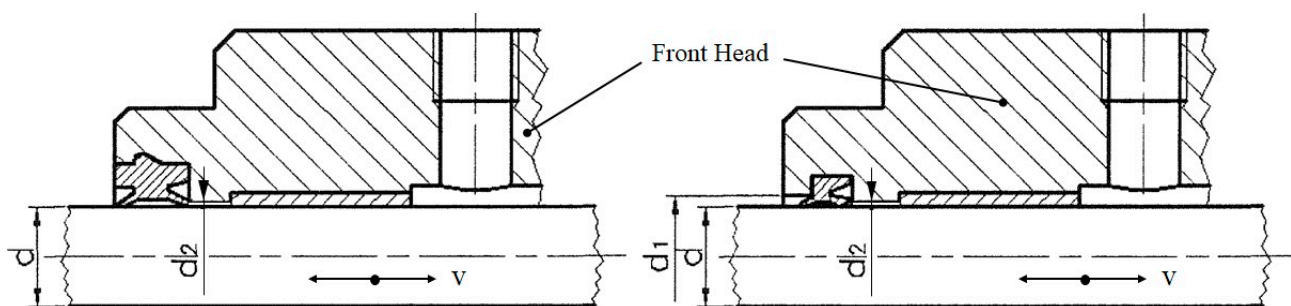
Figure 2 shows two mounting solutions of seals in the front head of a pneumatic cylinder: with fixing rubber ridge (left-side) and grooved seat (right side). For seals A2 and A3, the assembly is ensured by an annular ridge that matches a dedicated groove machined in the seat; the ridge constrains the seal axially, preventing it from coming out of

the seat during operation. Seals A1 and B1 rely on a grooved seat mounting. As known, the sealing mechanism relies on the elasticity and incompressibility of the elastomer and the existence of a mounting interference; indeed, this is allowed by the inner diameter  $d_i$  of the lip (Figure 1), which is smaller than the rod diameter  $d$  (Figures 1 and 2). Diameters  $d_1$  and  $d_2$  refer to the left-side and right-side axial shoulders of the seat. The sealed pressure is located on the right side of the front head in the front chamber of the pneumatic cylinder (not shown in Figure 2). As shown, the rod is animated by reciprocating motion, which involves seal and guide-bearing abrasion. This wear mechanism is responsible for an increasing gap between rod-guide mating surfaces, which appears as rod misalignment with subsequent degradation and failure of the seal.

**Figure 2.** Examples of the mounting of lip seals into its seat in a pneumatic cylinder, with open seat and fixing rubber ridge (left side) and grooved seat (right side).

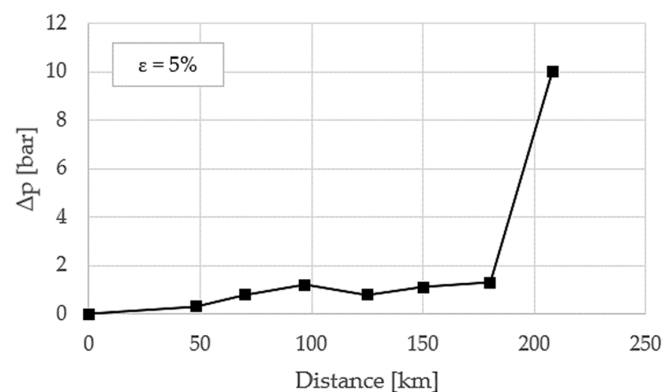
The reciprocating linear movement of the rod of the test bench is obtained by connecting the rod to a pneumatic cylinder with a stroke of 500 mm, controlled by a 5/2 two-stable positions electro valve. The distance travelled by the rod is recorded, and tests are carried out until the seals mounted in the test chamber are no longer able to guarantee their sealing function; this distance expresses the lifetime of the seals under the considered test conditions. To this aim, the movement of the rod was periodically interrupted, and leakages (through the seals) were assessed by measuring the pressure drop in the inner test chamber between the seals. The chamber is filled to the initial pressure of 10 bar (relative value), and after 1 h, the pressure decrease  $\Delta p$  is read. Leakage test is carried out even before starting the tests to check for leakages due to mounting eccentricity. Seals are considered out of service when the pressure drop  $\Delta p$  is equal to 10 bar, which corresponds to the complete emptying of the chamber down to the ambient pressure. Figure 5 shows an example of a leakage test. The pressure drop to failure is usually recorded as a peak after an extended period of run where pressure drop increases slowly; during this period, a variable behaviour is detected even with possible recovery of sealing capability. Then, close to failure, the sealing capability is usually lost abruptly.

**Figure 5.** A typical leakage test repeated across the duration of an endurance test.

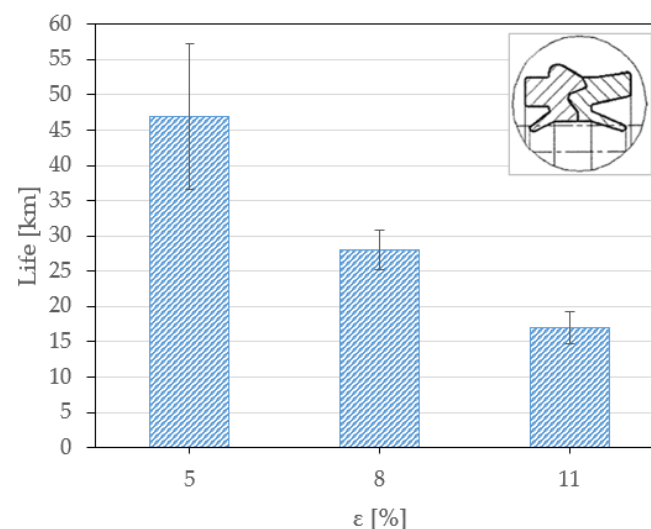
Figure 9 shows the estimated life of A3 seals. Compared with type A2, the life of these sealing elements is shorter when loaded through the same eccentricity value. Since A2 and A3 seals have the same geometry, the problem is related to materials. Polyurethane demonstrated its higher wear resistance with respect to NBR. Failure is typically from wear damages (failure mode III), where no case of seal extrusion was detected.

**Figure 9.** Lifetime for seal type A3 due to increased eccentricity.

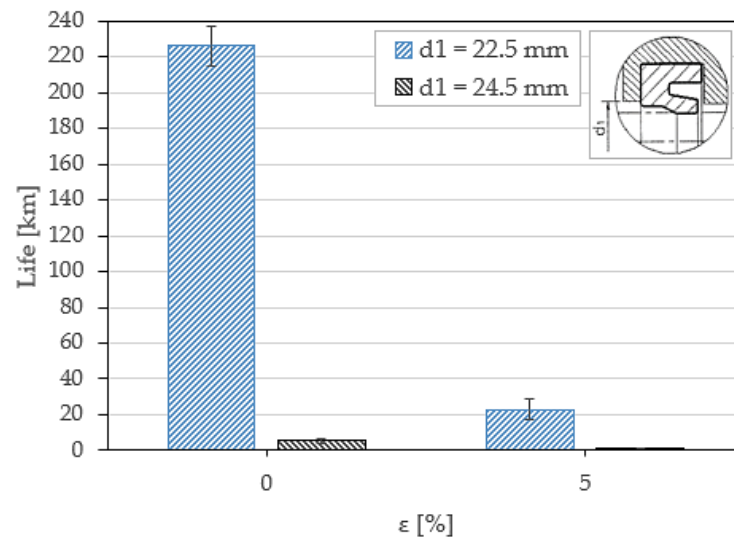
The estimated life of B1 seals is shown in Figure 10. Because B1 seals are the only ones without a rod scraper, a direct comparison with previous seal models is not possible. However, the service life of B1 seals is comparable to that of A1 seals, the latter having similar overall dimensions and the same material. As in the case of A1 seals, B1 showed an abrupt decrease in life with increased eccentricity.

**Figure 10.** Lifetime for seal type B1 due to increased eccentricity and increased diameter  $d_1$  of the seat shoulder.

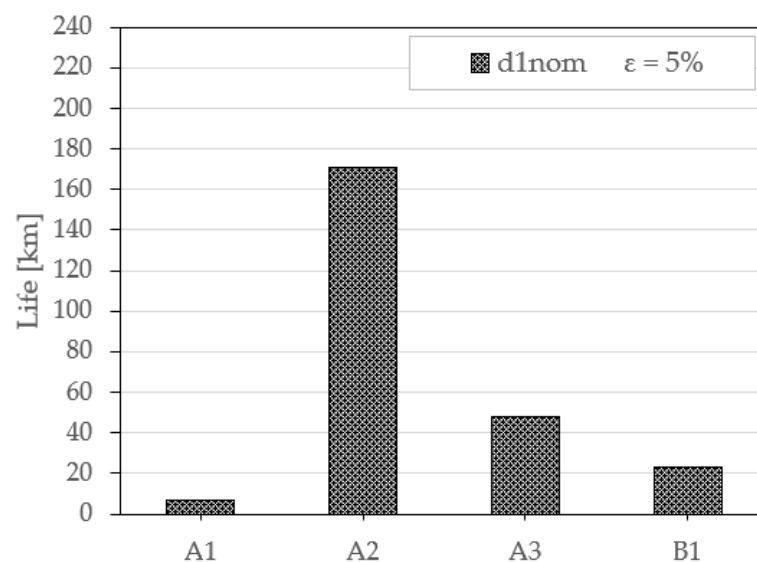
By way of comparison, Figure 11 shows the average experimental lifetime measured for seal types A1, A2, A3 and B1 when the shoulder diameter is the nominal value suggested by the seal manufacturer and the operational eccentricity during the tests is 5%.

**Figure 11.** Lifetime comparison with nominal value  $d_{1\text{nom}}$  of the shoulder and eccentricity of 5%.

A2 seals are the toughest, as they showed the highest wear resistance thanks to the high-performance material (EU) coupled with the increased mechanical strength against tearing and spiralisation provided by the stiffer cross-section. The key role of the material is highlighted in comparison with the A3 seals, whose average estimated life is three times lower than seal A2 while keeping the same cross-sectional geometry and overall dimensions.

The comparison between seals A3 and A1 indicates that the cross-sectional geometry plays a non-negligible role as well for the same material (NBR). The denser and squatter section of seal A3 positively affects the seal life, which is five times higher compared with A1 seals under a 5% eccentricity.

Among NBR seals, B1 seals also performed better than A1, and their life was, on average, 2.5 times higher under a 5% eccentricity and a nominal diameter of the shoulder. This effect is even larger if one compares the results obtained when the seal is retained by a nominal shoulder diameter  $d_{1,nom}$  and operated under null eccentricity, where the average life of seal B1 was approximately 5.5 times higher than seal A1 (see Figures 7 and 10). In other test conditions, e.g., null eccentricity and seat diameter larger than the nominal, the lifetimes are similar.

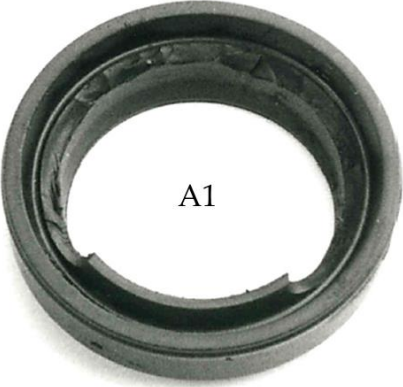
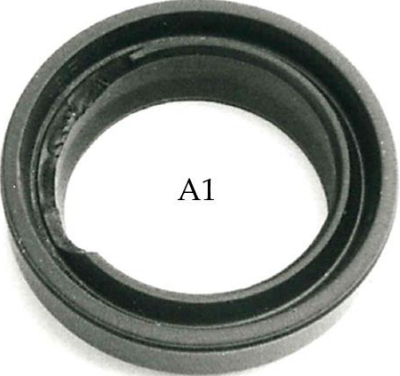
<p>Bulk continuous tearing of the sealing edge of the lip due to partial extrusion from the seat associated with a reduced retaining action of the shoulder (due to an increase in the diameter <math>d_1</math> of the seat shoulder). Sometimes, the lip detachment occurs without complete loss of material from the contact site. Failure often indicates the region where extrusion took place during the tests, and cross-section distortion of the seal during wear cycles may also be experienced in these regions.</p>	<p>Mode II and Mode I</p>

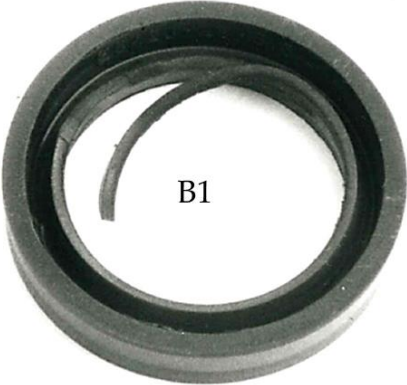
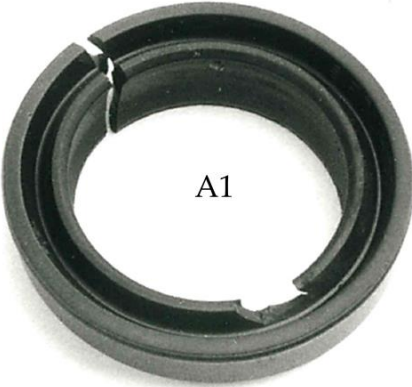
<p>Cracking of the sealing ring produced by a radial cut due to the complete ejection of the seal from its seat.</p>	<p>Mode II</p>
