Degradation of structural safety levels in prototype balanced beam systems

Rosario Ceravolo^{1,2*}, Erica Lenticchia^{1,2}, Gaetano Miraglia^{1,2}, Valerio Oliva^{1,2}

Abstract

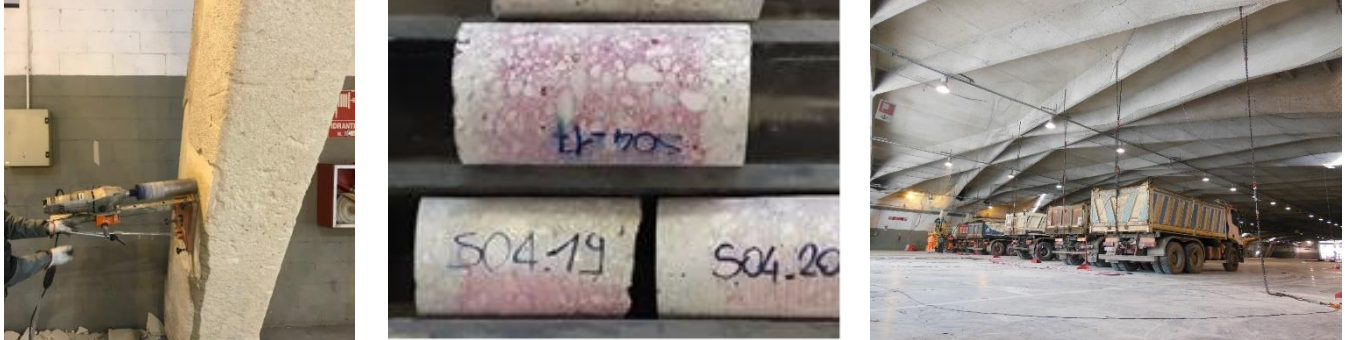
Figure 7 Pavilion V: Extraction of a concrete sample from a longer strut beam (left); carbonation tests on the samples of the ribs (center); view of the static tests with trucks connected to the ribs through jacks (right) [34].

Mechanical tests have been executed to evaluate the compressive strength of the different elements of the structure: samples were extracted from foundations, retaining walls, ribs, and longer strut beams (see **Figure 7** left). Each sample was analyzed with phenolphthalein to determine the progression of the carbonation front (**Figure 7** center) and then subjected to a compression test. The specimens were extracted and tested according to UNI EN 12504-1:2009 [36] and UNI EN 12390-3:2009 [37]. The total number of specimens extracted and tested was 32 [34]. **Table 1** summarizes the depth, diameters, ratios depth/diameter, compressive strengths, and carbonation depths of the cores.

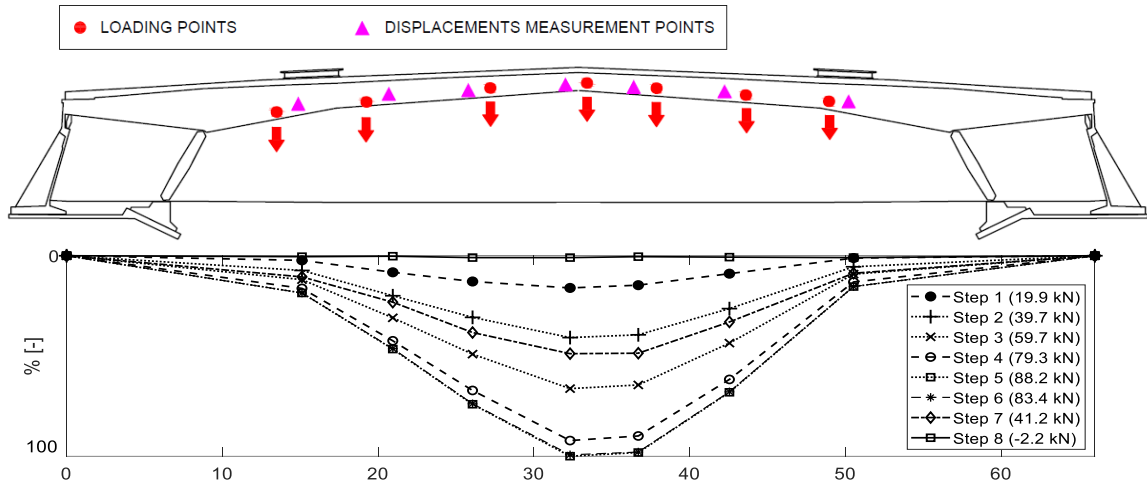
Figure 8 Pavilion V: normalized vertical displacements measured during the static test on a rib [34].

The maximum displacement measured during the static test on a rib was 4.36 mm. This result showed a relatively high stiffness of the structure under the imposed loads, despite a span of approximately 48 m between the inner supports. Moreover, the small displacements have proven a significant transversal collaboration of the ribs due to the numerous intersections between these elements, confirmed by the displacement measurement on the adjacent rib (equal to 3.20 mm in Step 5).

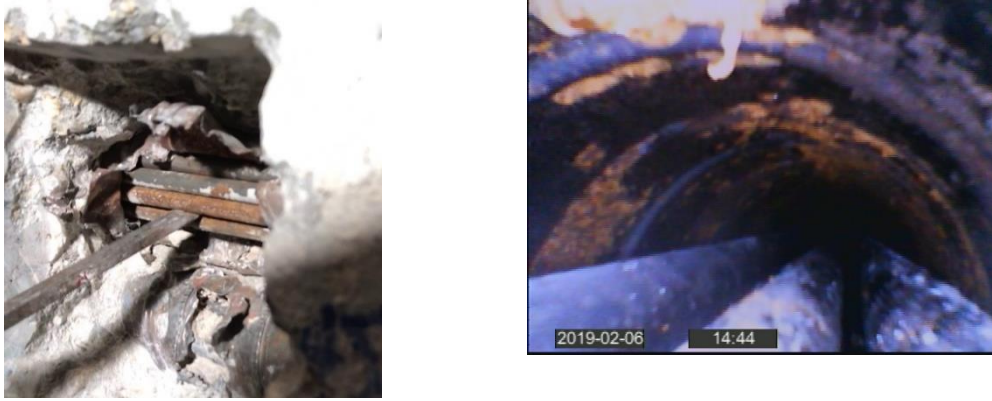
Figure 11 Visual inspection of post-tensioning tendons in the ribs at location S07.01 (left), and endoscopy inspection inside a duct of the rib at location S07.02, where grout filling of the duct is seen to be incomplete (right) [34].

Partial rupture or corrosion of post-tensioning tendons are difficult to directly locate using non-destructive tests, even if some high damping values found in translational modes have directed investigations towards local checks on the post-tensioned system of some sample balanced beams (locations S07.01 and S07.02 in **Figure 6**). In fact, despite the impossibility of making an exhaustive program of endoscopies and local assays, the inspections on the tendons of two ribs have revealed: i) presence of corrosion or full-blown rupture of some wires in the tendons, ii) poor grouting; iii) positioning errors. The poor grouting allowed to carry out an endoscopy inspection inside the duct (**Figure 11**).

In particular, hardened gray grout was found along the lower portion of the ducts, while poor segregated grout was found at the upper portion of the tendon, probably due to gravity separation processes. The grout filling of the ducts was not complete and regions where grout was segregated exhibited air voids along the top of the duct.

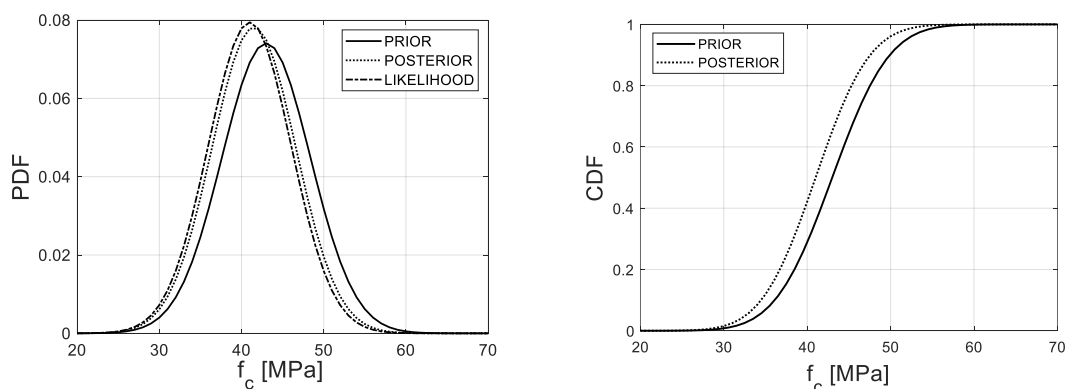
Figure 13 Concrete compression strength in a post-tensioned rib of Pavilion V as a results of 2019 campaign: prior and posterior probability density function (PDF) (left) and cumulative density function (CDF) (right).

Regarding concrete strength, the plots in **Figure 13** refer to the samples tested in 2019, and correspond to the prior and posterior probability and cumulative density functions for compression strength, f_c , obtained from Bayesian updating formulations [47], [48]. In particular, the density functions of both probability and cumulative (posterior PDF and CDF) have been calibrated on 18 samples extracted from the ribs and then tested.

The Bayesian updating results in a decrease of the average concrete compression strength of the ribs from 43.00 MPa to 41.51 MPa. As reported in the following subsection, this decrease on material strength (approximately 3÷4%) leads to a reduction of the ultimate load multiplier on the rib from 1.55 to 1.40 (approximately 10%), considering the cables in good health state.
