Degradation of structural safety levels in prototype balanced beam systems

Post-tensioned balanced beam structures are very sensitive to natural deterioration and excessive environmental attacks, which can lead to relatively rapid drops in safety levels. Since partial failure or corrosion of pre-stressing tendons can be difficult to detect, the strategy of last resort to ensure that safety levels are acceptable remains to perform a mechanical load test, with the risks that this entails. In the case of some iconic balanced beam systems, destructive investigations are further limited by the need to comply with the deontological standards valid for cultural heritage structures. The capacity and robustness of balanced beam systems can therefore be estimated by relying primarily on accurate mechanical models and sensitivity analyses against scenarios that may degrade safety. To this end, reference models can be corroborated by information from various sources, including experimental campaigns and archives. This study, in particular, focuses on the evaluation of the residual capacity offered by Morandi's prototype balanced beam scheme, to aid prognosis, and possibly support “decision-ma

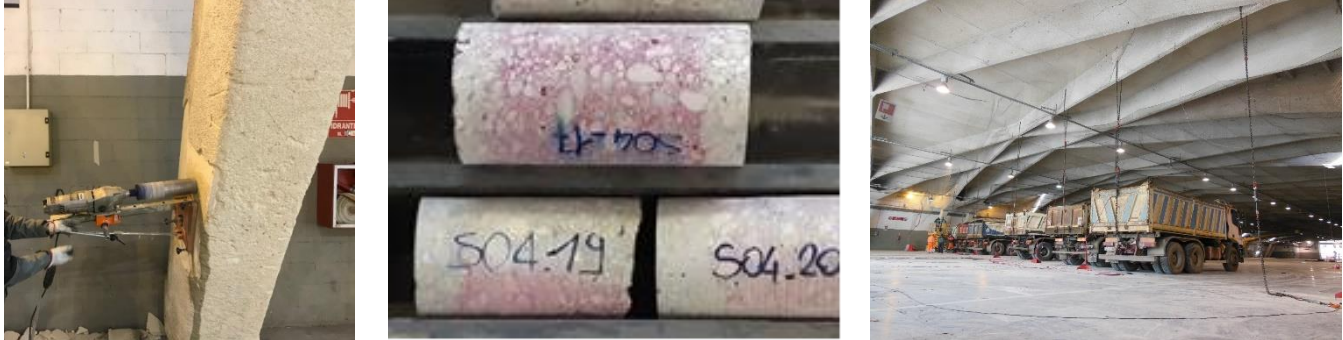
Mechanical tests have been executed to evaluate the compressive strength of the different elements of the structure: samples were extracted from foundations, retaining walls, ribs, and longer strut beams (see **Figure 7** left). Each sample was analyzed with phenolphthalein to determine the progression of the carbonation front (**Figure 7** center) and then subjected to a compression test. The specimens were extracted and tested according to UNI EN 12504-1:2009 [36] and UNI EN 12390-3:2009 [37]. The total number of specimens extracted and tested was 32 [34]. **Table 1** summarizes the depth, diameters, ratios depth/diameter, compressive strengths, and carbonation depths of the cores.

Figure 7 Pavilion V: Extraction of a concrete sample from a longer strut beam (left); carbonation tests on the samples of the ribs (center); view of the static tests with trucks connected to the ribs through jacks (right) [34].
