Improving the dynamic behaviour of historic buildings using experimental data: application to a Baroque church

# Improving the dynamic behaviour of historic buildings using experimental data: application to a Baroque church

The present study is necessarily developed around a real-world application. The case study is the Church of Santa Maria delle Grazie, better known as Santa Caterina, in Casale Monferrato (Alessandria), Italy, which represents one of the most important examples of baroque religious architecture of its territory. Throughout the years, the church of Santa Caterina has been subjected to several investigations. An extensive dynamic campaign, which resulted in the updating of a preliminary FEM of the church, was carried out in September 2010 [3]. The experimental campaign shed light on the high vulnerability of two distinctive elements of the church, viz. the lantern and the façade. Starting from 2019, the church has been interested by an extensive preservation campaign, also comprehending the strengthening interventions on the lantern (2021) and on the façade (2022).

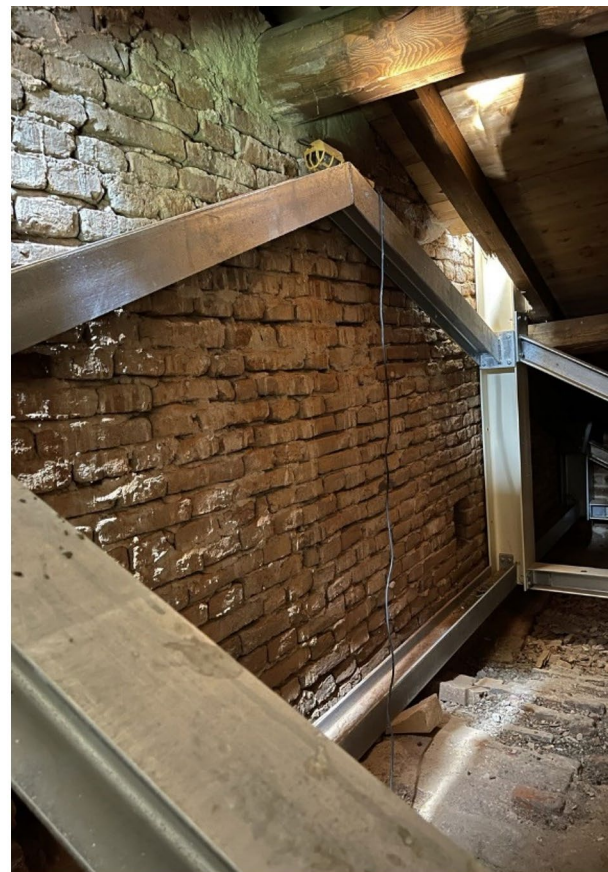
**Fig. 7** Installed intervention on the lantern (a) and on the façade (b)

The systems installed on the lantern and on the façade are reported in Fig. 7.

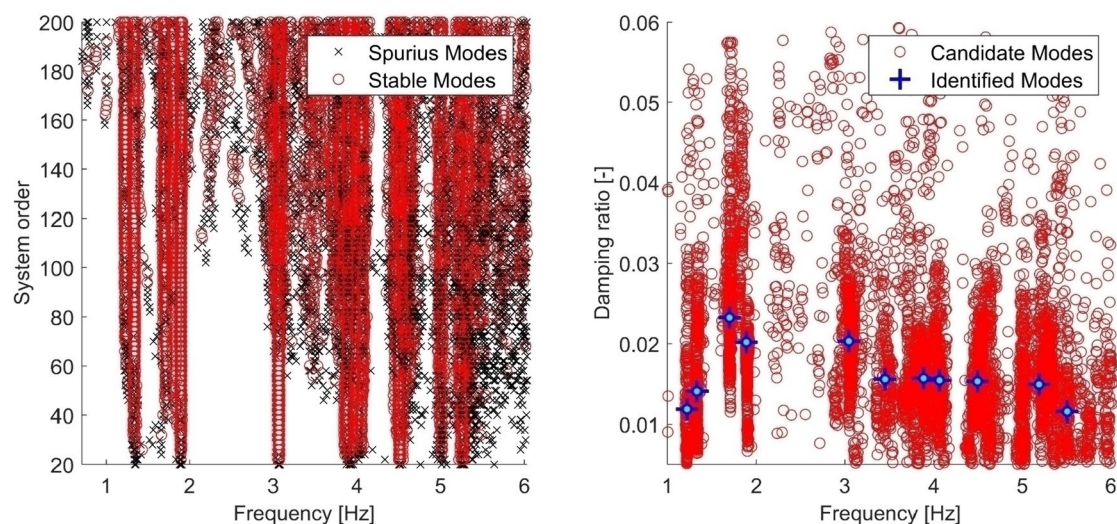
**Fig. 11** SSI algorithm: stabilization (left) and clustering (right) diagrams

the clusters. Finally, an operation of coupling and averaging of the results obtained from the seven identifications was carried out. This provided the modal parameters of the structure in terms of modal damping ratio, natural frequency and mode shape related to the diaphragmatic movements of the top part of the lantern. Figure 11 depicts the resulting stabilization and clustering diagram for the coupled identifications.
