Improving the dynamic behaviour of historic buildings using experimental data: application to a Baroque church

# Improving the dynamic behaviour of historic buildings using experimental data: application to a Baroque church

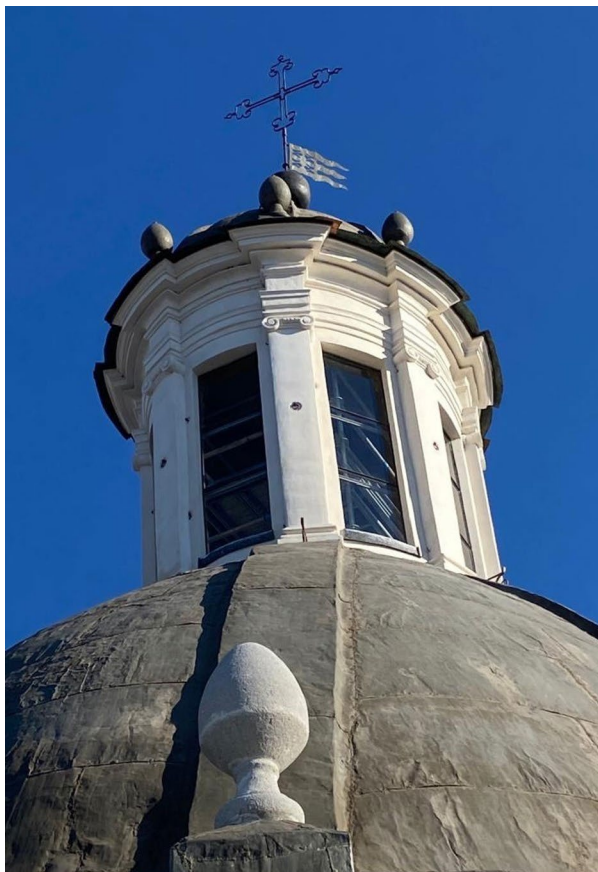
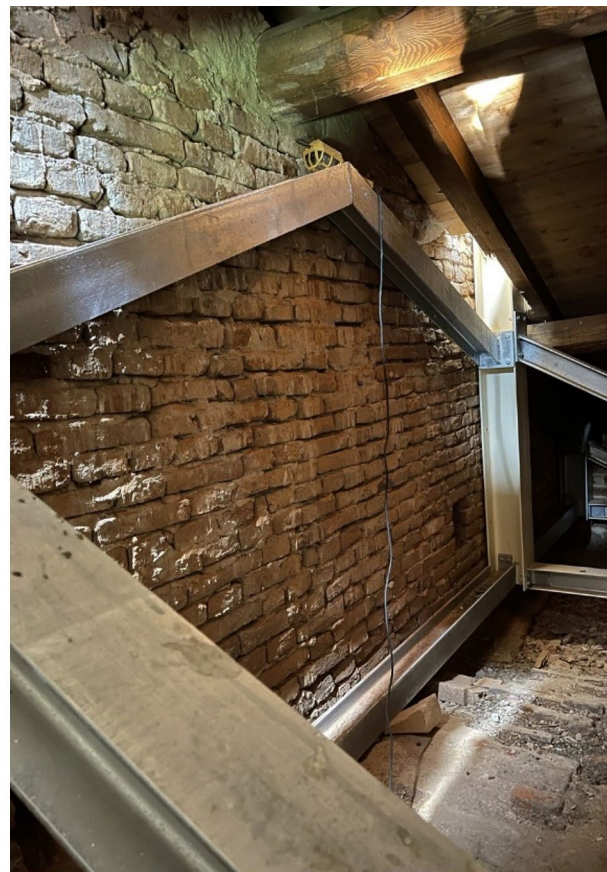
**Fig. 7** Installed intervention on the lantern (a) and on the façade (b)

The systems installed on the lantern and on the façade are reported in Fig. 7.
