## BRIDGE|50 research project: Residual structural performance of a 50-year-old bridge

**ABSTRACT:** This paper deals with the BRIDGE|50 research project aimed at investigating the residual structural performance of a 50-year-old concrete bridge recently dismantled in Italy. A group of 29 precast prestressed beams, including 25 I-beams and four box beams, and two pier caps has been placed in a testing site. The preliminary activities already developed and the planned experimental program are discussed. The project includes photographic mappings, drone surveys, non-destructive testing, full-scale load tests, and extraction of a large number of samples from the tested structural elements for laboratory tests.

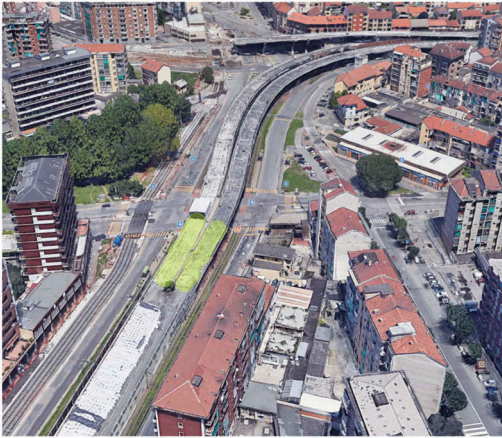
Figure 1. Aerial view of the Corso Grosseto viaduct.

The 50-year-old Corso Grosseto viaduct is a 80-span double deck road viaduct recently dismantled in Turin, Italy. Figure 1 show an aerial view of the viaduct still

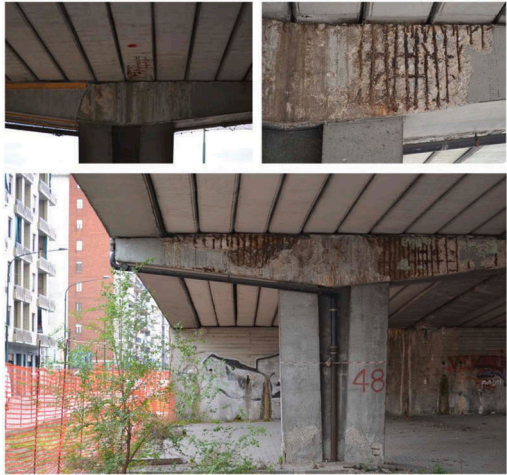
Figure 3. View of the bridge deck and details of the pier caps.

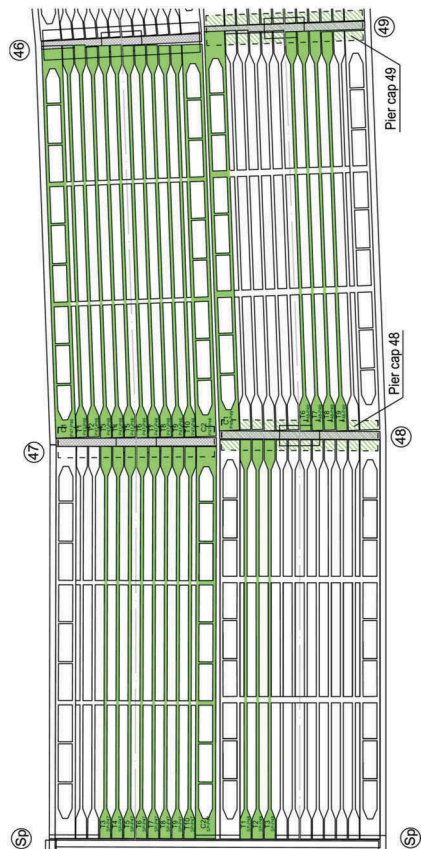
Figure 4. Deck beams and pier caps selected for testing.

deconstructed according to the plan shown in Figure 4 by cutting the structural members, including 29 PC deck beams (25 I-beams and four box beams) and

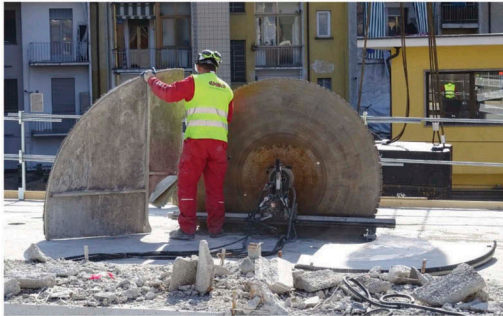
Figure 5. Cutting the beams of the bridge deck.

two PC pier caps, by using rotating disks with diamond wires (Figure 5). Therefore, the structural members have been lifted (Figure 6) and moved by trucks to the testing site (Figure 7). Figure 8 shows some of the beams during the storing process, with the beams placed sequentially on New Jersey supporting members in the testing site. A detailed description of the dismantling and deconstruction process of the bridge and setup of the testing site is described in Anghileri et al. (2020).

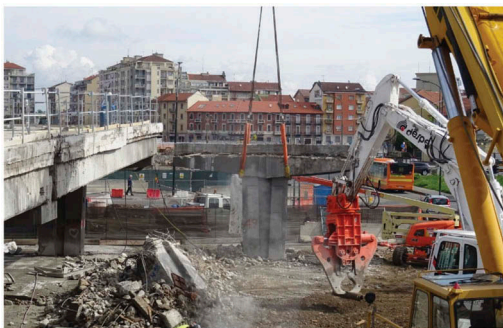
Figure 6. Lifting of a pier cap.

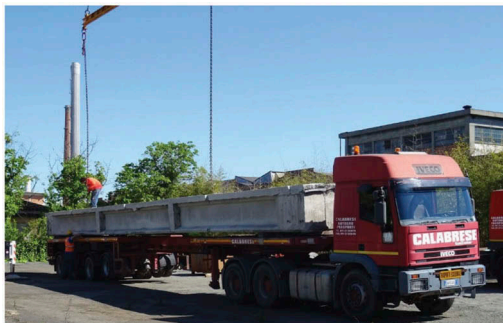
Figure 7. Beams moved by trucks to the testing site.

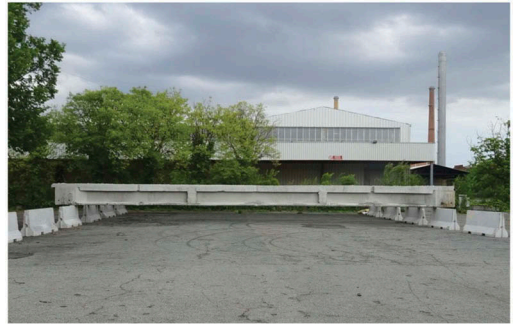
Figure 8. Beams placed sequentially on New Jersey supporting members in the testing site.

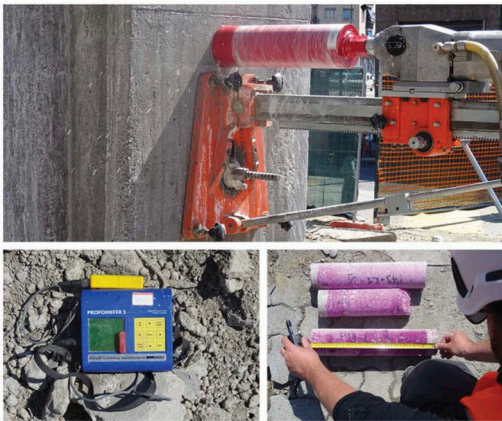
Figure 10. Concrete split coring and carbonation tests.

Concrete split cores have been extracted from a bridge pier and carbonation depth is assessed using a phenolphthalein solution as an indication of the location of the depassivation front, with possible corrosion in the zone ahead of this front (Figure 10). These results will complement the information from experimental load tests on both deck beams and pier caps.

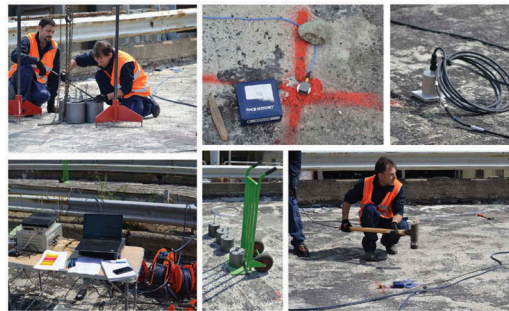
Figure 11. Dynamic identification experimental tests.

Finally, a preliminary dynamic tests campaign has been carried out on bridge decks. The purpose of this campaign is to characterize the dynamic behavior of the decks under service condition. Dynamic measurements have been acquired by using different excitation sources (Figure 11). The collected data have been analyzed in order to extract the principal

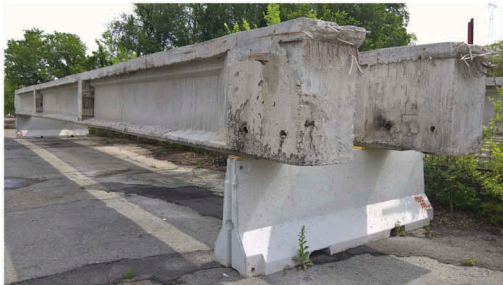
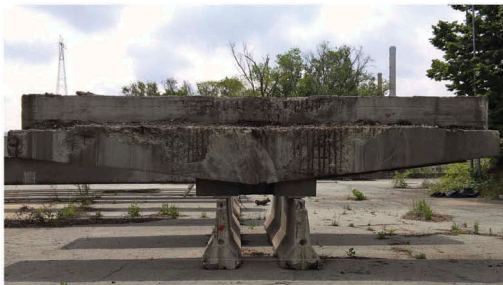
Figure 12. View of the structural elements stored in the testing site (29 deck beams, including 25 I-beams and four box beams, and two pier caps): (a,b,c) deck beams; (d) pier cap.

Contextually to the dismantling of the viaduct, 29 deck beams (25 I-beams and four box beams) and two pier caps have been collected from the deconstruction of two adjacent bridge spans and moved to the testing site. Figure 12 shows a series of deck beams (Figure 12a,b,c) and one pier cap (Figure 12d). The planned on-site activities include photographic mapping of the structural elements, drone surveys, non-destructive diagnostic tests, full-scale load tests, and a large number of samples from the tested structural elements (concrete cores and samples of reinforcing steel bars and prestressing steel wires) for laboratory mechanical and chemical-physical tests to be performed at Politecnico di Milano and Politecnico di Torino.

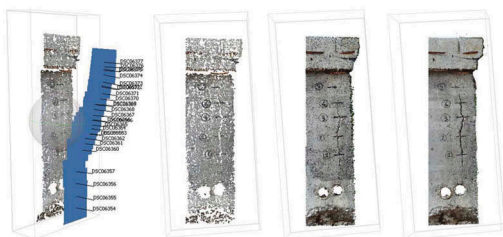
Figure 13. Mapping of photographic images to 3D surfaces.

Preliminary photographic mappings and drone surveys have been performed. Figure 13 shows the sequence of a mapping of photographic images to 3D surfaces. This mapping is used to detect damage and cracking states, as shown in Figure 14 for a deck beam. Extensive non-destructive diagnostic tests, including sclerometric, magnetometric, and ultrasonic investigations have been also performed (Figure 15).
