Dynamic response of damaged precast bridge girders

D. Sabia, A. Quattrone, F. Tondolo & P. Savino

Department of Structural, Geotechnical and Building Engineering, Politecnico di Torino, Torino, Italy

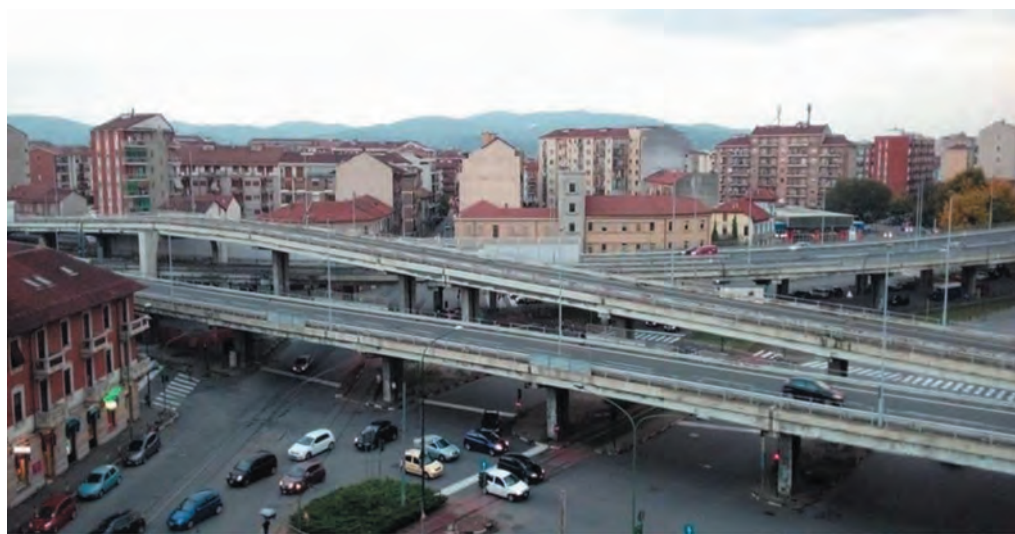
Figure 1. Corso Grosseto viaduct before the dismantling.

The Corso Grosseto viaduct was built in 1970. It was originally constituted by 90 concrete decks having variable spans, from 16 m to 24 m, and a total length of 1400 m (Figure 1). Each deck was composed of 10 precast prestressed concrete I-beams and 2 external precast prestressed concrete U-beams, simply supported at piers, and connected transversely by 3 equally spaced diaphragms and, on the top, by a 0.14 m concrete slab (Figure 2). A set of 25 prestressed concrete beams constituting the decks have been dismantled and collected in a testing area, where a bench test has been realized to perform both static and dynamic tests. The collected structural elements belong to the first four decks of the southern part of the viaduct, highlighted in green in Figure 2-a. The technical drawings of the I-beams cross section and the on-site casted slab, object of the present work, are shown in Figure 2 - b.

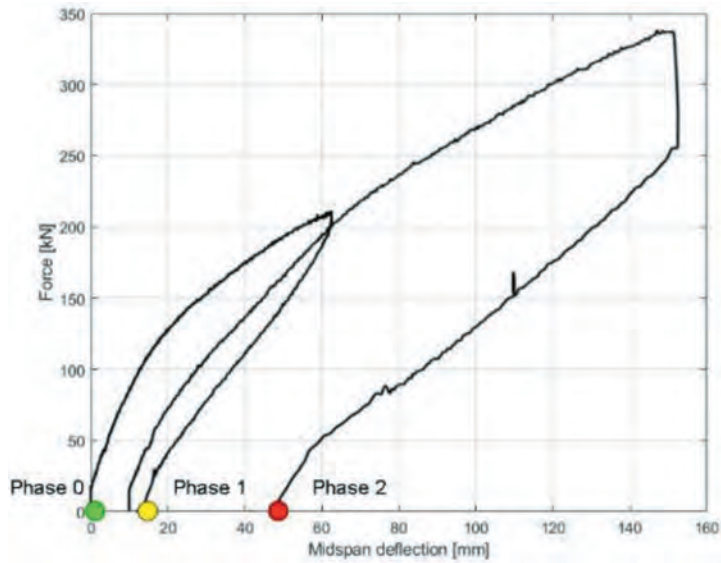
Figure 4. Force – midspan deflection. The dots indicate the phase test.

Dynamic tests were performed on all beams prior to the application of static loads (Phase 0). Whenever possible, the tests were repeated in an intermediate condition (Phase 1), and at the end of the static test (Phase 2), following the attainment of the ultimate failure load (Figure 4). The Phase 1 corresponds to the unloading condition, subsequent the reaching of the full cracked condition, identified in Table 2 as a fraction of the ultimate bending moment reached during the static tests calculated in the rupture section.

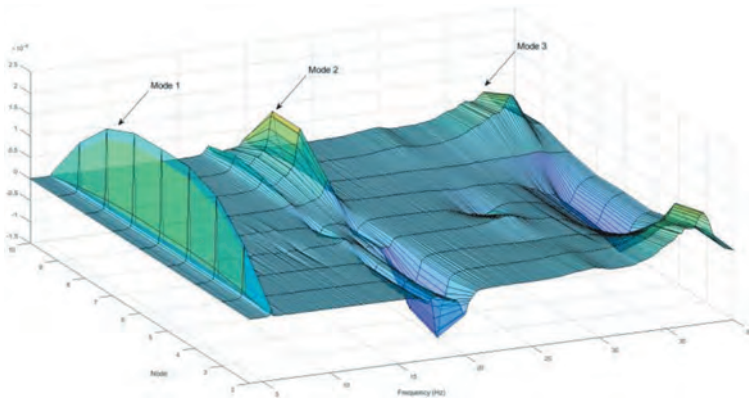
Figure 5. Example of mode shapes of the first three bending modes of the beam B06 – phase 0.

The sign is either positive or negative, considering the direction of the peak along imaginary axis. This implies that the phase angle is either 0° or 180° . After a preliminary analysis of the spectral content, the signals were pretreated by filtering out of the bandwidth [0 - 100 Hz], removing the trends. The FRFs have been estimated basing on each singular impulse acceleration data and then averaged for each hitting position. The first three modal components are clearly identified as shown by the example proposed in Figure 5. The mode shapes associated to these components correspond to the three main flexural modes of the beam. The modal coordinates are estimated by the imaginary part of the FRFs.
