Resilience and sustainability assessment of a prestressed concrete viaduct

M. Domaneschi & R. Cucuzza

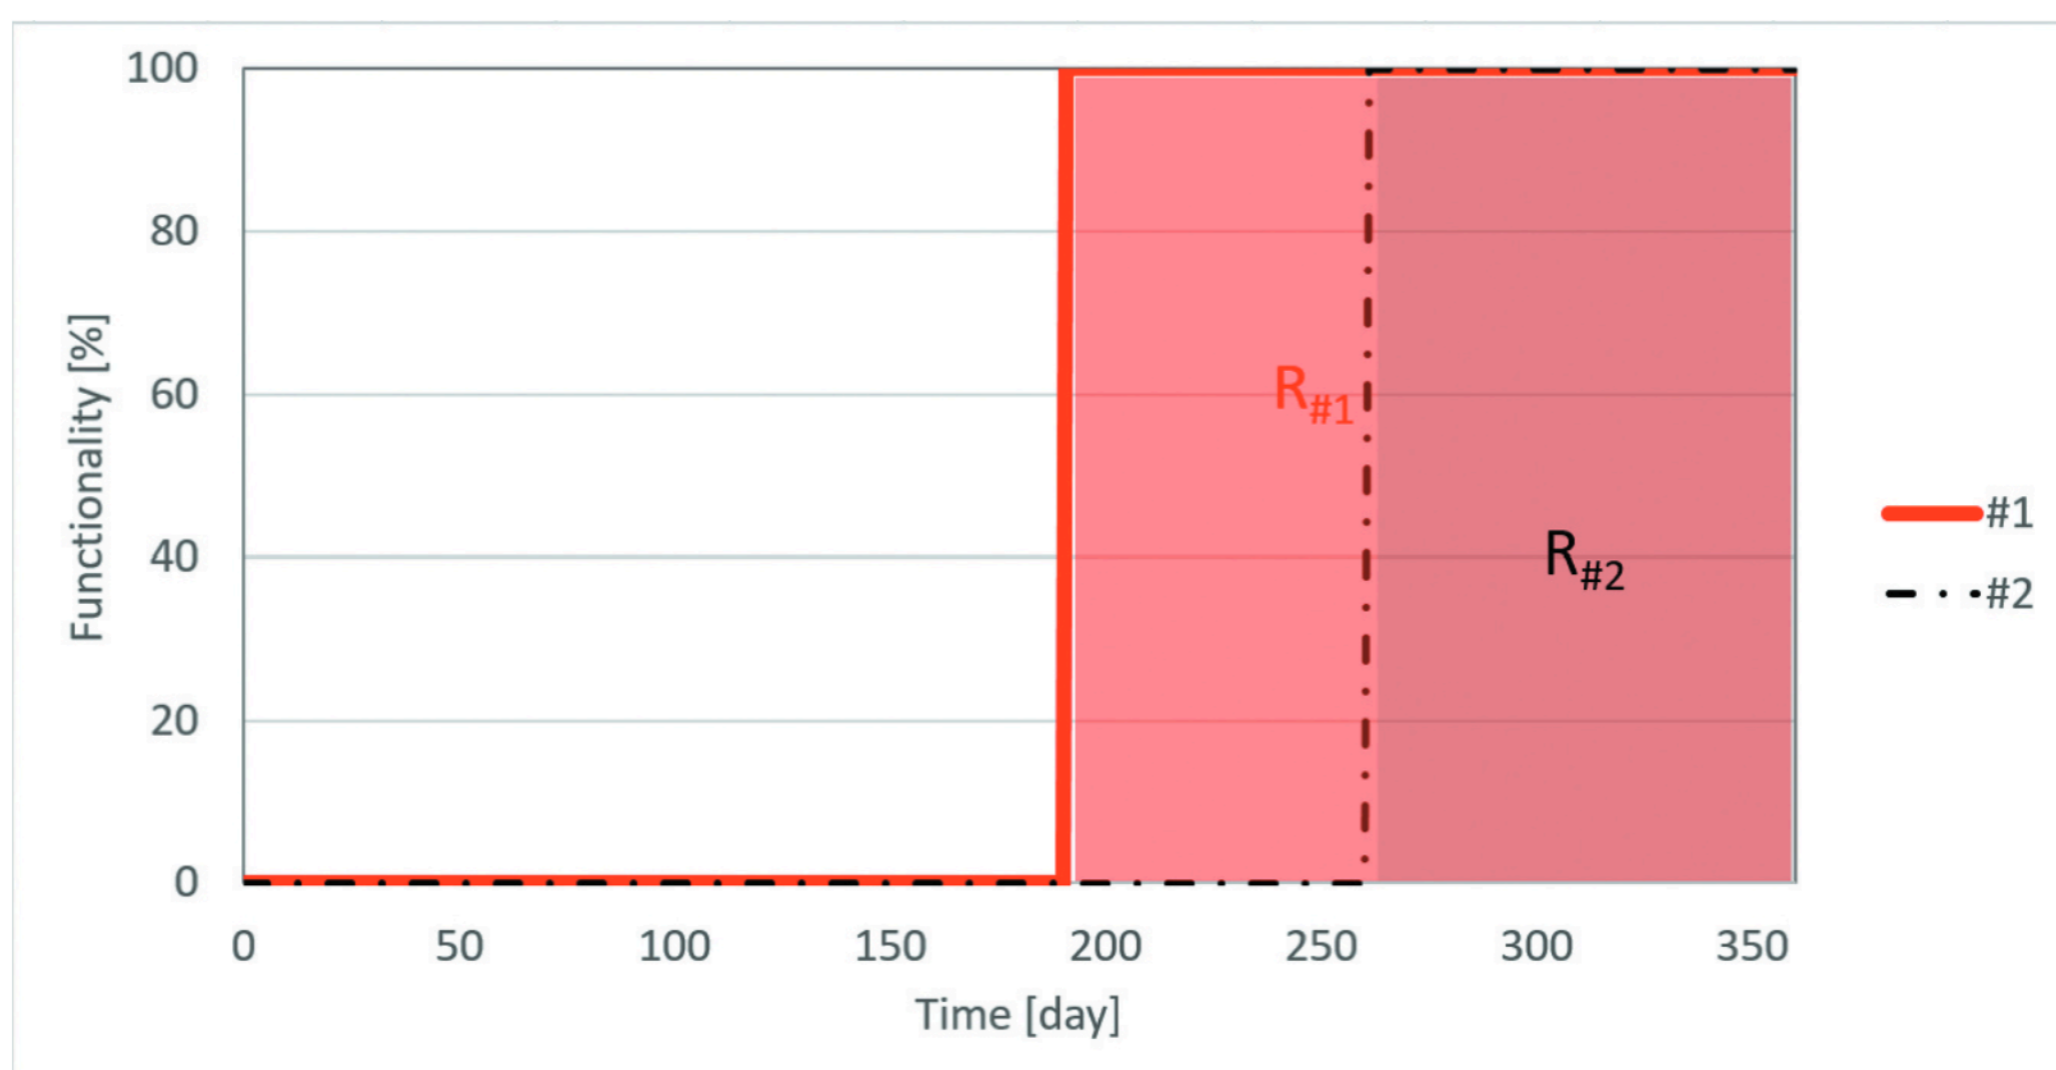
Figure 2. Functionality curves and resilience (transitability).

Figure 2 illustrates the functionality curves for the proposed solutions, starting at time 0 when either the whole deck or Gerber beams only are demolished, resulting in a complete bridge closure. In Scenario #1, demolition using explosives is estimated to take around 10 days, while for Scenario #2, controlled demolition of the Gerber beams will take approximately 20 days.

For the solution involving deck replacement or a portion of it, it is assumed that before demolition starts, the replacement structure is prepared nearby for swift replacement. Specifically, installing the new deck is estimated to take 3 months for Solution #1. Scenario #2, involving new Gerber beams and external prestressing cables for the cantilevers, is estimated to take 5 months.

Upon construction completion, the estimated timeline for testing, processing (technical-administrative approval), and full bridge reopening is set at 90 days. Post this period, it is assumed that the bridge's transit capability will be restored to 100%. Resilience values for the different scenarios considering a maximum closure period of 360 days are tabulated in Table 3.

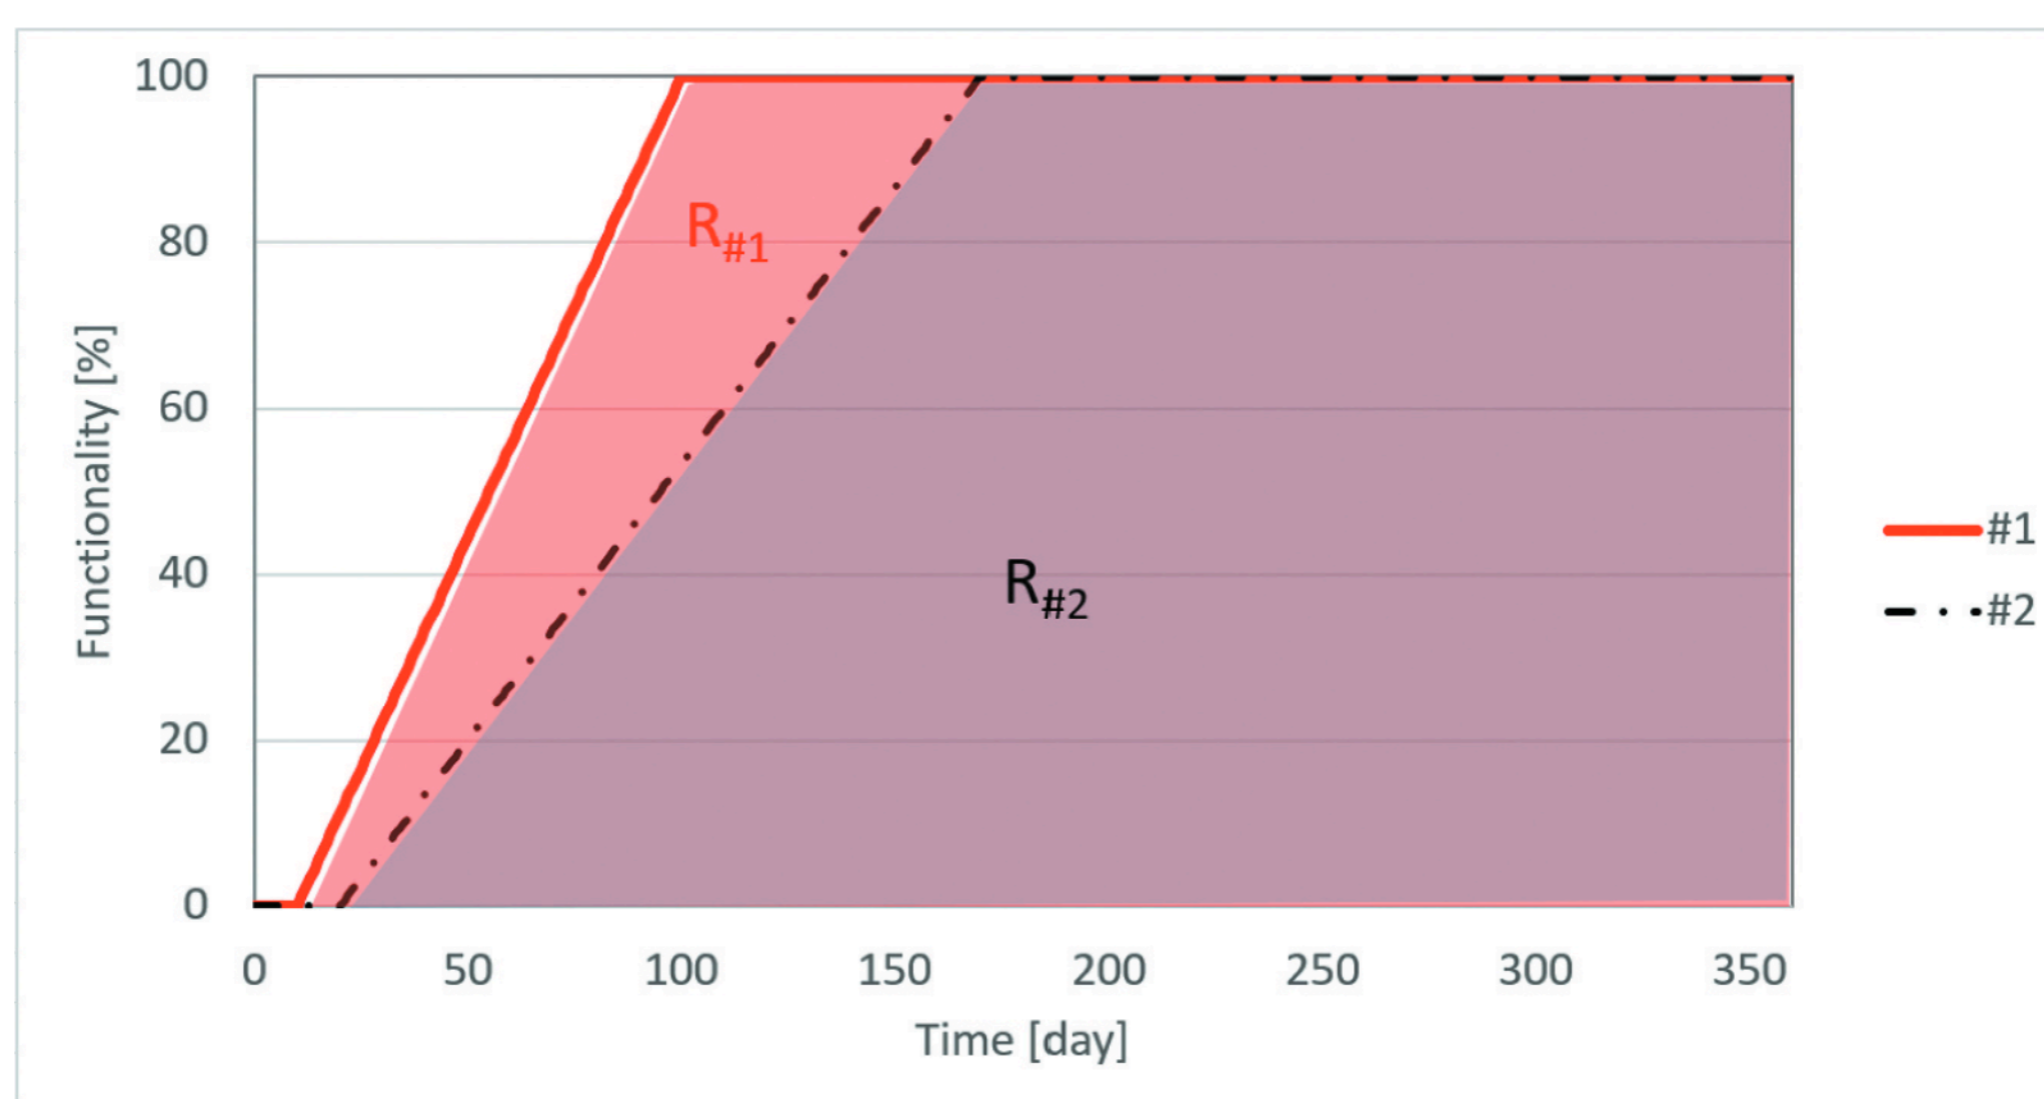
Figure 3. Functionality curves and resilience (capacity).

Shows the trends of the capacity curves for the various assumed scenarios, while Table 4 reports the resilience values computed concerning capacity.
