Even the details make a difference: problems and solutions regarding interventions on historic masonry cornices

Keywords: Masonry cornices, Palazzo Carignano, terracotta elements, planned conservation, decay.

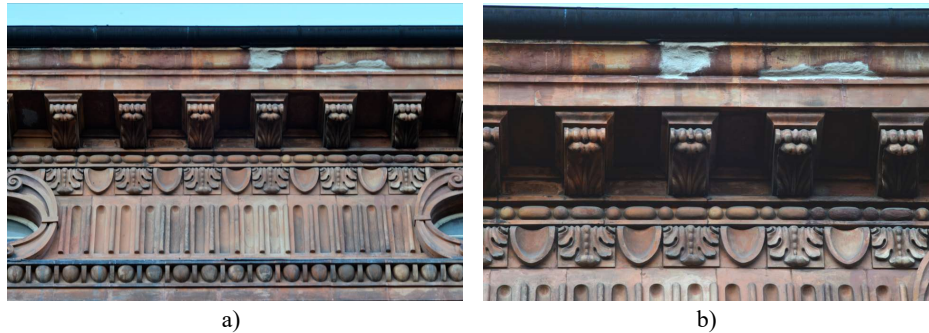
Fig. 2. a) The overall view of a module of the decorative apparatus of the crowning cornice of the 19th century façade: noteworthy is the design of the cornice above the corbels, which is no longer made with repeated courses of solid brick elements, but with the superimposition of two specially shaped elements made on a bench; b) Detail of the upper cornice of the 19th century façade. Recent cleaning work has revealed earlier additions and consolidations to the hollow brick mouldings that complete the decorative system. The deterioration of these elements is closely linked to the presence of persistent infiltration from the rainwater collection system. (Pictures were taken on February 2024, by M. Zerbinatti).

The analysis of the results of this activity has shown, by comparison, a more diffuse and advanced degradation on the south and west-east façades (in relation to exposure factors and the resulting thermal expansion); with particular reference to the courtyard façades, a generally worse state of conservation of the 19th-century portions appears (Fig. 2a). The overall view of a module of the decorative apparatus of the crowning cornice of the 19th-century façade shows a diffuse lack of homogeneity in the chromatic characteristics of the individual elements, which can be attributed to sub-optimal production and firing processes. Also noteworthy is the design of the cornice above the corbels, which is no longer made with repeated courses of solid brick elements, but with the superimposition of two specially shaped elements made on a bench. The repeated and widespread phenomena of deterioration and detachment of significant parts are in this case due to the simultaneous presence of errors in the design and execution of the system and the persistent infiltration of rainwater from the upper part of the covering (Fig. 2b).

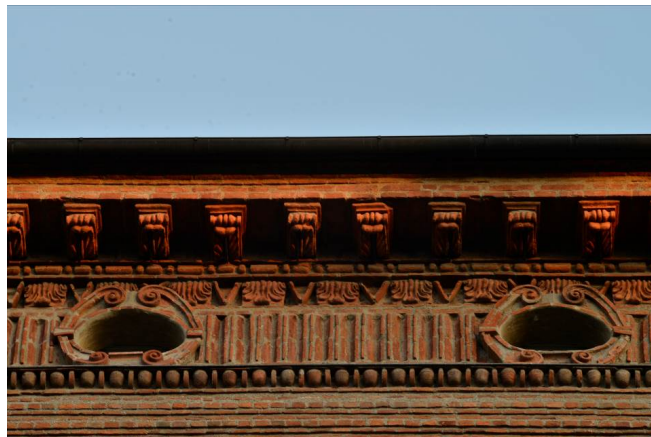
Fig. 3. Upper cornice of the 17th century façade: replacement and partial consolidation of the closing courses and some decorated corbels can be appreciated. In this case, the moulded terracotta elements that make up the corbels, which are the most fragile part of the system, are adequately protected by the upper part of the cornice, which is made of solid bricks with a traditional masonry texture (Pictures were taken on February 2024, by M. Zerbinatti).

In fact, although the frames and decorative elements of the nineteenth-century installation interpreted the 17th century (Fig. 3) core in an attempt to achieve formal continuity, there are numerous aspects of discontinuity: not only different materials, sizes, production and firing techniques, but also different assembly and installation systems affected by design faults.
