Hydric erosion in touristic beaches influenced by extreme rainfall events: case contribution of the pluvial drainage of the Ancon Hotel, Cuba

# Hydric erosion in touristic beaches influenced by extreme rainfall events: case contribution of the pluvial drainage of the Ancon Hotel, Cuba.

Omar Gutiérrez Benítez, Department of Chemical Engineering, University of Cienfuegos Carlos Rafael Rodríguez. Cienfuegos, Cuba, [ogutierrez@ucf.edu.cu](mailto:ogutierrez@ucf.edu.cu)

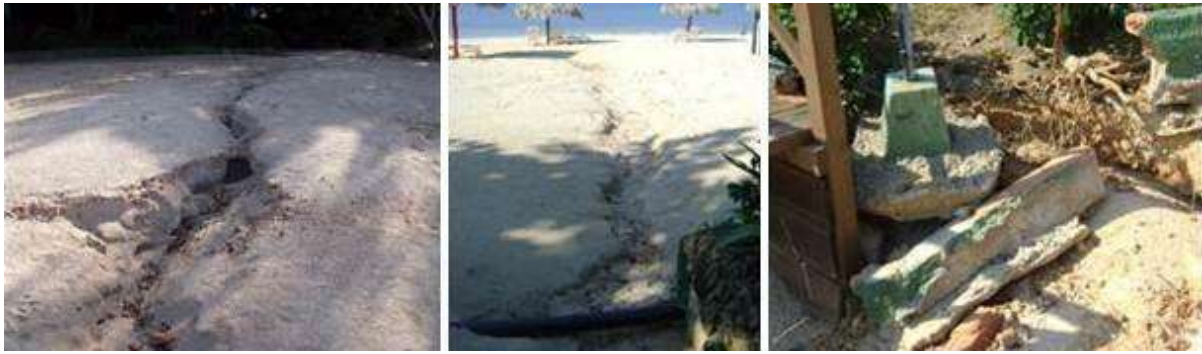
**Figure 3.** Sample of hydric erosion evidence in the berm, and green areas adjacent to strata 1 and 2.

As far as it concerns with what has been discussed, strata 1 and 2 coincide with a rugged relief, a woodland with a superficial root system and poor vegetation. Figure 3 shows some of the evidence detected.
