Hydric erosion in touristic beaches influenced by extreme rainfall events: case contribution of the pluvial drainage of the Ancon Hotel, Cuba

*Proceedings of the 61st ESReDA Seminar
Politecnico di Torino, Italy
22-23 September 2022*

Hydric erosion in touristic beaches influenced by extreme rainfall events: case contribution of the pluvial drainage of the Ancon Hotel, Cuba.

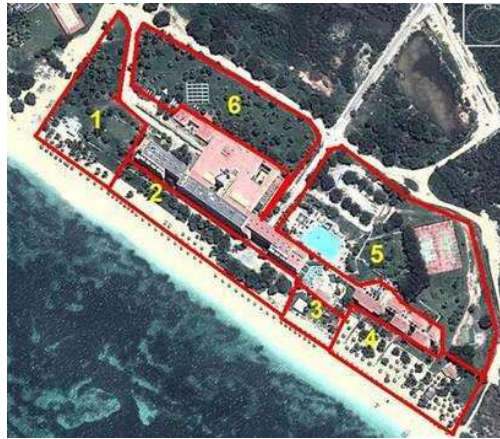
Figure 1. Ancon Hotel and beach sector. Representation of the defined strata.

The satellite image of the study area (Figure 1) shows the proximity of the hotel buildings to the emerged area of the beach (berm), separated only by a longitudinal strip of green areas with small squares and stairs for access to the beach. The six strata into which the study area was divided can also be appreciated.

First, the relief of strata 1, 2 and 3 were classified as hilly and undulating. Moreover, the average slopes were between 5 % and 15 %, reaching 25 % in stratum 1. The rest of the strata were classified as flat, with less than 5 % slopes.

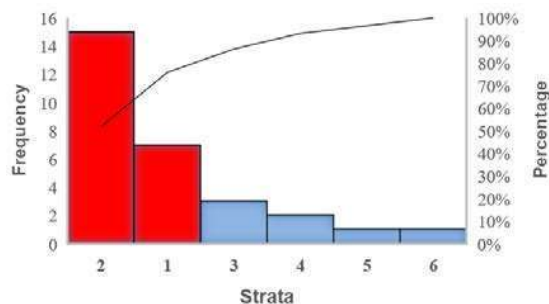
Figure 2. Pareto diagram for erosional evidence. Analysis by strata.

In the Ancon Hotel beach emerged area (berm) considerable predominates the hydric erosion, in correspondence with the characteristics and factors reported in the literature [26-29]. The Pareto diagram in Figure 2 illustrates the absolute frequency of the erosive evidence recorded in each stratum (left vertical axis) and the accumulated percentage concerning the factual evidence that appeared in all the strata (line above the bars). As could be appreciated, over the 75 % erosion evidence was concentrated in strata 1 and 2 (southwest sector of the main building). In these strata, the presence of several rigid build elements was observed, such as the extra hotel point of sale, hotel platforms, terraces, stairs, concrete walkways in the green area of the hotel, concrete slabs, hoses, and surface pipes in the emerged area of the beach, as well as the longitudinal retaining wall contiguous to the green area of the hotel and the emerged area of the beach.

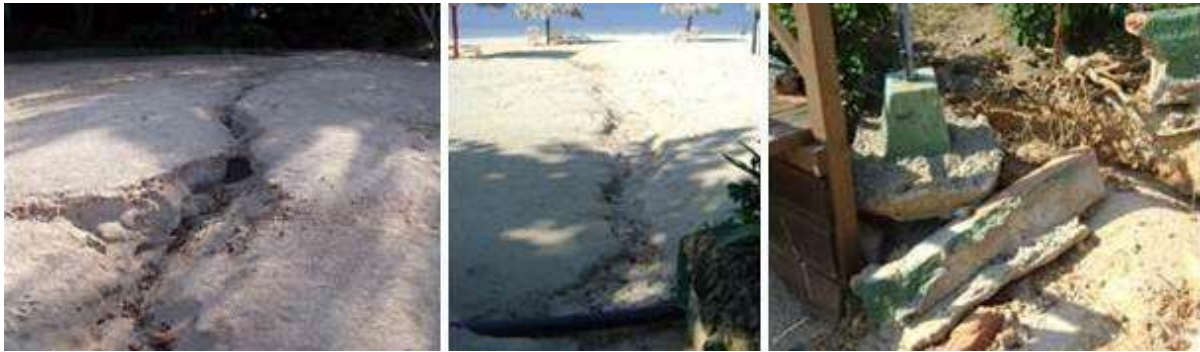
Figure 3. Sample of hydric erosion evidence in the berm, and green areas adjacent to strata 1 and 2.

As far as it concerns with what has been discussed, strata 1 and 2 coincide with a rugged relief, a woodland with a superficial root system and poor vegetation. Figure 3 shows some of the evidence detected.

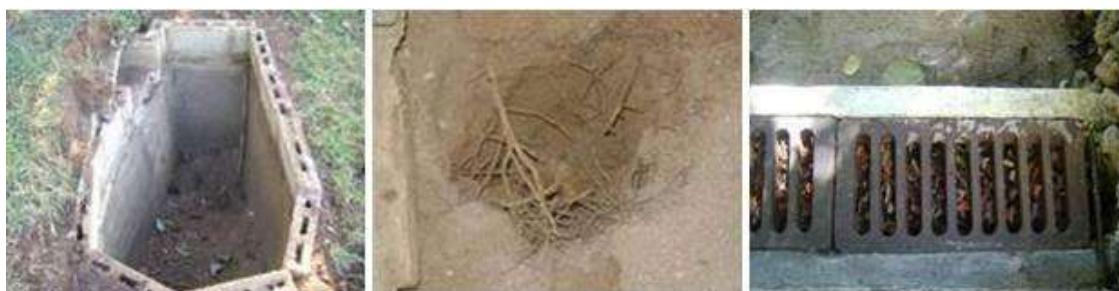
Figure 5. Evidence of technical and maintenance deficiencies in the infiltration works.

With a glance to the Figure 5, could be appreciated that filter beds were silted and filled with trash, soil, and sediment carried away by runoff from outside or covered areas. Regarding these issues, joint to the fact of plant rooting inside the filter beds the infiltration capacity of the wells was sensibly decreased with slow relative absorption (infiltration rate of 3.21 min).

Palliative solutions consist of relief leveling, soil tillage, turf improvement, technological improvements in the infiltration wells and the construction of infiltration ditches, and collectors. The infiltration trenches were also considered as a palliative solution according with its application in similar study case [35].
