Gravity-induced collapse of a soft rock cliff due to notch growth

Gravity-induced collapse of a soft rock cliff due to notch growth / Napoli, M.L., Barbero, M., Mascioli, F., Miccadei, E.. -  
In: ENVIRONMENTAL GEOTECHNICS. - ISSN 2051-803X. - ELETTRONICO. - 12:3(2025), pp. 183-193.  
[10.1680/jenge.24.00052]

**Manuscript title:** Gravity-induced collapse of a soft rock cliff due to notch growth

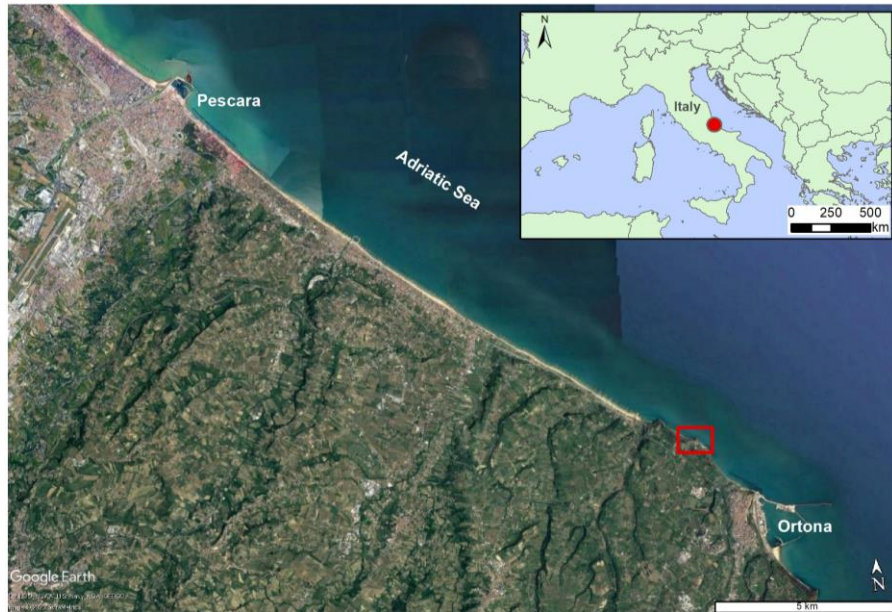
Fig. 1

First, 2D finite element (FE) analyses were carried out on homogeneous steep seacliffs with variable heights (from 7 m up to 25 m) and the same basal notch, to investigate if and how the slenderness of the rock overhangs affects their failure mechanism. The geometry and the mechanical properties of the cliff were based on the study of Calista *et al.* (2019) and Miccadei *et al.* (2019), related to the popular tourist site of Punta Ferruccio promontory, located in the Adriatic Sea (Abruzzo, Italy), which has been affected by several rockfalls in the last decades (Figure 1).

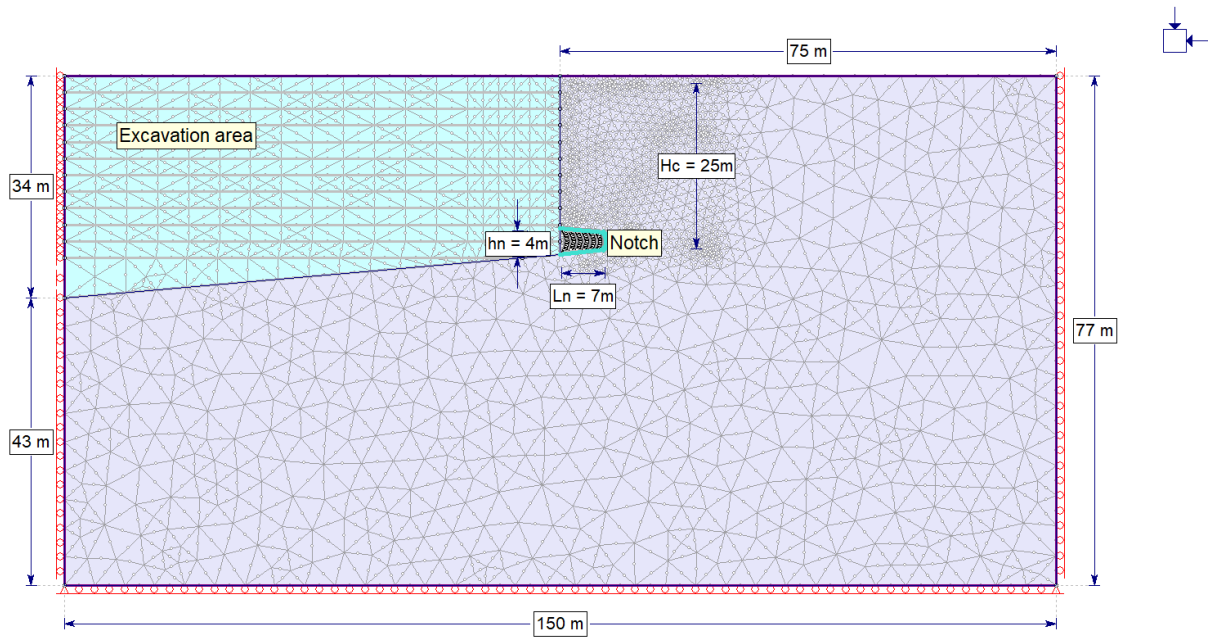
Fig. 2

node triangular elements were used to mesh the models, increasing the elements density close to the cliff face and the notch. In order to avoid stress modelling disturbance, two excavation processes (i.e. each one including several excavation stages) were simulated: the former in the left part of the model so as to reproduce the vertical cliff face, with a removal of 2.5 m layers of rock per stage; the second, in order to simulate the notch growth and its effect on the stability of the cliff, with a removal of 1 m of notch depth per stage (Figure 2).

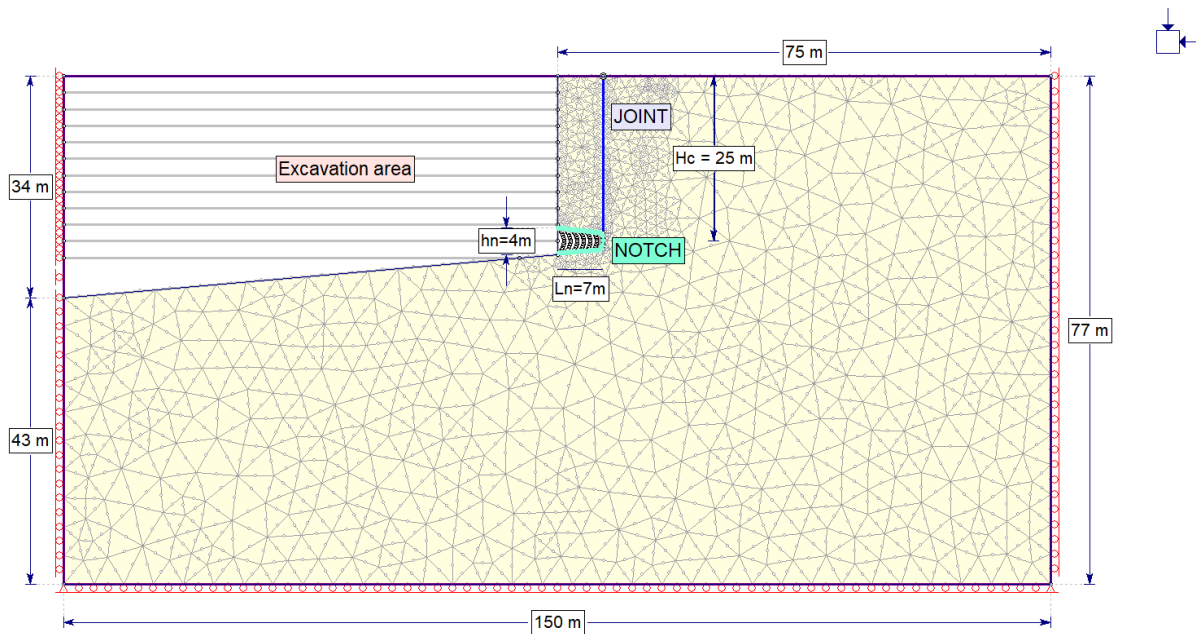
Fig. 7

1) to include a vertical deep joint, in the position observed on site. The joint is modelled with the RS2 code with the first end (on the cliff surface) open and the last end closed. As shown in Figure 7, the discontinuity was located 7 m far from the exposed cliff face.
