Point clouds and surface analyses to detect anomalies

Point clouds and surface analyses to detect anomalies / Sammartano, Giulia; Patrucco, Giacomo; Perri, Stefano; Spano',
Antonia - In: The Halls of Turin Exhibition Center by Pier Luigi Nervi: a multi-disciplinary approach for diagnosis and
preservationELETTRONICO. - Los Angeles : Getty foundation, 2023. - pp. 154-167

3c Point clouds and surface analyses to detect anomalies

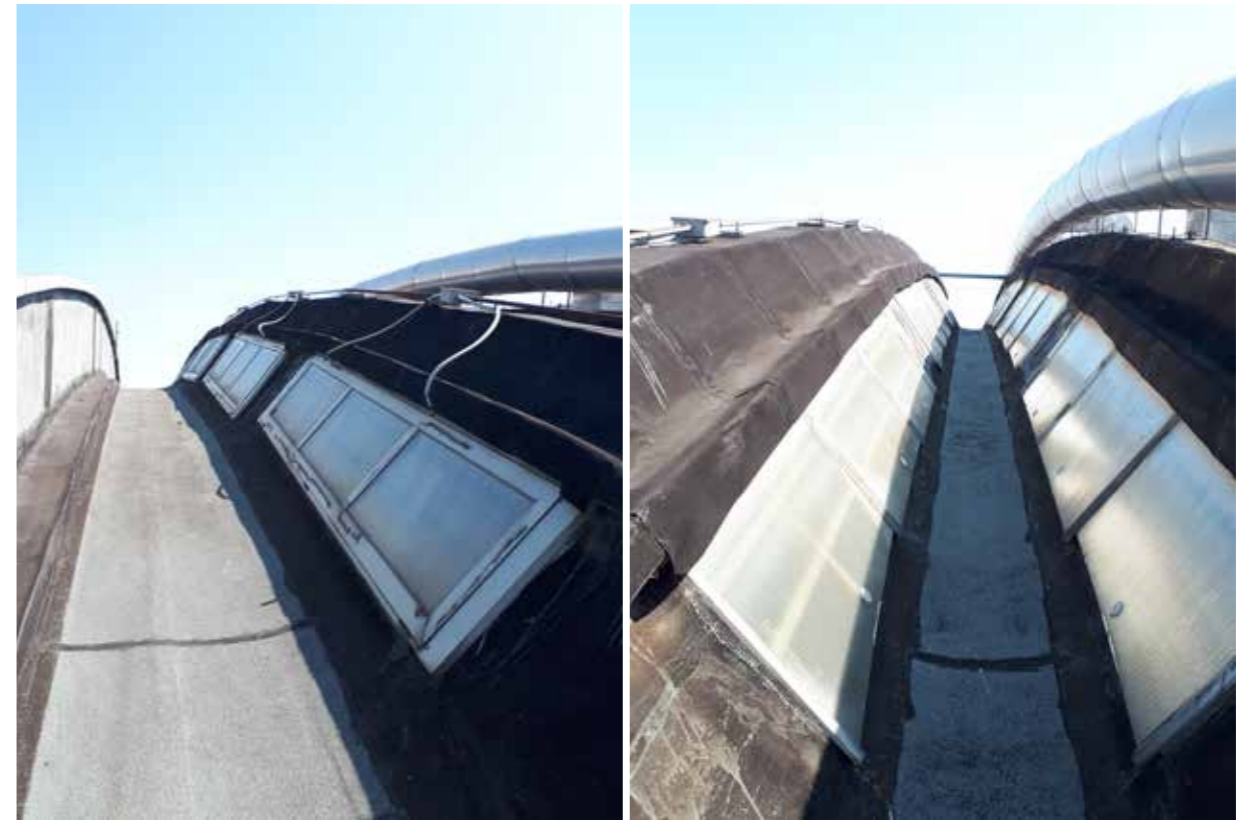
3c 5.8: Different types of skylights in the roof of Hall B, with an automatic opening mechanism that requires a larger frame and fixed openings

We can add that the openings that allow light to enter Hall B are of two kinds: the first set has automatic opening mechanisms to air the room, whereas another series is fixed. The two configurations have different thicknesses, which makes it more difficult to calculate their thickness. (Figure 3c 5.8) Lastly, it is still useful to point out that walking on the surface of the bituminous sheath of the roof causes rainwater leaks that infiltrate inside the membrane.

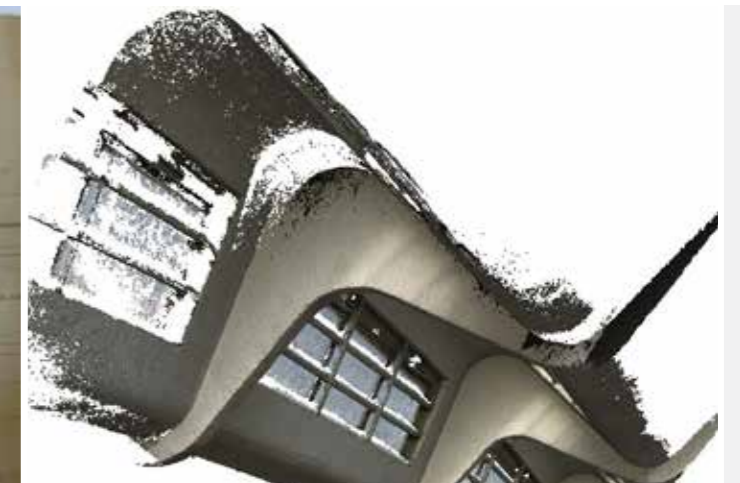
3c 5.9. (left): An in-depth study of the wave element of the Hall B vault in a very detailed drawing by Pier Luigi Nervi (CSAC, Università di Parma, courtesy Fondation PLN Project); (right) a view of the point cloud derived from close range photogrammetry of the same constructive element.

Subsequently, the portion detected by close-range photogrammetry using images acquired from close range through the elevator was selected as the sample surface (Figure 3c 5.9). This careful combination of medium surfaces led to the vectorization of the sections of the large, vaulted structure shown in the panels of the architectural drawings (Figures 3c 5.10)
