Point clouds and surface analyses to detect anomalies

Point clouds and surface analyses to detect anomalies / Sammartano, Giulia; Patrucco, Giacomo; Perri, Stefano; Spano', Antonia - In: The Halls of Turin Exhibition Center by Pier Luigi Nervi: a multi-disciplinary approach for diagnosis and preservationELETTRONICO. - Los Angeles : Getty foundation, 2023. - pp. 154-167

### 3c Point clouds and surface analyses to detect anomalies

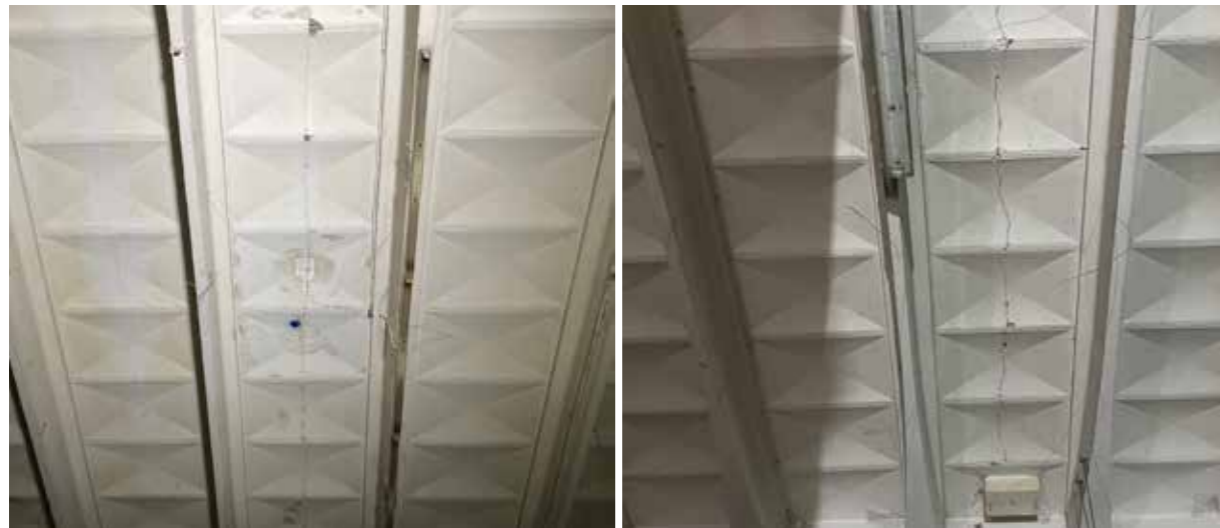
3c 2.1: Two examples of cracks running along the longitudinal direction of reinforced concrete ceiling panels. To be clearly visible even simply in a photo, the light from the flash had to pinpoint the anomaly, hence the difficulty to use photogrammetry

The examination of the point cloud and especially of the triangulated surface (mesh) made it possible to estimate and map the presence of cracks that all ran parallel to the direction of the prefabricated, reinforced concrete panels (Figures 3c 2.1 and 3c 2.2).

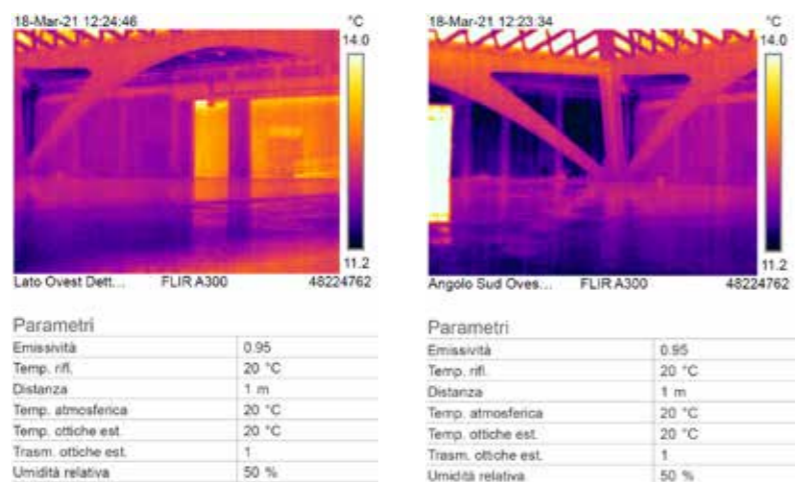
3c.3.2: Two examples of thermograms acquired by A. Manuello and E. Lenticchia and reported in Chapter 5a 4.7; the second image shows an anomaly, in the height of the pilasters and the ring beam, which suggested the Geomatics group should conduct a more in-depth analysis.

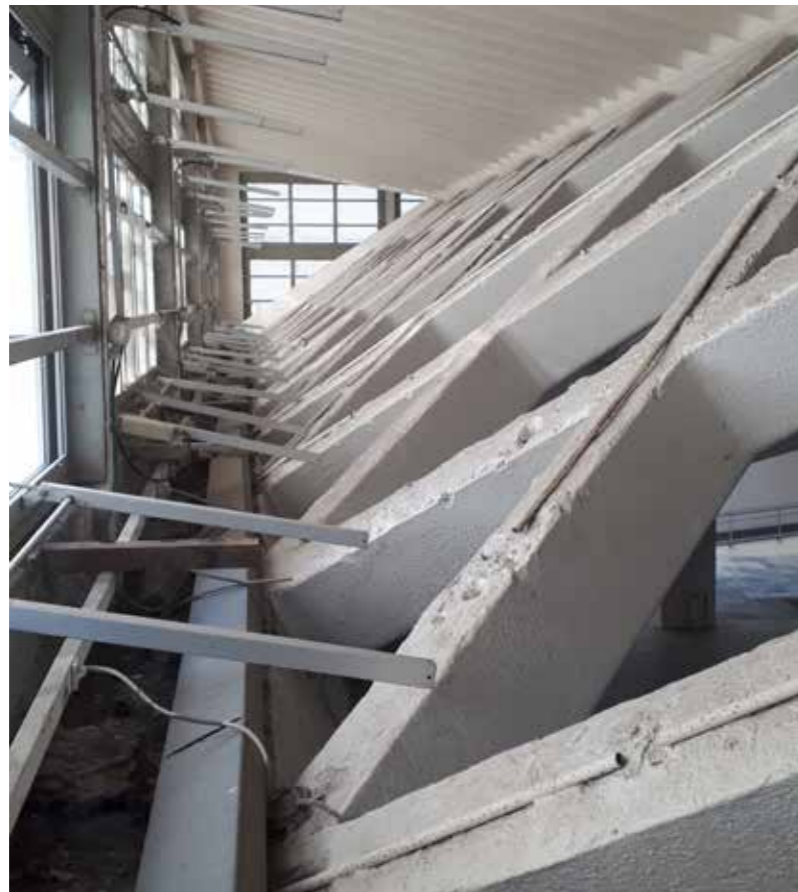
3c 5.2: A view of the vaulted portion of Hall C without panels between the ribs to allow the hall to be illuminated.

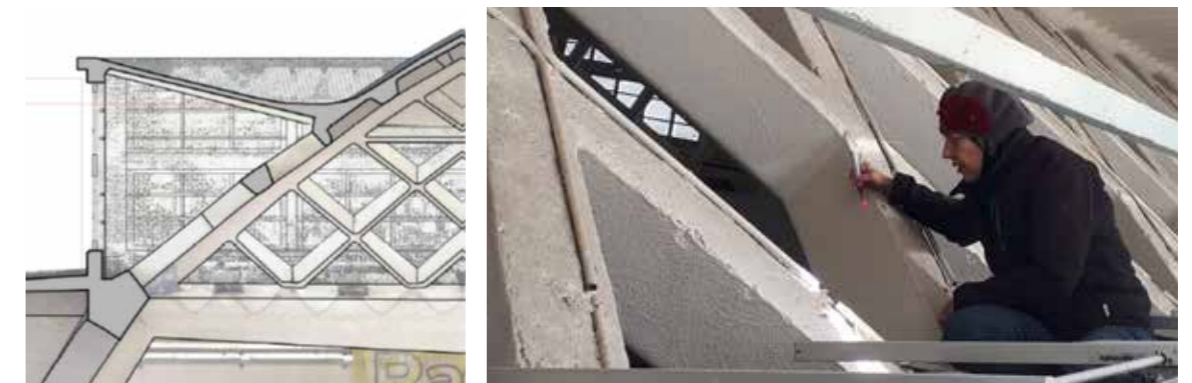
3c 5.4: A view of the same construction detail using the drawing with the overlapped orthophoto and a phase of the topographic measurement to assess the intrados-extrados relationship.

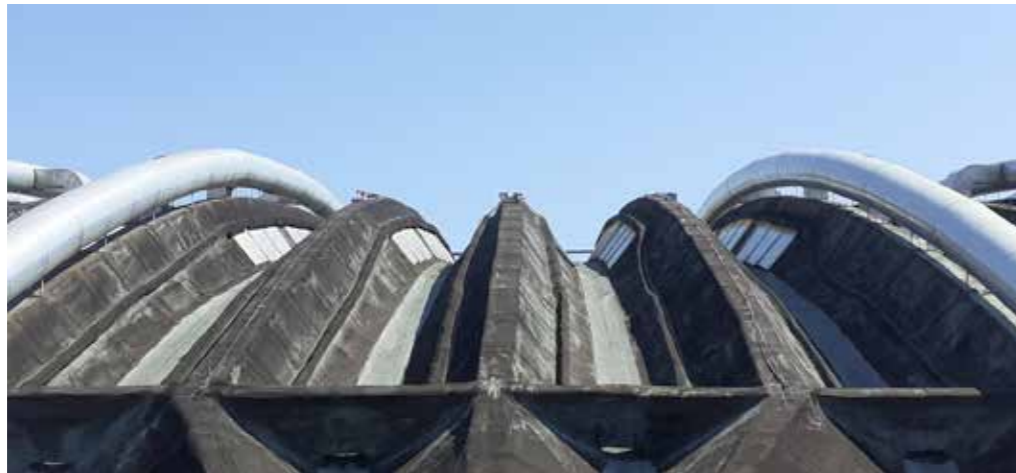
3c 5.6: A view of the impressive shape of the parabolic-like waves of Hall B, with surfaces not oriented in favor of the incidence of the projecting rays of the photogrammetric blocks of images.

As regards the shape of the waves of the roof of Hall B, the measurement and verification operations were far more complicated (Figure 3c 5.6). First of all, we should point out, that the direction of the projecting rays appears to be useful for solving the photogrammetric problem from the aerial perspective of the UAV, the smooth surfaces of Hall C and the apse dome certainly offered surfaces with easier directions to reconstruct.

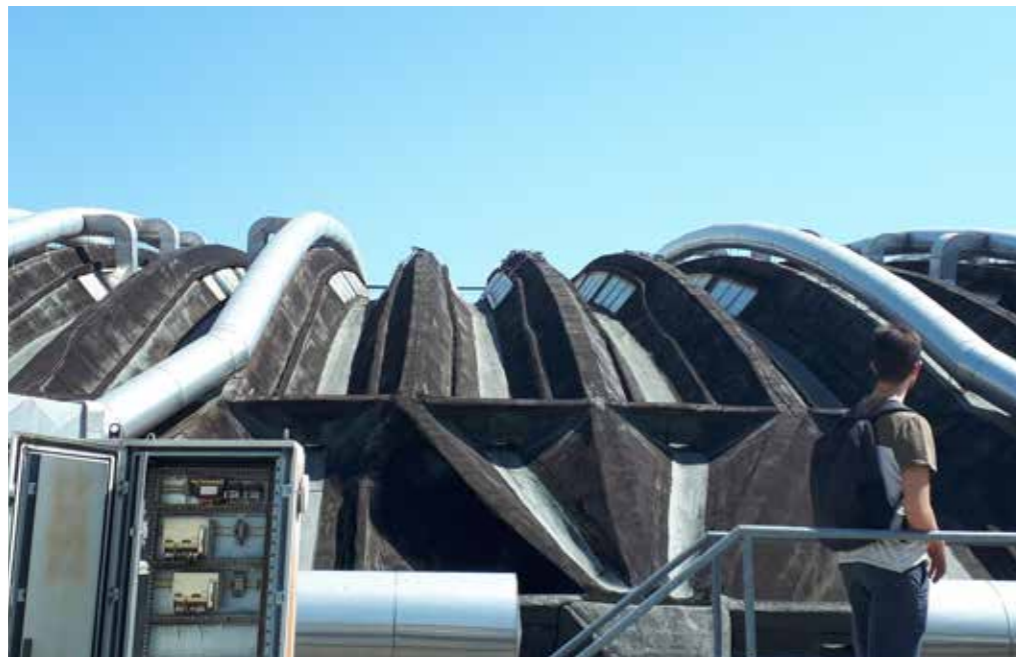
3c 5.7: Presence of a high quantity of systems and surfaces made of reflective materials in the roof of Hall B

It should also be noted that the roof of the wave vault has a series of superstructures relating to the systems with reflective surfaces (pipelines and skylights), which are particularly critical for the photogrammetric technique based on visible spectrum images (Figure 3c 5.7).

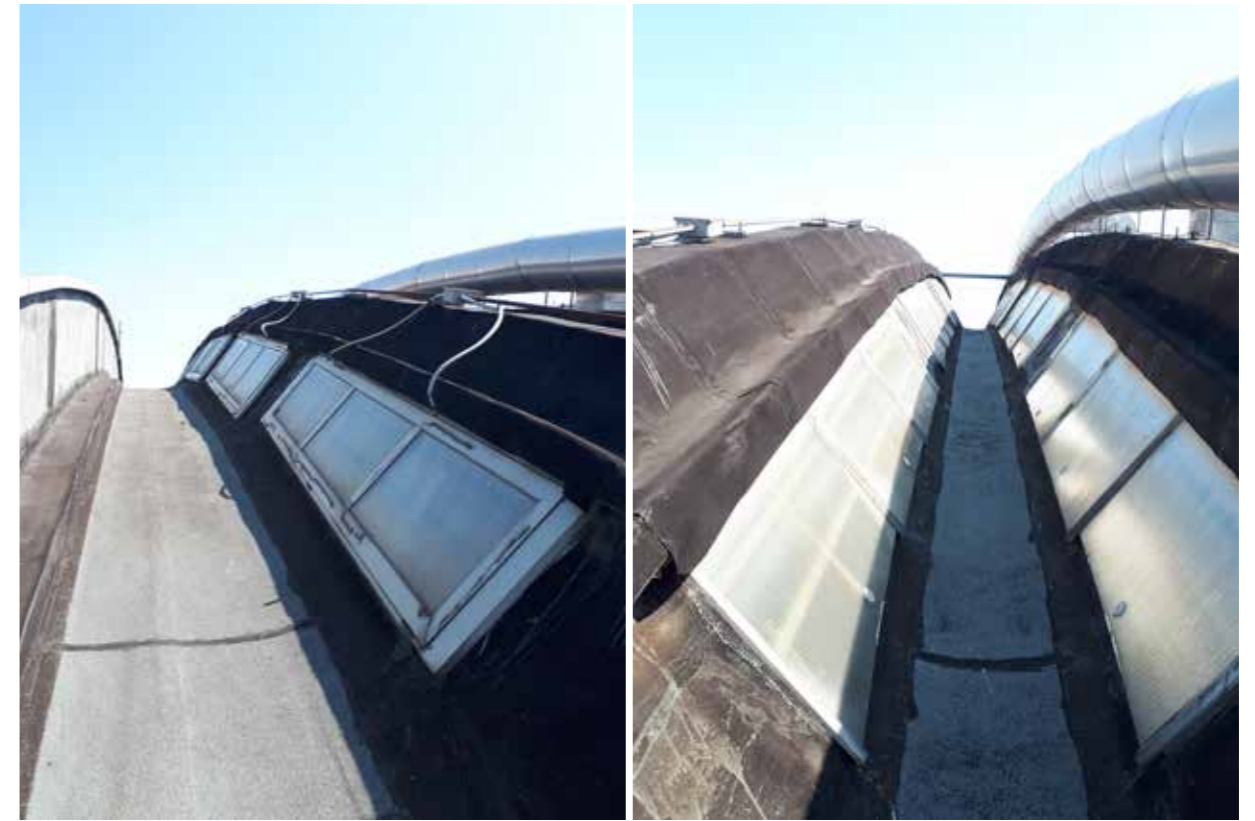
3c 5.8: Different types of skylights in the roof of Hall B, with an automatic opening mechanism that requires a larger frame and fixed openings

We can add that the openings that allow light to enter Hall B are of two kinds: the first set has automatic opening mechanisms to air the room, whereas another series is fixed. The two configurations have different thicknesses, which makes it more difficult to calculate their thickness. (Figure 3c 5.8) Lastly, it is still useful to point out that walking on the surface of the bituminous sheath of the roof causes rainwater leaks that infiltrate inside the membrane.

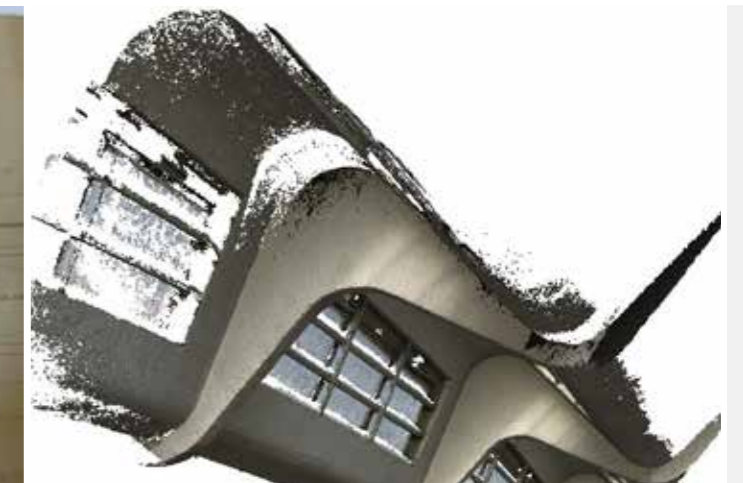
3c 5.9. (left): An in-depth study of the wave element of the Hall B vault in a very detailed drawing by Pier Luigi Nervi (CSAC, Università di Parma, courtesy Fondation PLN Project); (right) a view of the point cloud derived from close range photogrammetry of the same constructive element.

Subsequently, the portion detected by close-range photogrammetry using images acquired from close range through the elevator was selected as the sample surface (Figure 3c 5.9). This careful combination of medium surfaces led to the vectorization of the sections of the large, vaulted structure shown in the panels of the architectural drawings (Figures 3c 5.10)
