Point clouds and surface analyses to detect anomalies

Point clouds and surface analyses to detect anomalies / Sammartano, Giulia; Patrucco, Giacomo; Perri, Stefano; Spano', Antonia - In: The Halls of Turin Exhibition Center by Pier Luigi Nervi: a multi-disciplinary approach for diagnosis and preservationELETTRONICO. - Los Angeles : Getty foundation, 2023. - pp. 154-167

3c Point clouds and surface analyses to detect anomalies

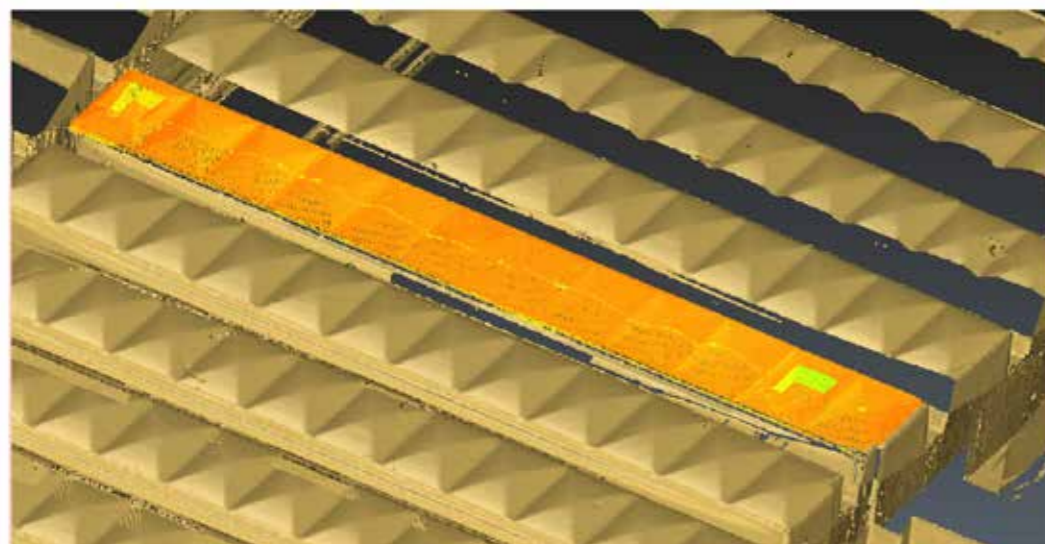
3c 2.2: A view of the triangulated surface (mesh) of a portion of the basement ceiling of Hall B; a portion of the cloud of points relating to a row of prefabricated panels was superimposed to better highlight the reading of the crack

The examination of the point cloud and especially of the triangulated surface (mesh) made it possible to estimate and map the presence of cracks that all ran parallel to the direction of the prefabricated, reinforced concrete panels (Figures 3c 2.1 and 3c 2.2).

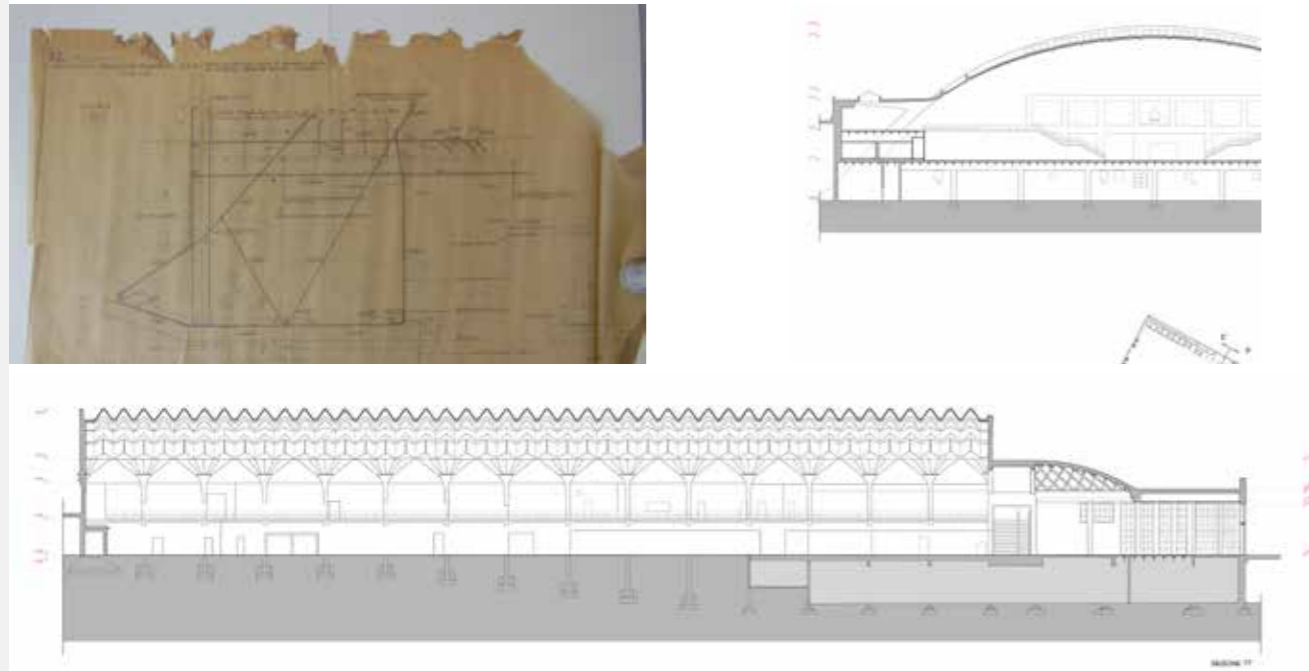
3c.3.1: Completion of the architectural drawings with the integration of the design of the foundations according to Pier Luigi Nervi's design drawings. (above, left) the foundation of an inclined pillar (CSAC, Università di Parma, courtesy Fondation PLN Project), (above right) an extract of Section EE', (below) longitudinal section TT', performed not in the centre line.

the Nervi project documented by the project drawings (CSAC, Università di Parma, courtesy Fondation PLN Project); as regards Hall B, since all the inclined pillars are an integral part of the architectural design of the room space, they are in full view and there is no doubt as to the location of the foundations (Figure 3c.3.1)

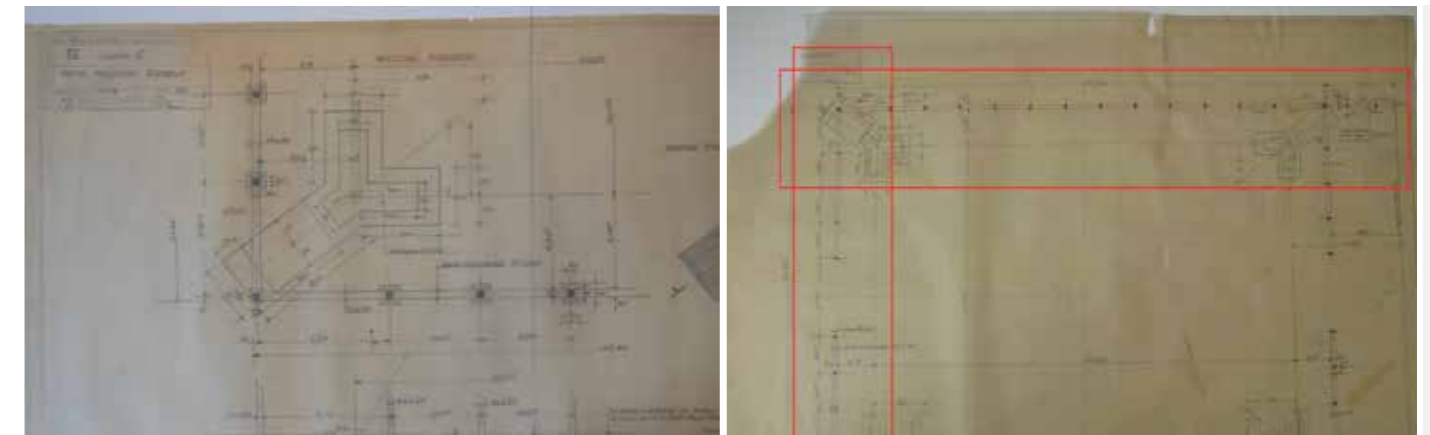
3c.3.3: Plan of the foundations of Hall C, and (above) a detail of the foundation plinth positioned at the corners of the room.

As regards the drawings in Figure 3c.3.3, the foundations feature four large plinths positioned respectively at the four top corners of the hall. They are made of reinforced concrete and support the four arches of the hall. As regards the perimeter walls, the 40x30 cm section pillars disappear into the masonry and the angular pillars resting on the plinths that support the arches have a 40x40 cm cross-section.²

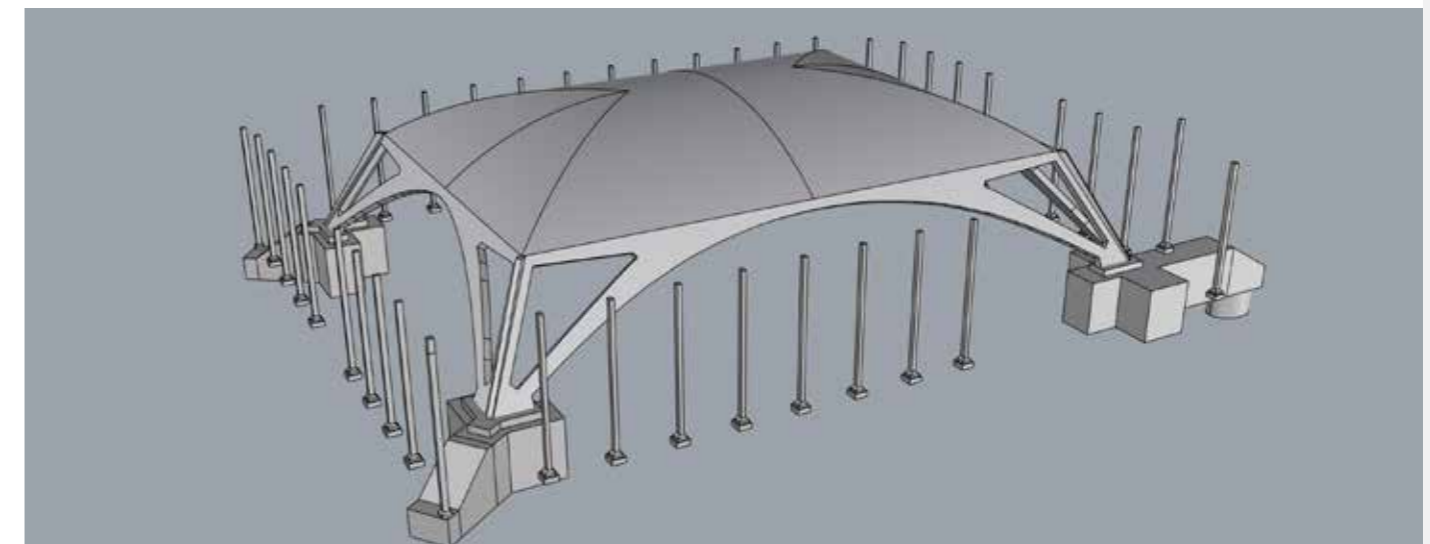
3c.3.4: A 3D model generated from Nervi's drawing, focusing on the main structural elements of Hall C (foundations, pillars, arches, and the vault.) (elab. Cofano)

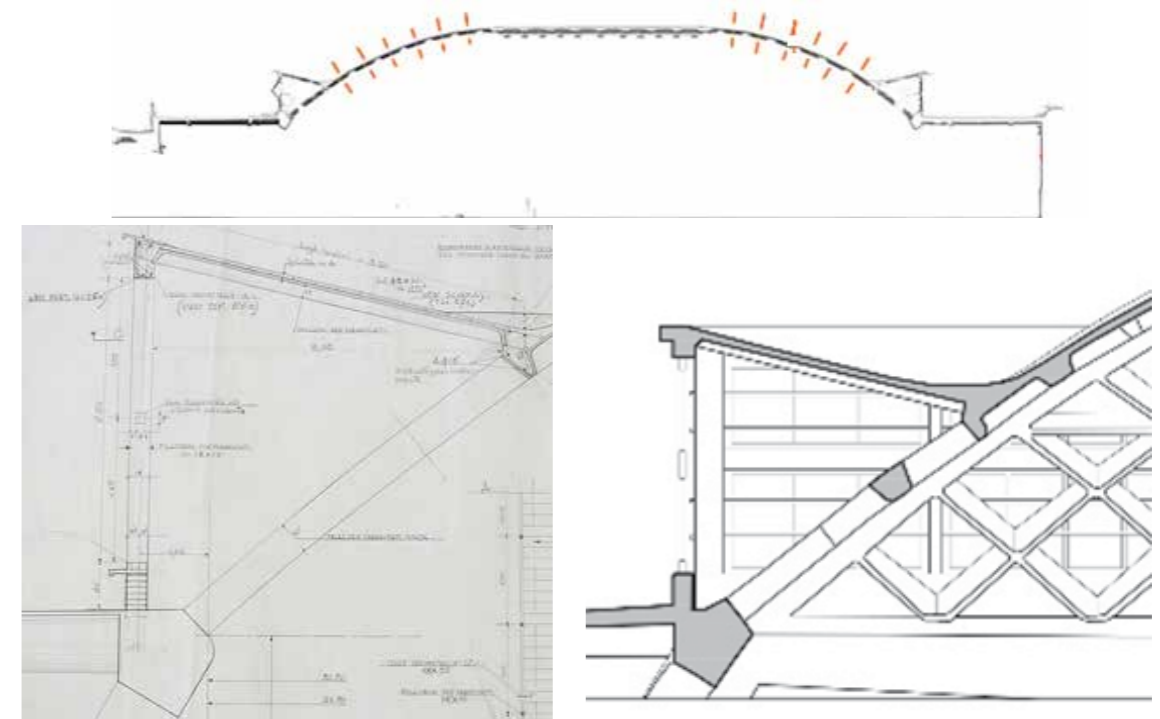
3c 5.3: Correspondence between sections of the reality-based point model and archive drawings (CSAC, Università di Parma, courtesy Fondation PLN Project). In orange, the 12 thickness measurement points were verified on the cloud, and in red the longitudinal verification was directed on the skylight of Hall C.

Starting from Hall C, particular interest was dedicated to the possibility of verifying the correspondence of the ferrocement elements of the design phase with the actual construction, thanks to a reality-based model. To do this, the archive drawings relating to Hall C were analyzed and a correspondence was created with the real sections [figure 3c.5.3]. The expected thickness of the latter was 5cm, with the addition of a 2cm

waterproof sheath. It was decided to verify this correspondence on the 3D model using a sample of 12 points distributed on the curvature of the envelope. The average value calculated from this sample of measurements was 7.4 cm, with a standard deviation of 1.2 cm. These values would prove to be perfectly consistent with Nervi's project. However, this thickness of the envelope, which cannot be verified empirically, was replaced by a further verification based on a direct measurement performed on the perimeter skylight, Figure 3c.5.4. This results in a residual 1 cm error from the 3D cloud with respect to the project drawing, Figure 3c.5.3.

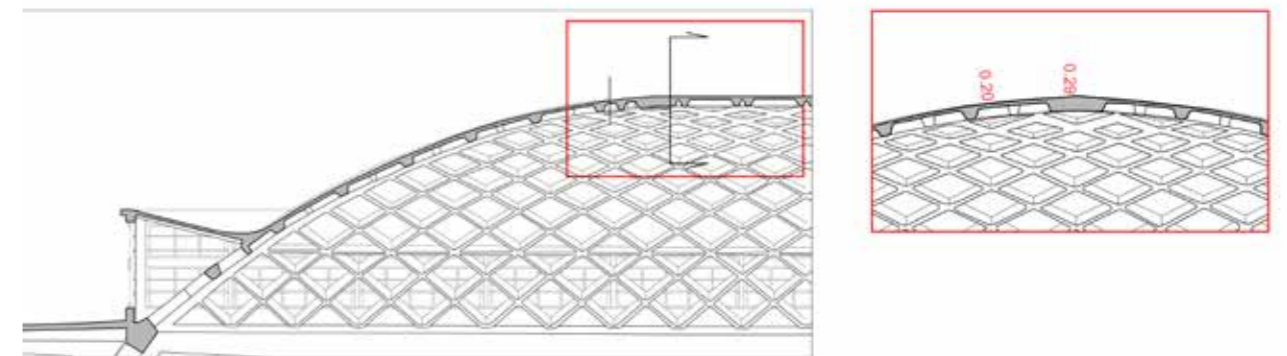
3c 5.5: A final drawing representing the dimensional relations between the envelope thickness and the ribs.

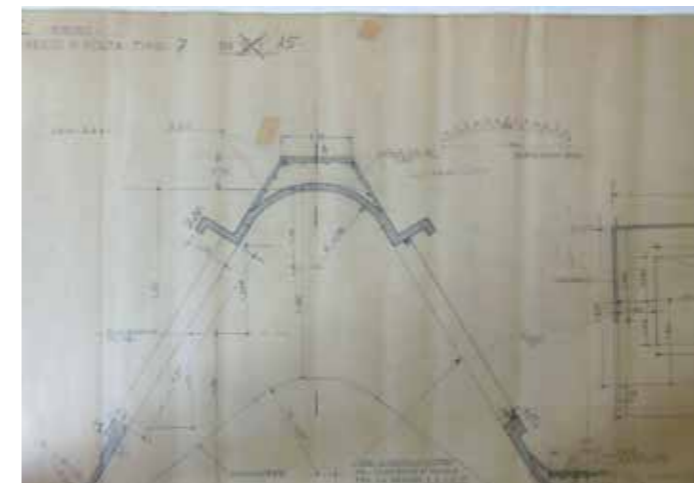
3c 5.9. (left): An in-depth study of the wave element of the Hall B vault in a very detailed drawing by Pier Luigi Nervi (CSAC, Università di Parma, courtesy Fondation PLN Project); (right) a view of the point cloud derived from close range photogrammetry of the same constructive element.

Subsequently, the portion detected by close-range photogrammetry using images acquired from close range through the elevator was selected as the sample surface (Figure 3c 5.9). This careful combination of medium surfaces led to the vectorization of the sections of the large, vaulted structure shown in the panels of the architectural drawings (Figures 3c 5.10)

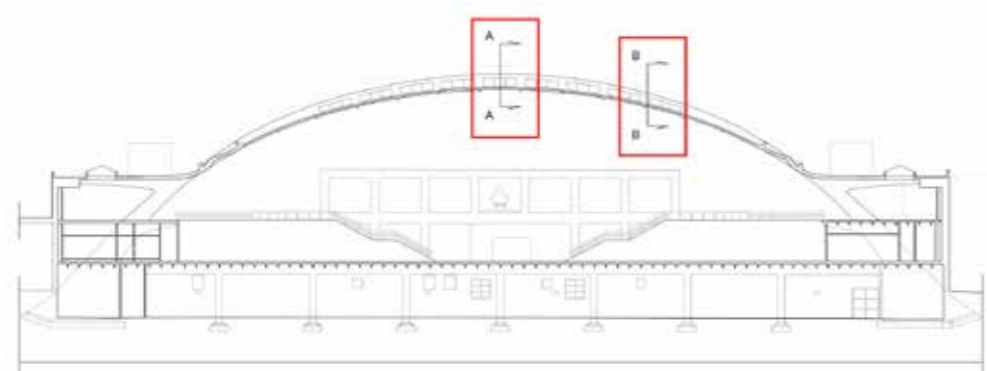
3c 5.10: Studies to calculate the thicknesses of the envelope of the vault of Hall B, and related architectural drawings in cross-section.

In essence, the strategy adopted to determine the envelope of the undulated thin-shell vault of Hall B was as follows: a targeted photogrammetric process of the aerial block of images was re-performed, using only the images pertaining to the coverage of Hall B and an attempt was made to optimize the results in relation to noise and residual errors on the control points. In the light of this result, careful extraction of the average surface was carried out along the entire extension of the extrados of the undulated vault.
