Dynamic measurements for assessing bridge response to foundation scour

M. Aimar, M. Civera, B. Chiaia, S. Foti, A. Quattrone & D. Sabia

1 INTRODUCTION: FOUNDATION SCOUR IN RIVER BRIDGES

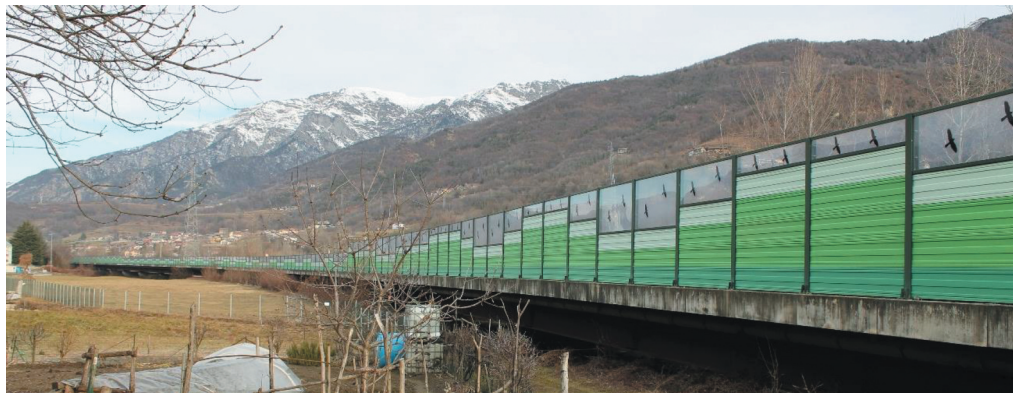
Figure 1. Side view of the Inverso Pinasca bridge in its full length, as captured during preliminary in situ surveys (February 3rd, 2023).

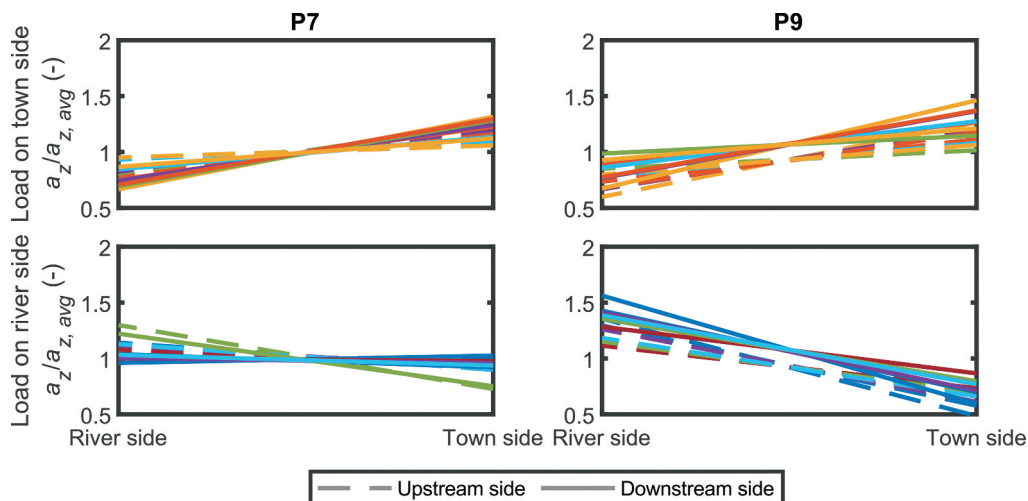
Figure 7. Estimated normalized acceleration RMS at the pier caps, for P7 and P9 and for loads applied on the town side or the river side. Results are clustered according to the considered side of the pier cap (i.e., downstream and upstream). Each color corresponds to a specific load (i.e., vehicle moving on the deck), with the continuous line representing the vibration level observed downstream and the dashed line representing the response on the upstream side.

For a quick assessment of the foundation response, this study estimated the RMS vertical acceleration (here, labelled as a_z) recorded at the vertices of each pier cap, consistently with the approach adopted in (Foti & Sabia, 2010). For a more reliable estimate, a_z was computed from 10-s long time windows extracted from the recorded data, each corresponding to the passage of a vehicle on the bridge deck. Figure 7 shows the estimated a_z for piers P7 and P9, that is, the ones with the least and the most scoured foundations. Results are clustered according to the side of the load application. Furthermore, they highlight the trend on the upstream side and the downstream side, to investigate asymmetries both in the town-river direction and along the longitudinal axis of the bridge. Finally, for each pulse considered, a_z data are normalized with respect to their average value, to remove the influence of the load entity on their magnitude.

In all the cases, a larger a_z is observed at the side corresponding to the load application, as expected. However, some relevant differences can be observed when comparing the dynamic behavior of P9 and P7. On the one hand, the spatial distribution of a_z is similar when vehicles pass on the town side, in terms of asymmetry. Instead, for loads

on the riverside, a_z is quasi-uniform in P7 (as the normalized value is almost close to the unit) whereas larger variations are observed for P9. This means that, for the same loads, the vibration levels in P9 are highly asymmetric compared to P7, due to the stiffness variations induced by foundation scour. On the other hand, in P9, a_z is significantly larger downstream than upstream. Notably, this is observed both on the town side and on the river side, for all the considered load pulses and application locations. Instead, this discrepancy is smaller in P8 (not reported here) and almost negligible in P7. This result was somewhat unexpected, as the erosion mostly acts along the longitudinal axis of the bridge and should not produce relevant differences in the response between upstream and downstream. Instead, this evidence may indicate that stiffness variations in the soil-structure system due to scour also occur along the flow direction of the river – and not only in the transverse direction, as it may be expected from the available information. This may be a consequence of the curvature of the main river channel, which results in a complex morphology of the scour hole.
