Performance of historical ferrocement specimens subjected to corrosive environments

Performance of historical ferrocement specimens subjected to corrosive environments / Lenticchia, Erica; Sorrentino, Gerardo; Ceravolo, Rosario; Tondolo, Francesco. - In: STRUCTURAL CONCRETE. - ISSN 1464-4177. - (2024).  
[10.1002/suco.202400579]

Ferrocement is a type of thin wall-reinforced concrete composed of hydraulic cement mortar reinforced with several layers of steel wire mesh. The material is used as a low-cost construction and retrofit solution and allows the creation of very thin elements. In the past, the material was also used to build some structural engineering masterpieces that currently face preservation challenges. Despite the use of the material, few studies have analyzed its durability with respect to corrosion and its evaluation for preservation purposes. The paper presents the results of a testing campaign on ferrocement replica specimens subjected to a corrosive environment. After an aggressive aging procedure, where the specimens are exposed to chloride ingress, the specimens are tested through a four-point bending test to compare their performances. Results of the mechanic

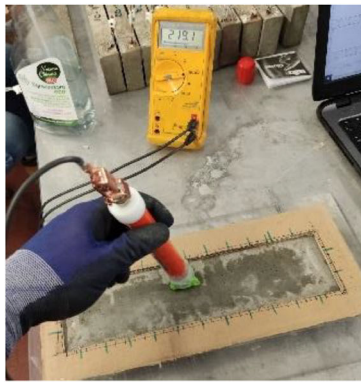
FIGURE 8 (a) Corrosion potential measurement. (b) Corrosion potential measurements scheme showing the 20 points of acquisition.

Half-cell corrosion potential measurements are carried out with a Cu/CuSO<sub>4</sub> reference electrode (Figure 8a). Half-cell corrosion potential is measured before starting the aging cycle, and every 2 weeks, during the aging process. All the data collected are evaluated in accordance ASTM C876 Guidelines<sup>35</sup> for corrosion potential of reinforcement steel without cover in concrete. The values are evaluated as follows:

(Figure 8b). Before performing the measurements, the treated surface is wetted by spraying water.
