Performance of historical ferrocement specimens subjected to corrosive environments

Abstract

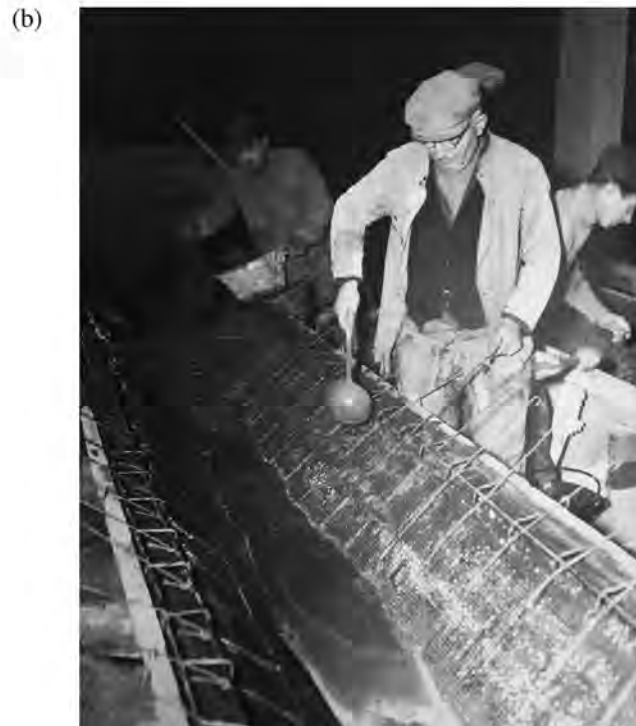
FIGURE 2 (a) Illustration of construction details related to ferrocement corrugated beams.³⁰ It is possible to appreciate the number of the wire mesh layers and the variations in thickness in the cross section. (b) Prefabrication on site of the undulated beams in ferrocement (1949–1950).¹⁷

The corrugated beam consisted of a precise combination of reinforcement, with wire mesh and high-quality cement mortar. Its cross-sectional area was not constant but increased from the outside inward towards the arches, where it reached its maximum size (Figure 2a). The element was 0.94 m wide, 9.5 m long, as mentioned

before, and with a height ranging from 0.26 to 0.44 m at the highest part. It is a modular element with remarkable strength characteristics, despite its slight thickness (2–4 cm). From the original design, the internal reinforcement of the corrugated beam in Hall C consisted of three layers of wire mesh weighing 0.600 kg/m^2 , both above and below the ordinary reinforcement, to form the characteristic curved shape^{25,27,30} (Figure 2b).

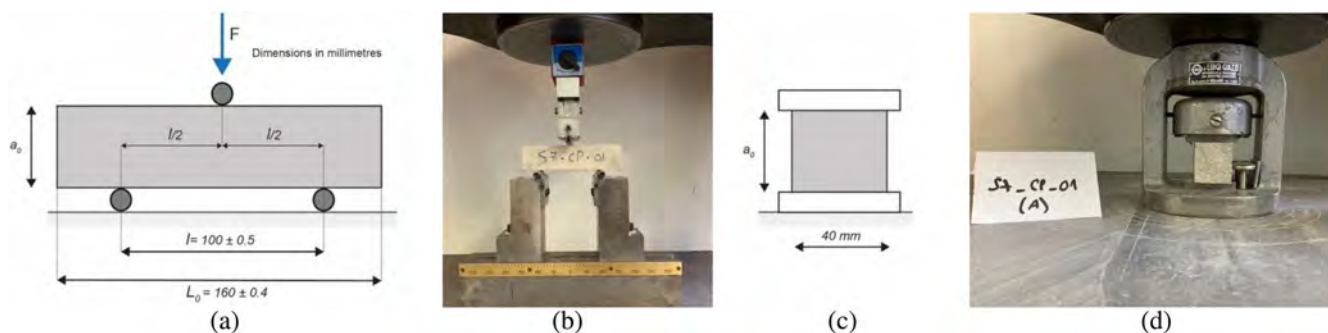
FIGURE 4 Setup of the characterization of the cement matrix: Scheme of the setup according to the EN ISO 1015-11 for the three-point bending test (a) and the actual test (b); scheme of the setup according to the EN ISO 1015-11 (c) and the compressive test (d).

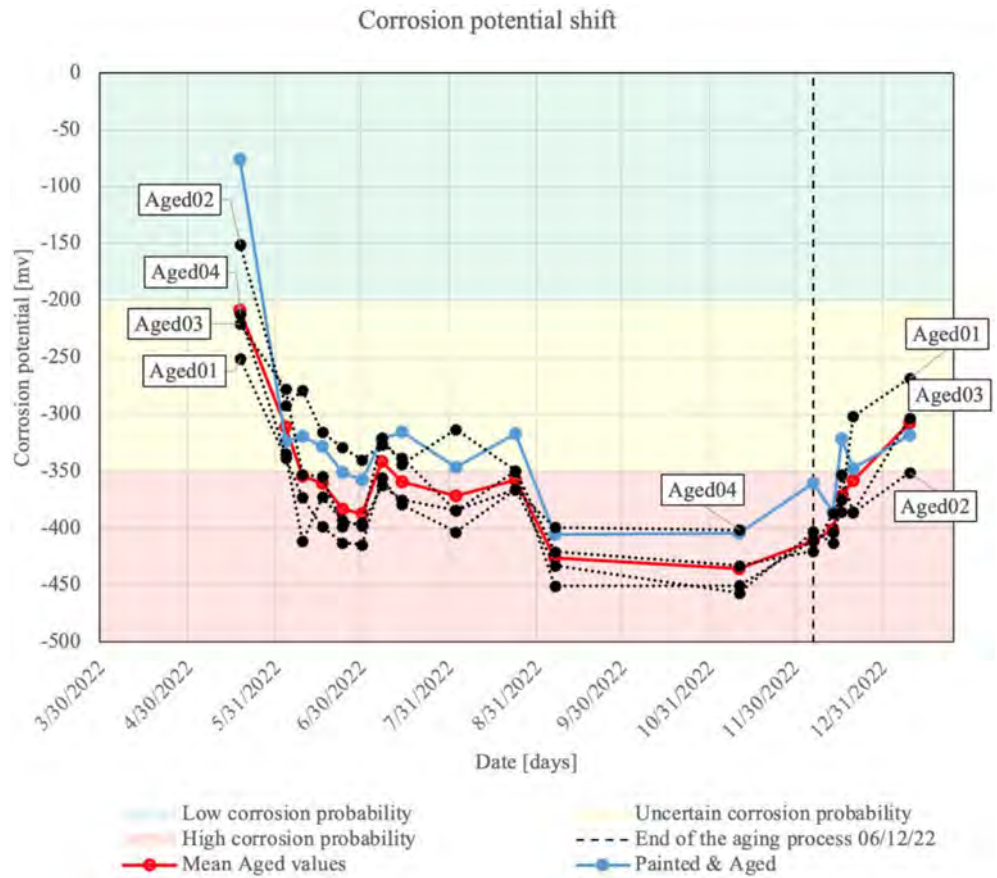
FIGURE 9 Corrosion potential shift the samples monitored during the 6 months aging period. The dotted line represents the stopping point of the aging process, after which the specimens were left to dry in a protected environment. One of the samples was treated with a layer of water-based acrylic paint in order to better simulate the exposure situation in the halls.

The results of the half-cell potential tests carried out during the aging procedure are depicted in Figure 9. The dotted line represents the stopping point of the aging process, after which the specimens were left to dry in a protected environment. It is important to highlight that half-cell corrosion potential measurements were used to monitor changes in the performance of the samples during time. It has been largely demonstrated that half-cell potential tests carry out large uncertainties and are greatly affected by environmental conditions and other factors.¹ To overcome as much as possible this bias, the singles measurements values were taken as a mere
