Performance of historical ferrocement specimens subjected to corrosive environments

Performance of historical ferrocement specimens subjected to corrosive environments / Lenticchia, E., Sorrentino, G., Ceravolo, R., Tondolo, F.. - In: STRUCTURAL CONCRETE. - ISSN 1464-4177. - 26:5(2025), pp. 5785-5806. [10.1002/suco.202400579]

ARTICLE

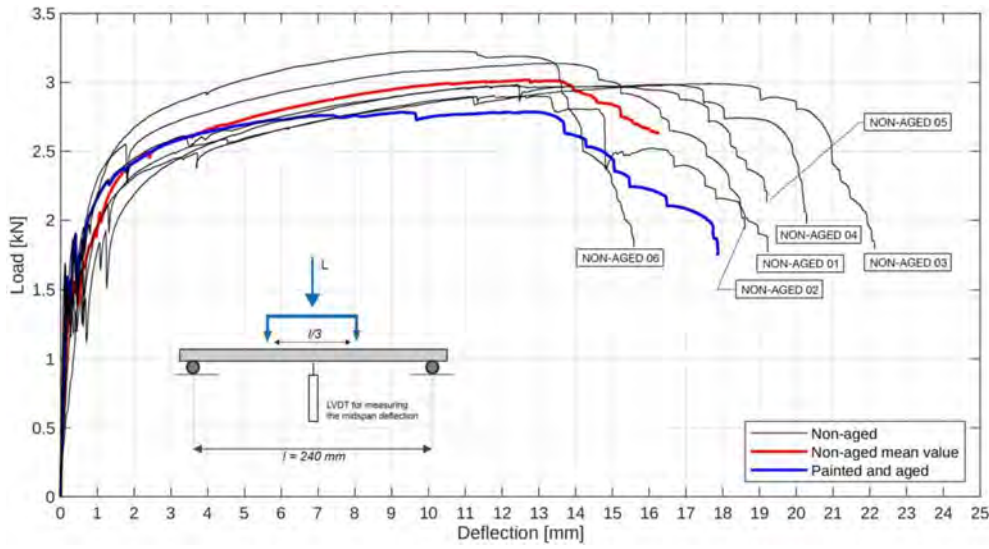
FIGURE 14 Four-point bending test load-deflection pattern, non-aged samples + painted and aged.
