Performance of historical ferrocement specimens subjected to corrosive environments

Performance of historical ferrocement specimens subjected to corrosive environments / Lenticchia, E., Sorrentino, G., Ceravolo, R., Tondolo, F.. - In: STRUCTURAL CONCRETE. - ISSN 1464-4177. - 26:5(2025), pp. 5785-5806. [10.1002/suco.202400579]

ARTICLE

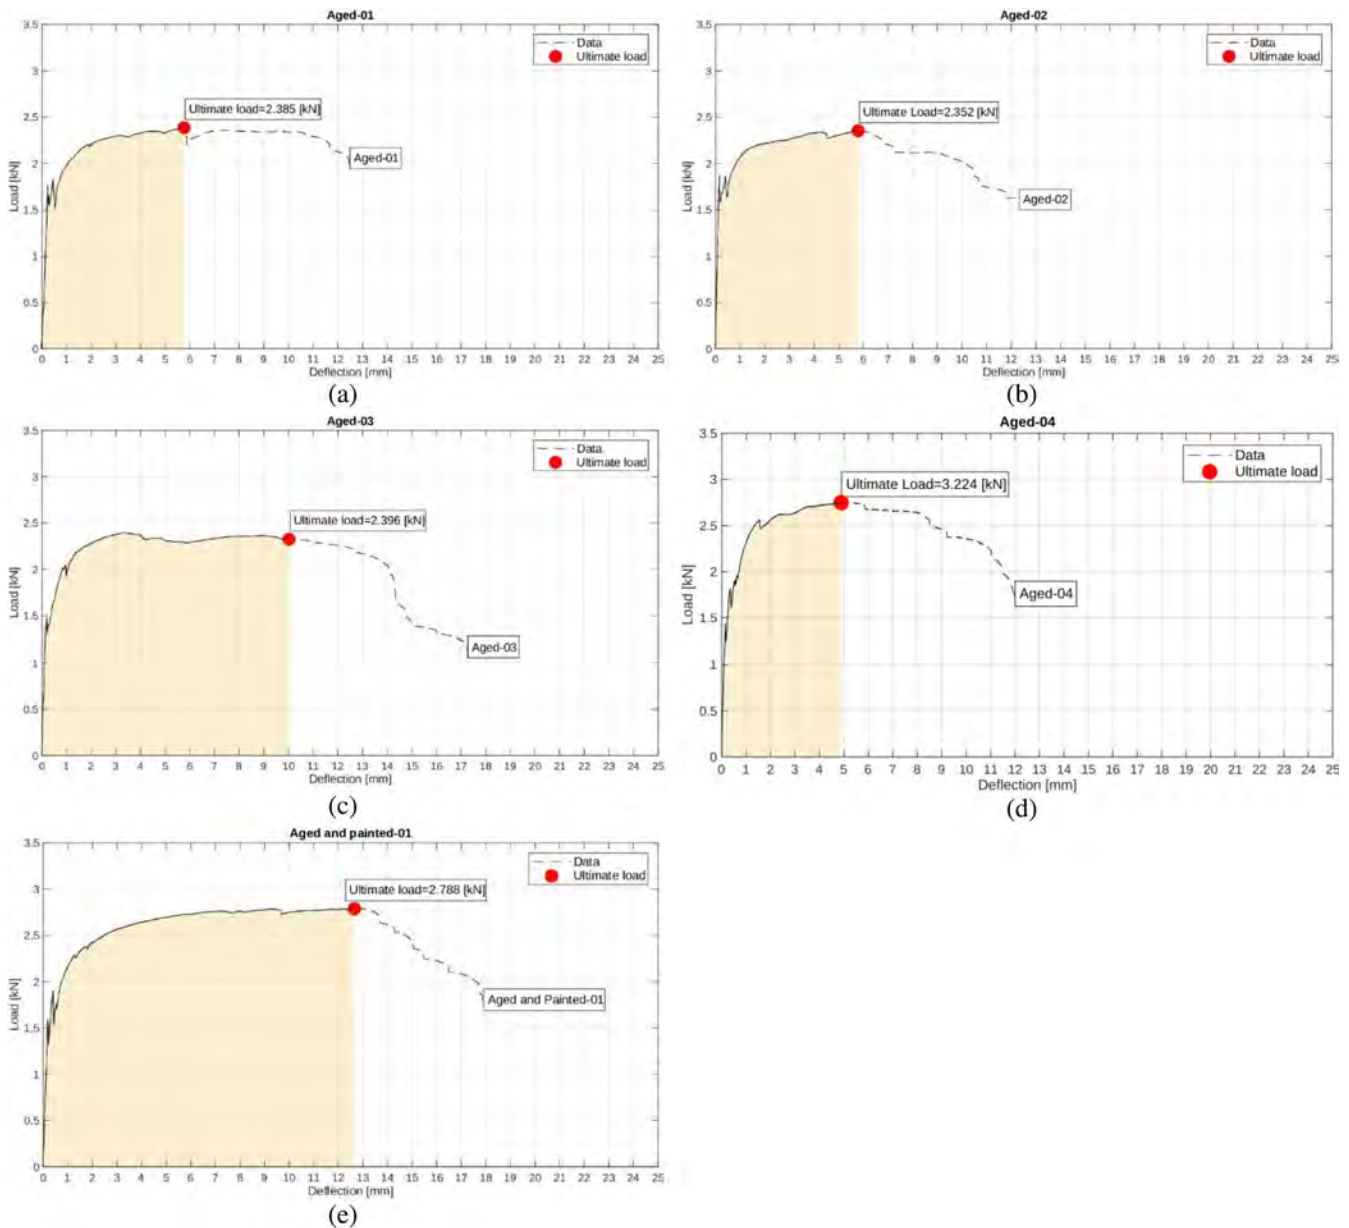
FIGURE 13 Four-point bending test load-deflection pattern with ultimate load point and work highlighted, aged samples from (a) to (d), painted and aged (e).

Table 9 reports the results of the flexural tests of aggregated samples in terms of ultimate load and δ_u (defined as the deflection at the ultimate load). Results are used to evaluate the mechanical properties of the ferrocement samples by comparing the performance of the aged and non-aged ones. Table 10 reports the results in terms of mean values and their standard deviation for each parameter (ultimate load, work, and δ_u). The comparison is done in terms of percentage loss compared to the non-aged samples; moreover, an additional parameter useful to evaluate the ductility of the material is by comparing the loss of work, which is represented by the underlying area of the load-deflection (Figures 13 and 15).
